January 27, 2022

Project No. 0352436

Subject: CCR Units – 2021 Annual Inspection and Fugitive Dust
Control Report
Calaveras Power Station
San Antonio, Texas

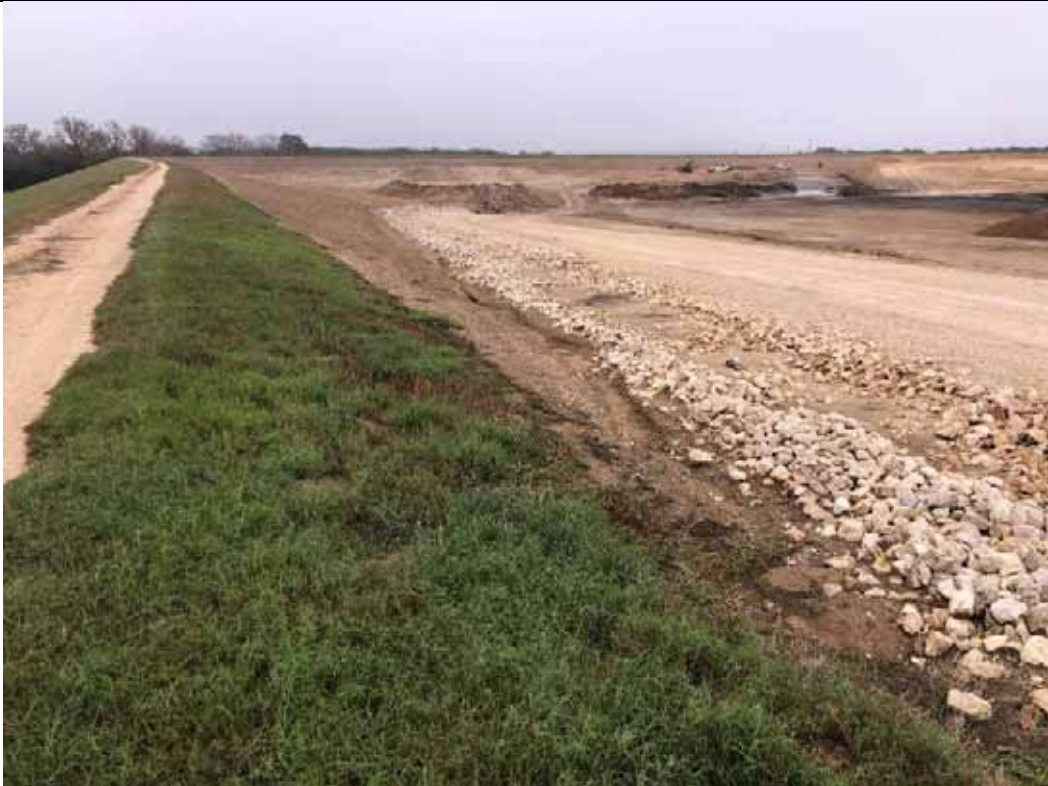
Photograph: 1 Fly Ash Landfill – standing on northwest corner – facing west.
Photo taken 12/14/2021.

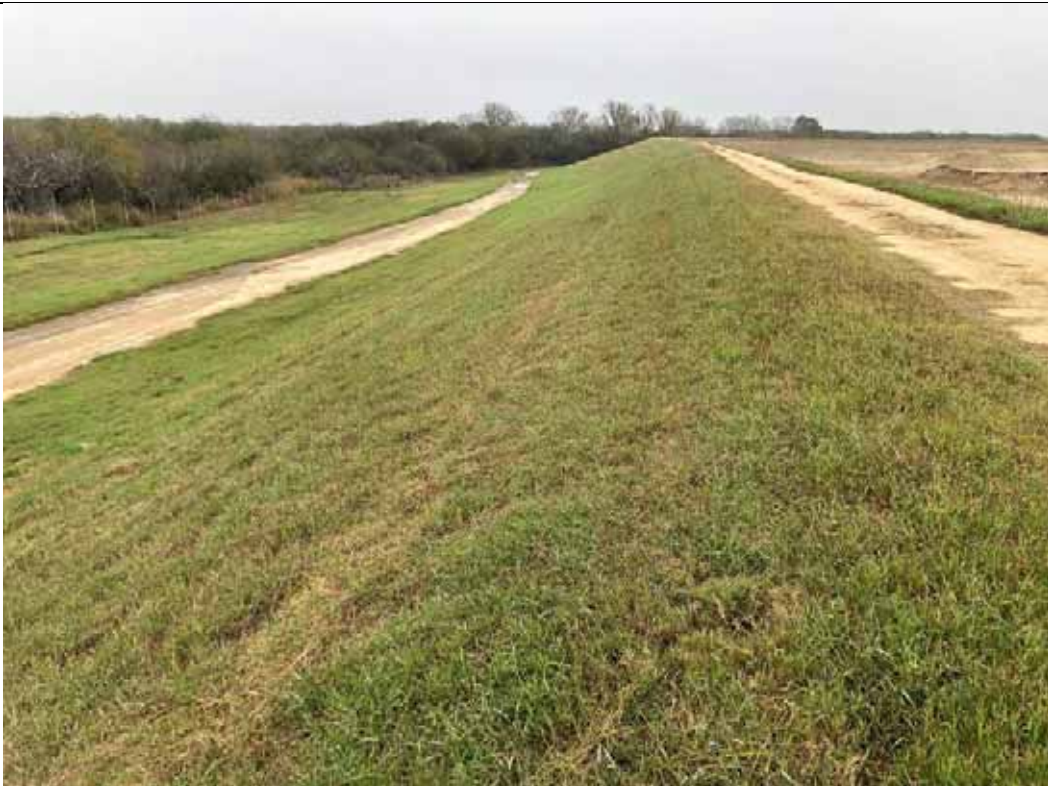
Photograph: 2 Fly Ash Landfill – standing on northwest corner – facing west.
Photo taken 12/14/2021.

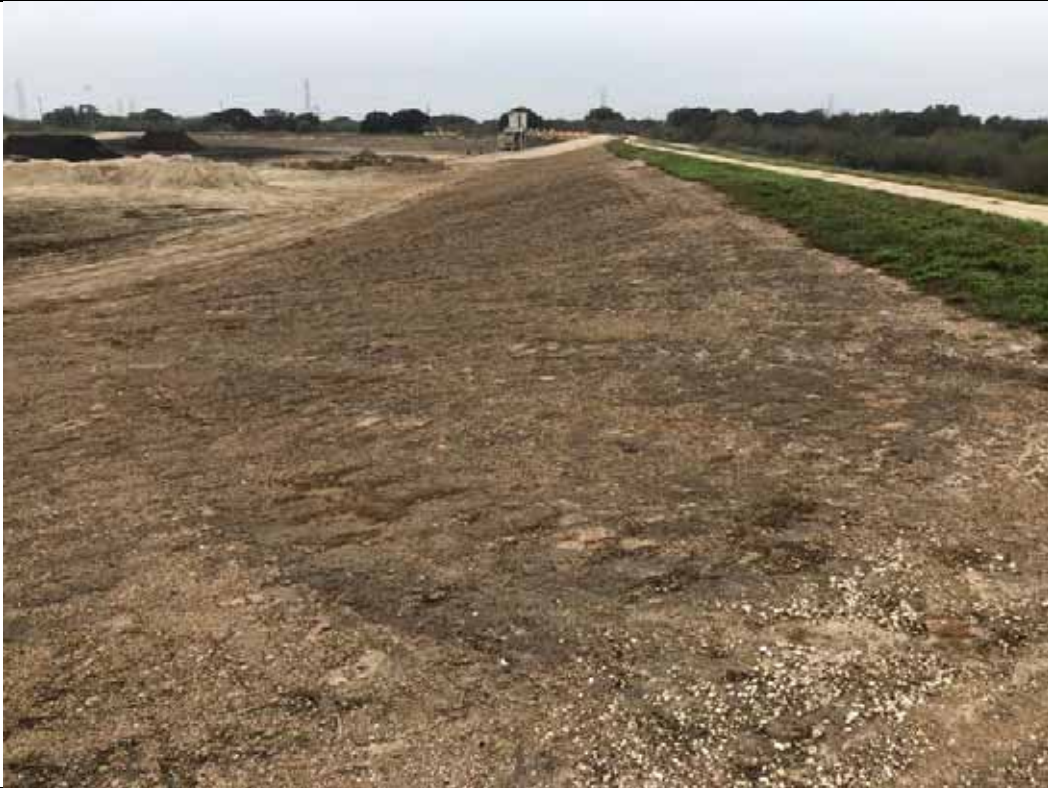
Photograph: 3 Fly Ash Landfill – standing on northwest corner – facing south.
Photo taken 12/14/2021.

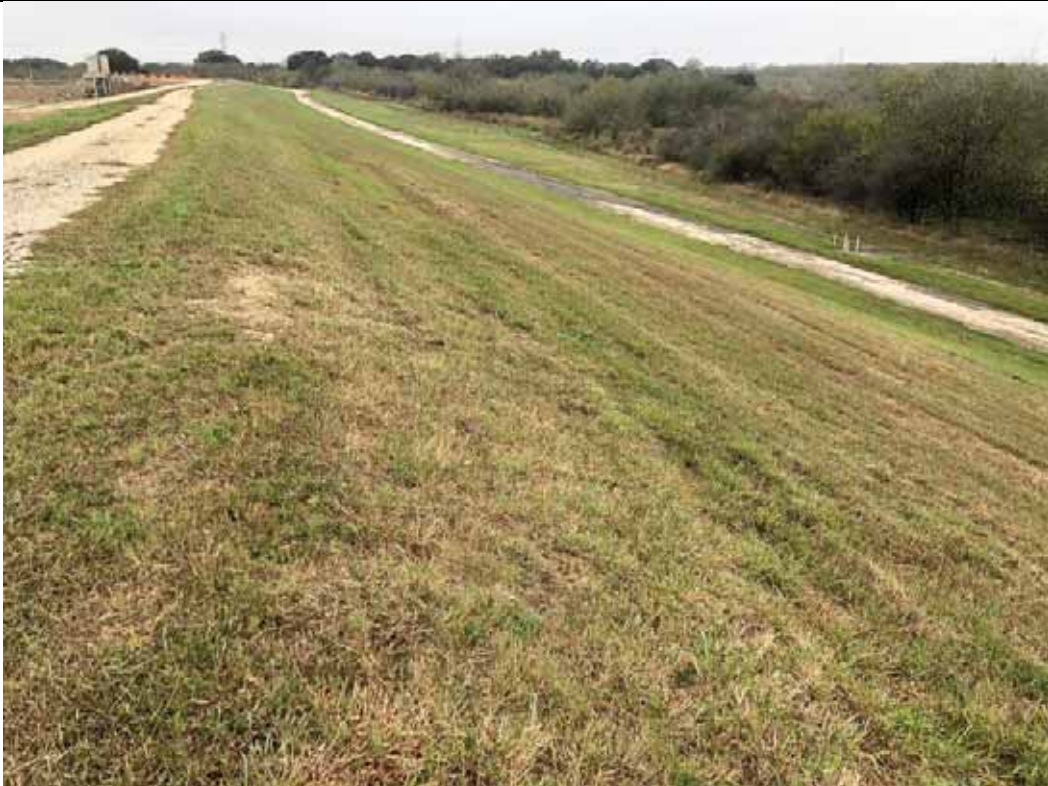
Photograph: 4 Fly Ash Landfill – standing on northwest corner – facing south.
Photo taken 12/14/2021.

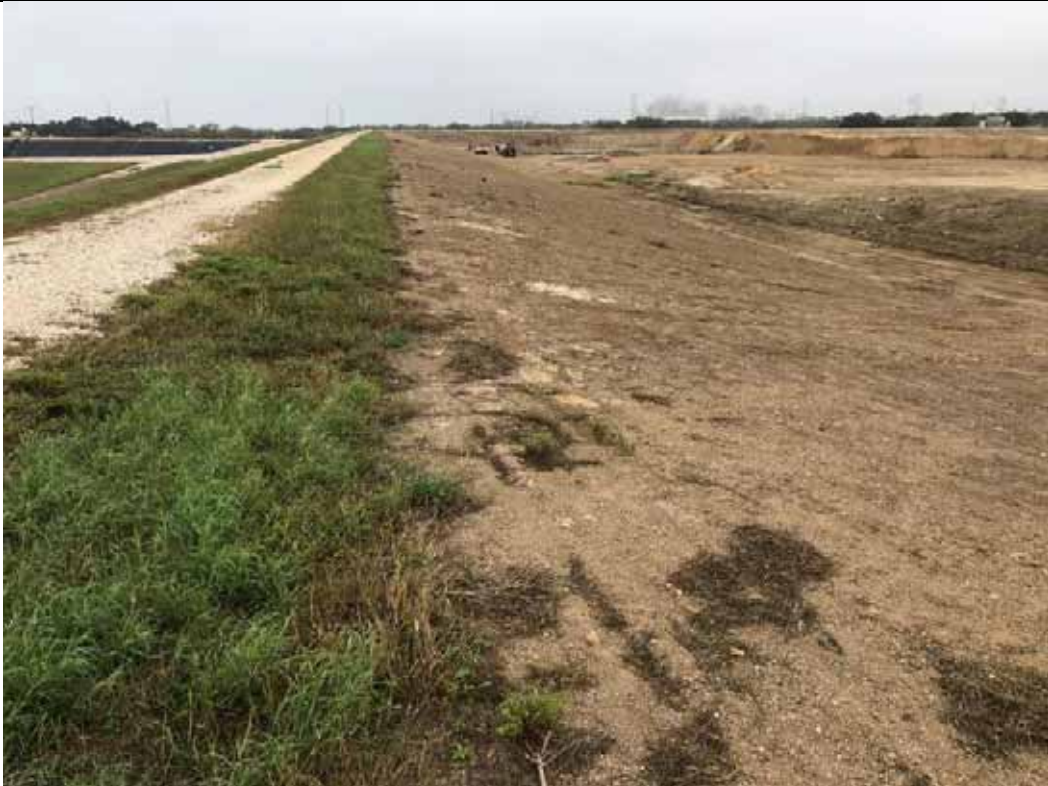
Photograph: 5 Fly Ash Landfill – standing on northeast corner – facing south.
Photo taken 12/14/2021.

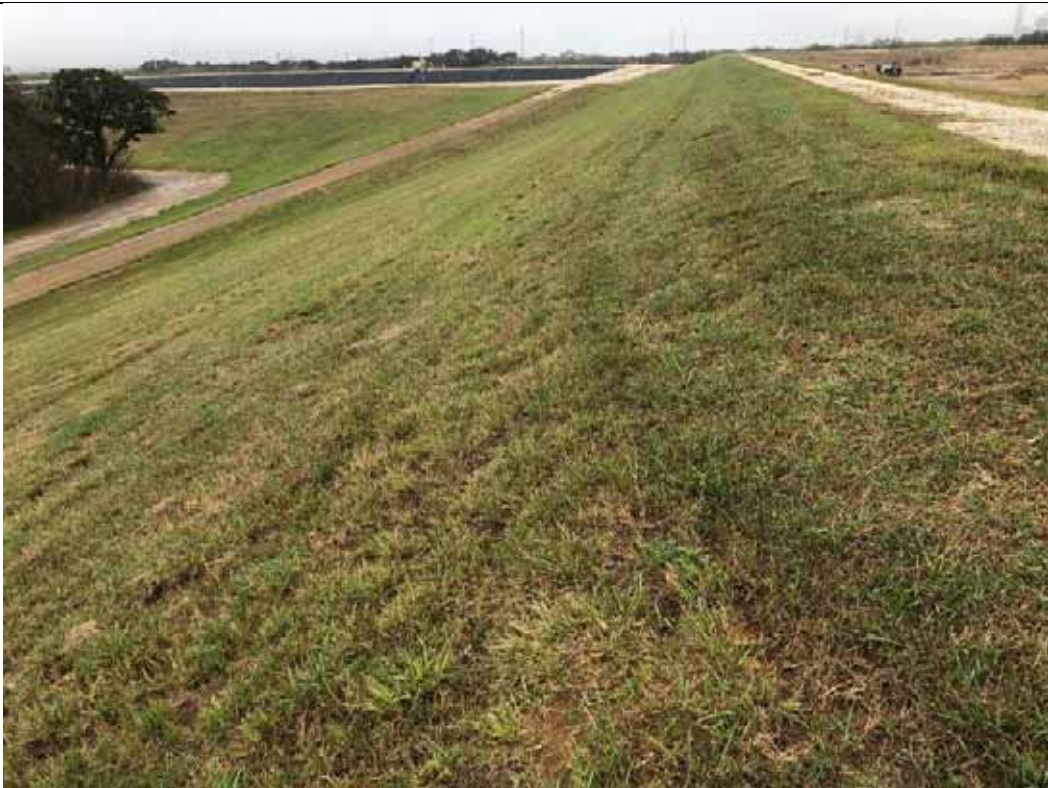
Photograph: 6 Fly Ash Landfill – standing on northeast corner – facing south.
Photo taken 12/14/2021.

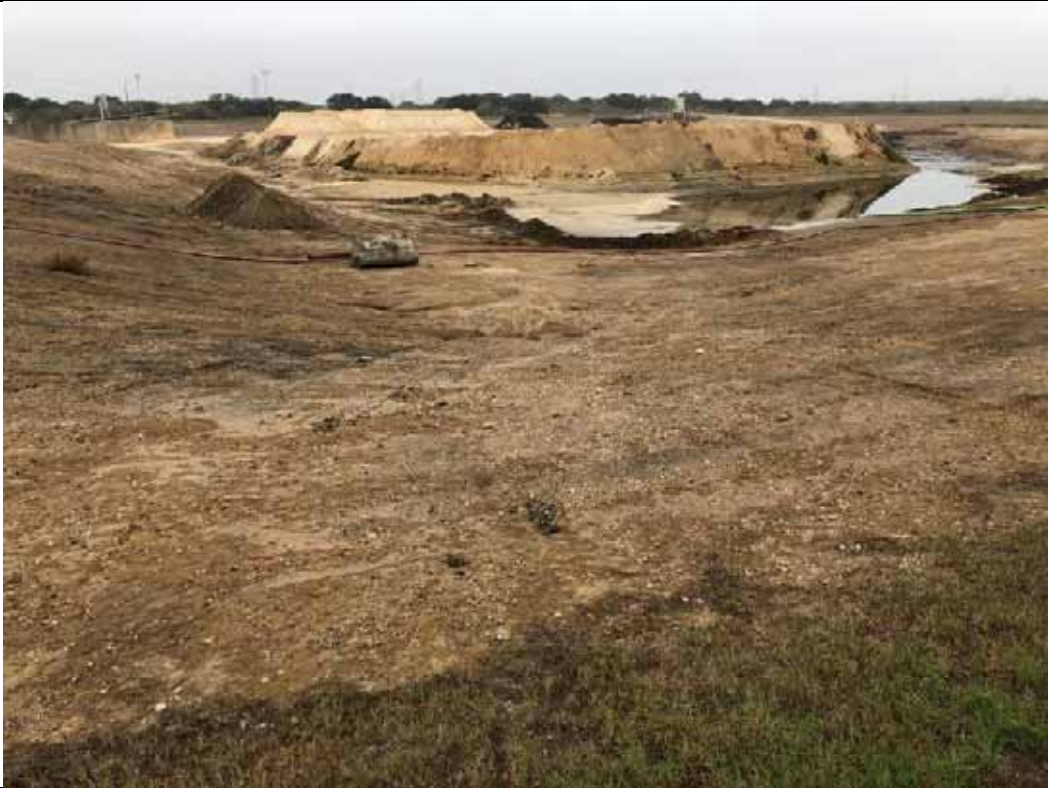
Photograph: 7 Fly Ash Landfill – standing on southeast corner – facing west. Radial stacker located in southwest corner and stormwater discharge piping in southeast corner of landfill. Photo taken 12/14/2021.

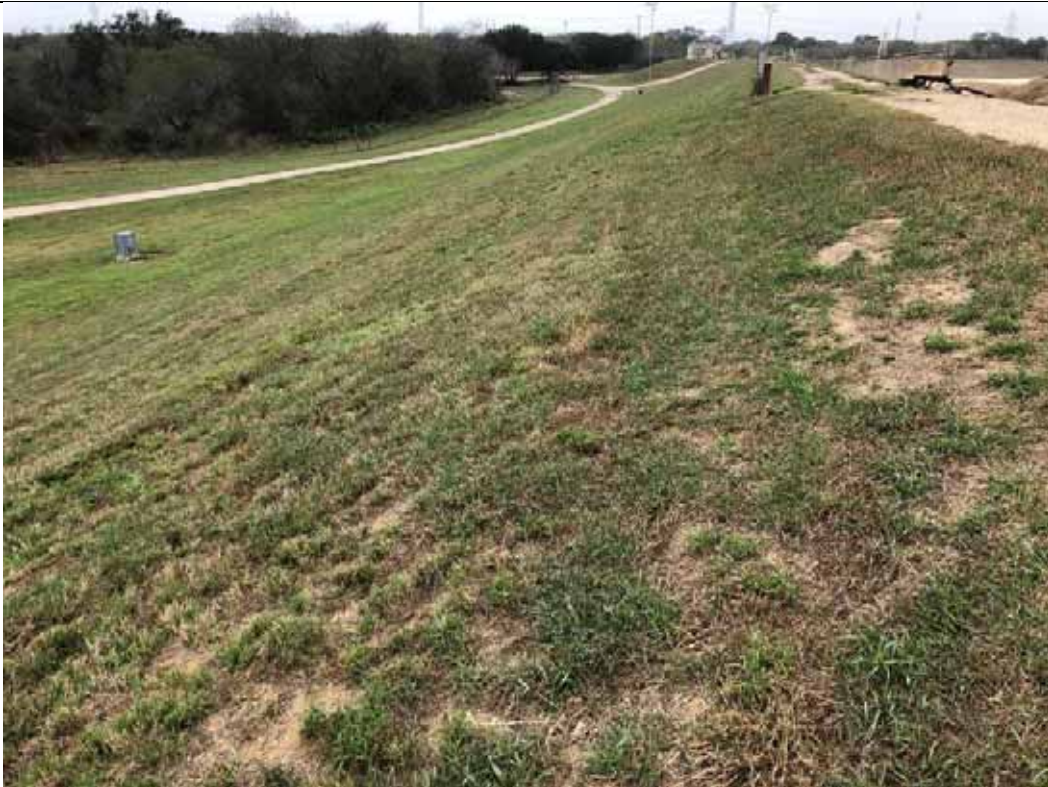
Photograph: 8 Fly Ash Landfill – standing on southeast corner – facing west. Radial stacker located in southwest corner and stormwater discharge piping in southeast corner of landfill. Photo taken 12/14/2021.

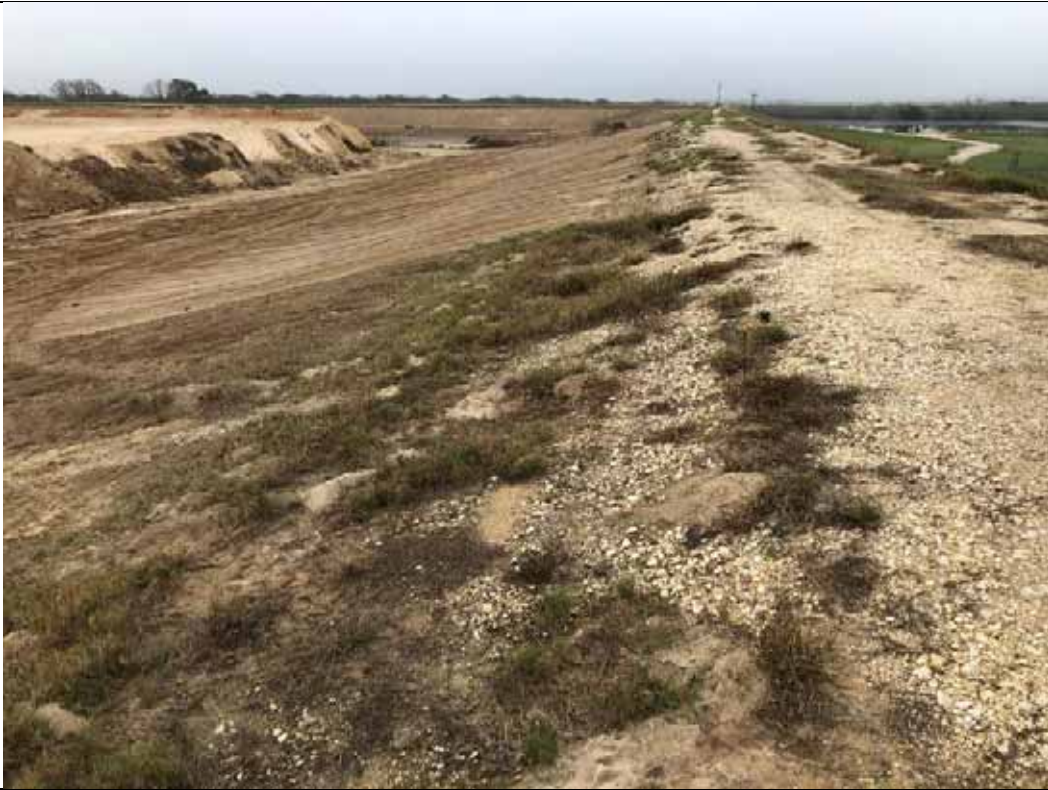
Photograph: 9 Fly Ash Landfill – standing on southwest corner – facing east.
Photo taken 12/14/2021.

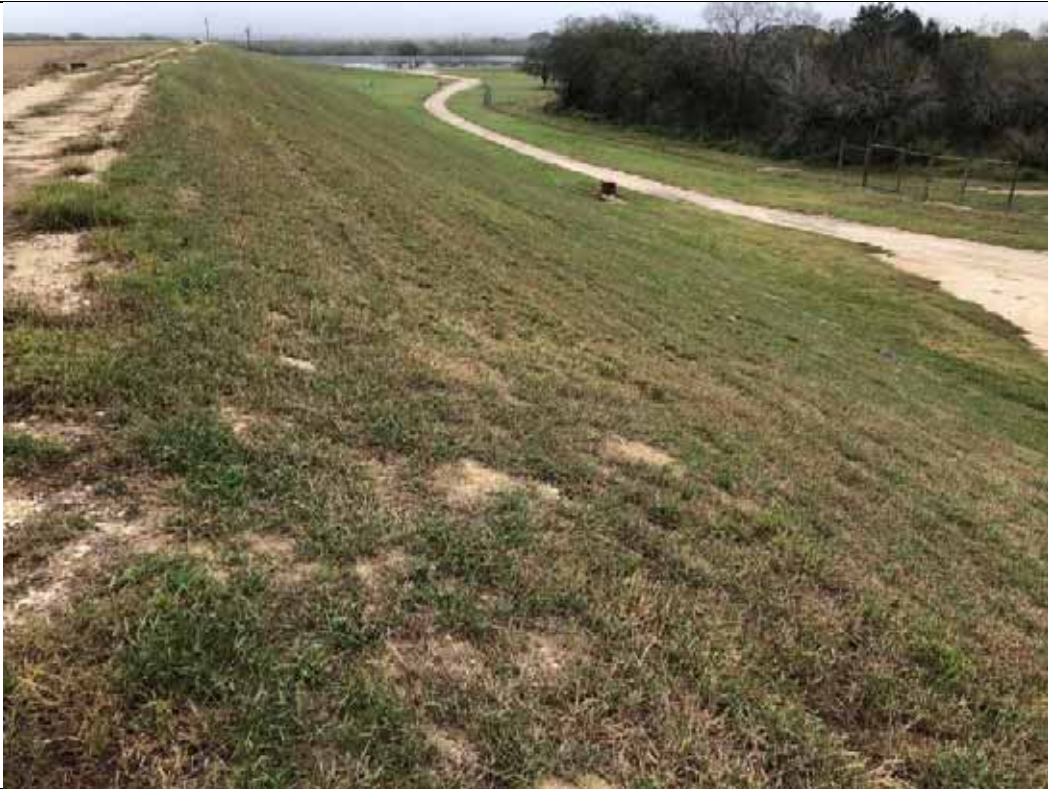
Photograph: 10 Fly Ash Landfill – standing on southwest corner – facing east.
Photo taken 12/14/2021.

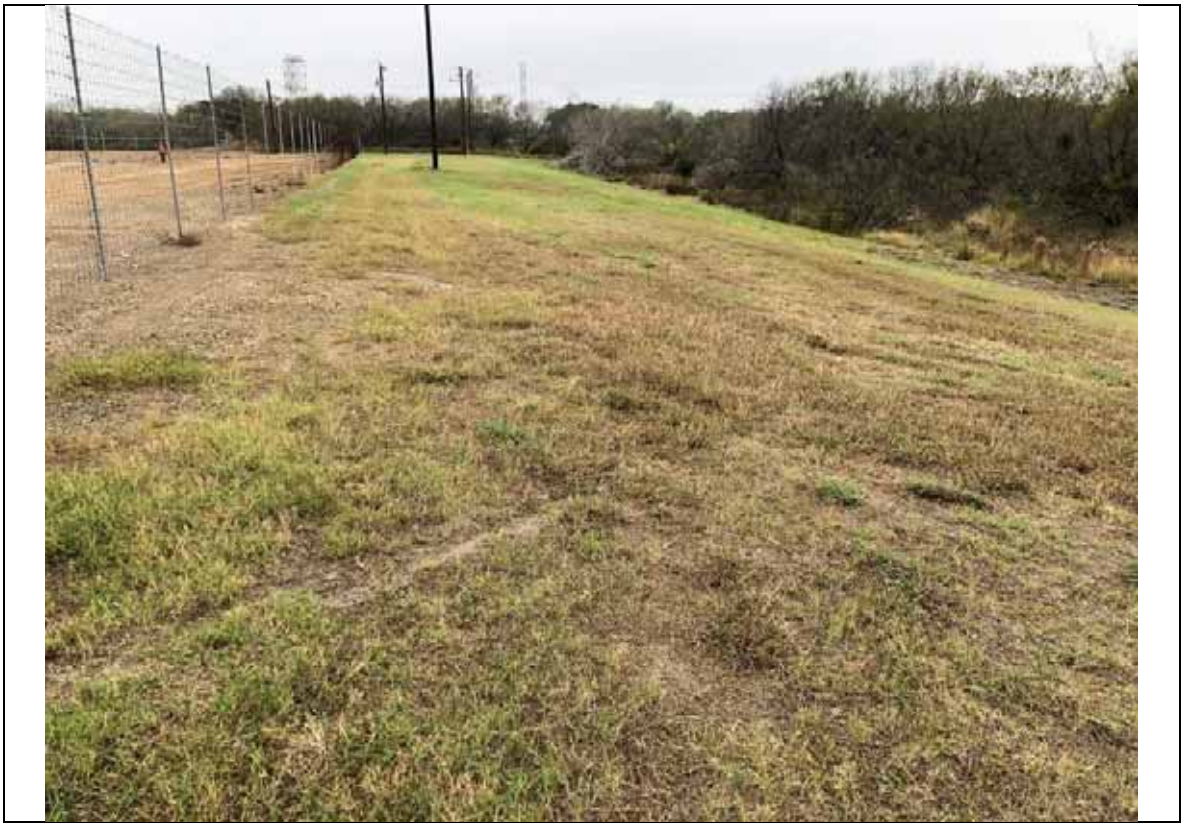
Photograph: 11 Evaporation Pond – standing on the northeast corner – facing west.
Photo taken 12/14/2021.

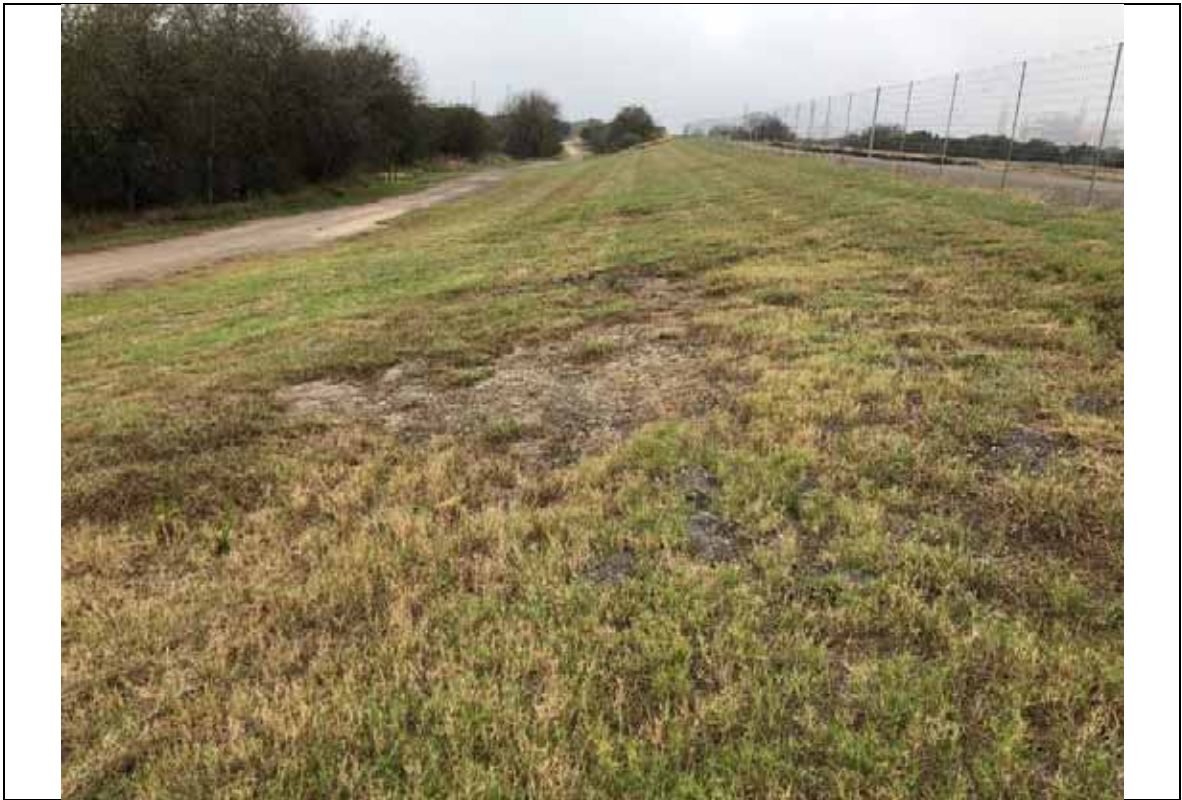
Photograph: 12 Evaporation Pond – standing on the northeast corner – facing south.
Photo taken 12/14/2021.

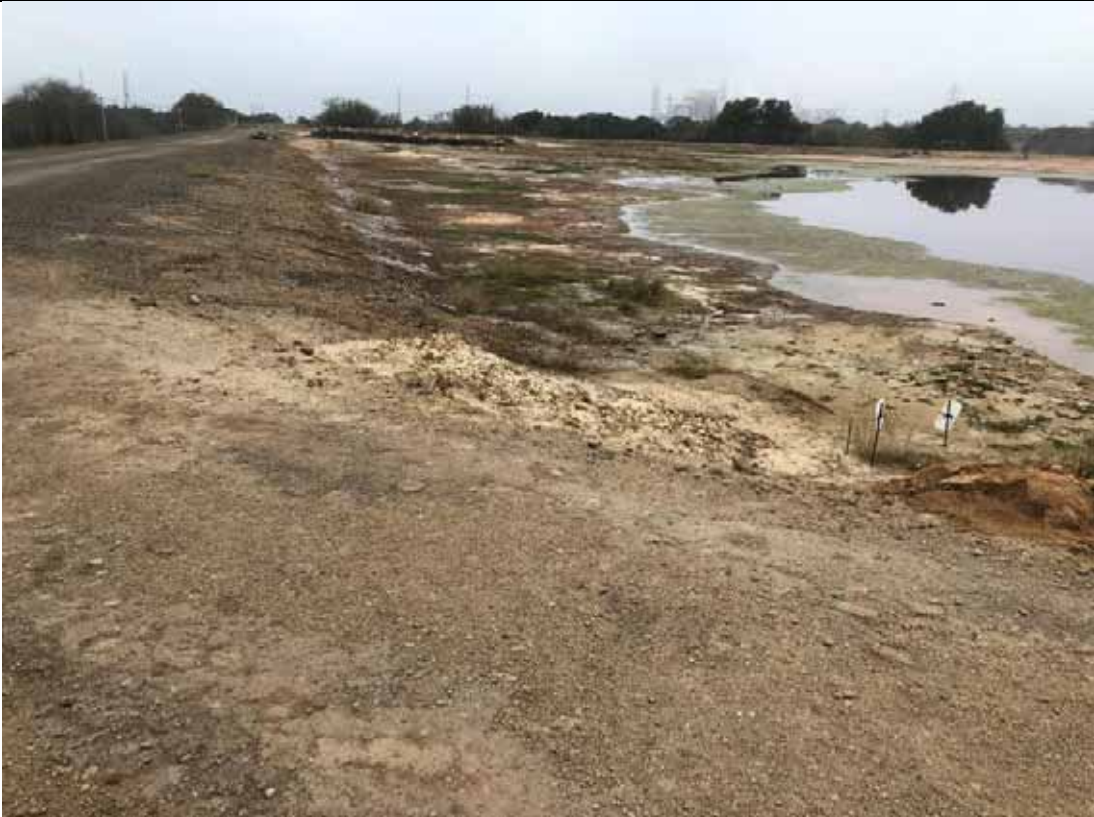
Photograph: 13 Evaporation Pond – standing on the northeast corner – facing south.
Photo taken 12/14/2021.

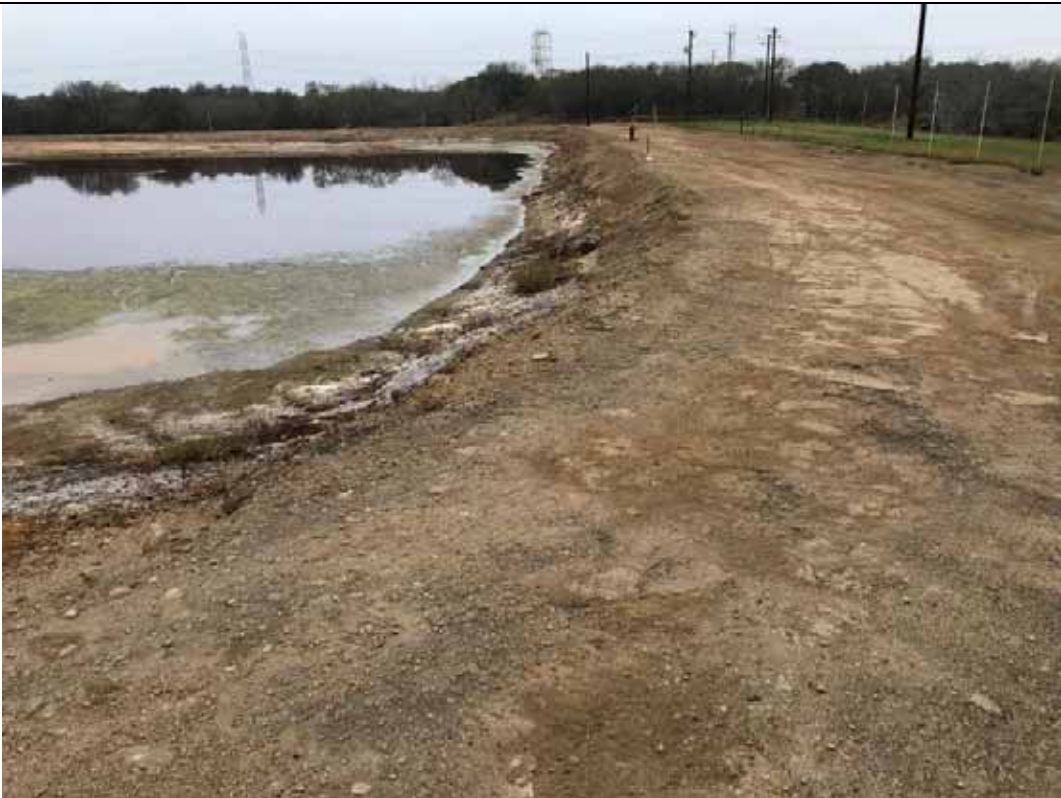
Photograph: 14 Evaporation Pond – standing on the northeast corner – facing west.
Photo taken 12/14/2021.

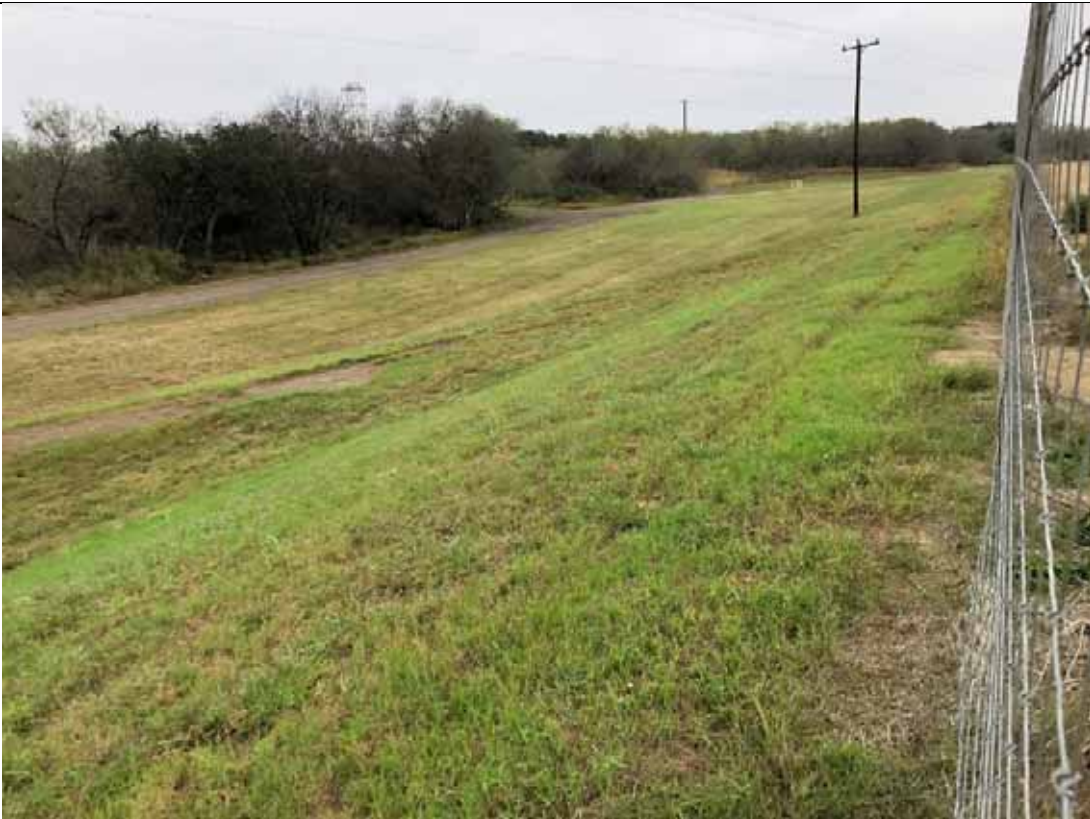
Photograph: 15 Evaporation Pond – standing on the southwest corner – facing north.
Photo taken 12/14/2021.

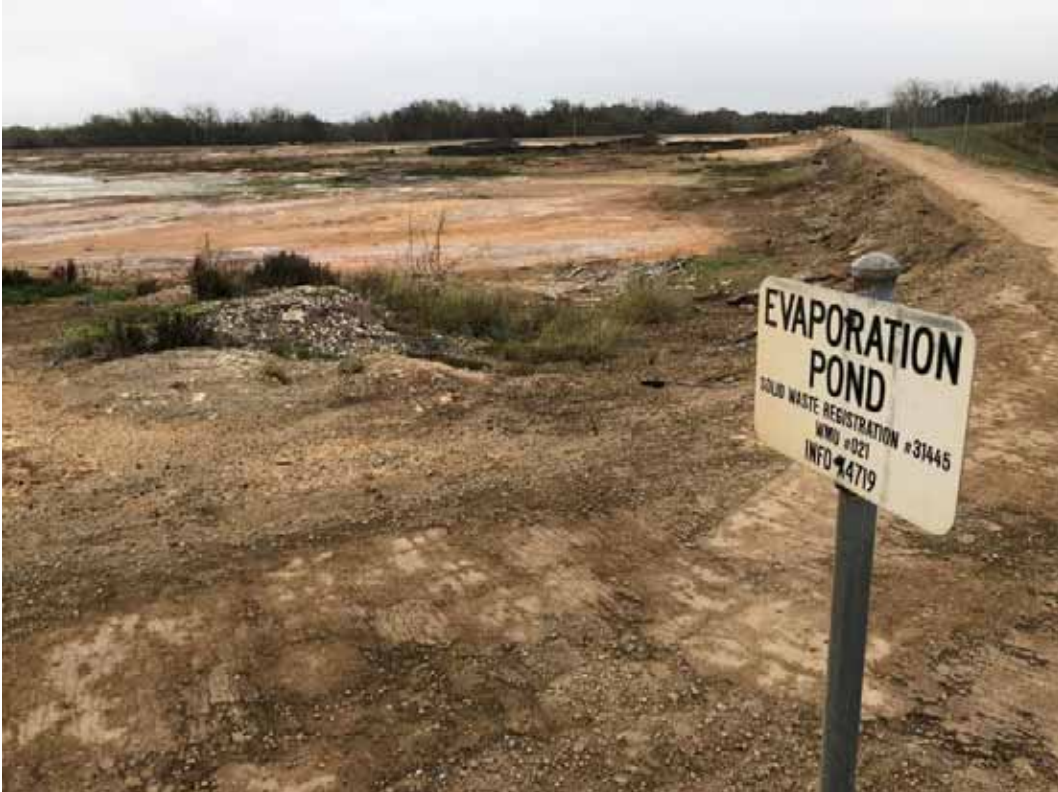
Photograph: 16 Evaporation Pond – standing on the southwest corner – facing east.
Photo taken 12/14/2021.

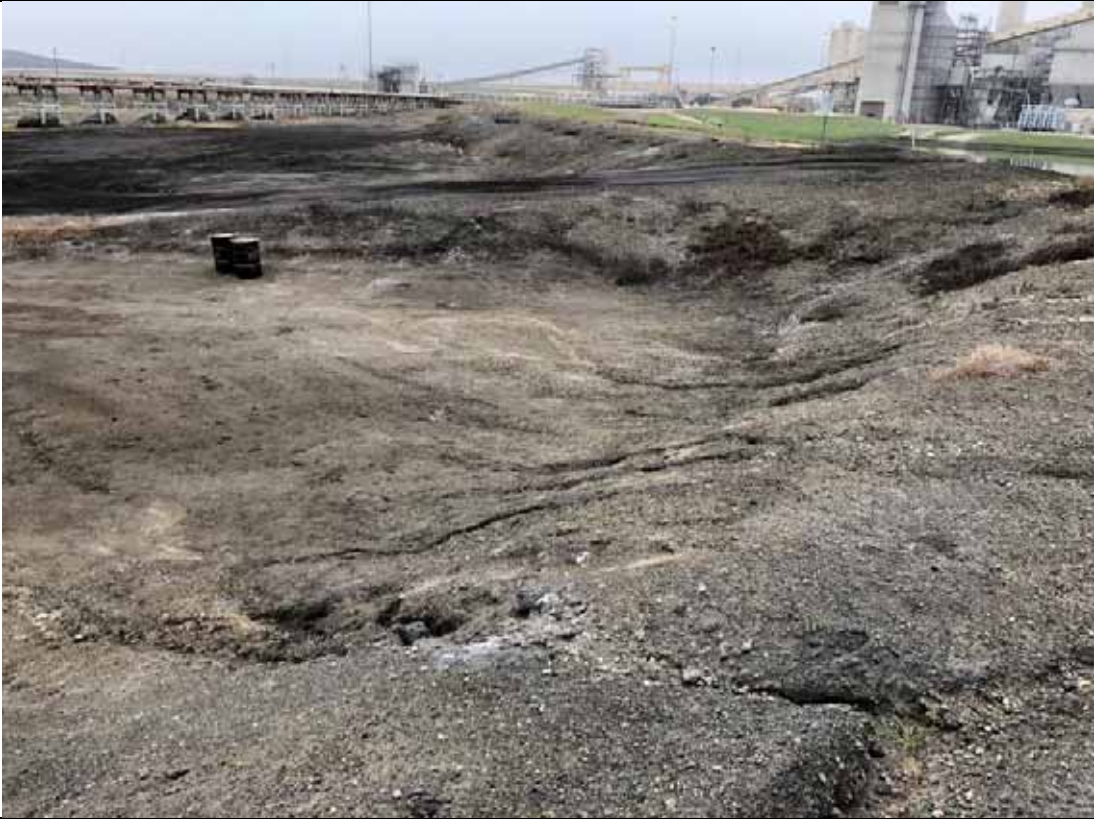
Photograph: 17 North Bottom Ash Pond – standing on northwest corner – facing southwest. Photo taken 12/14/2021.

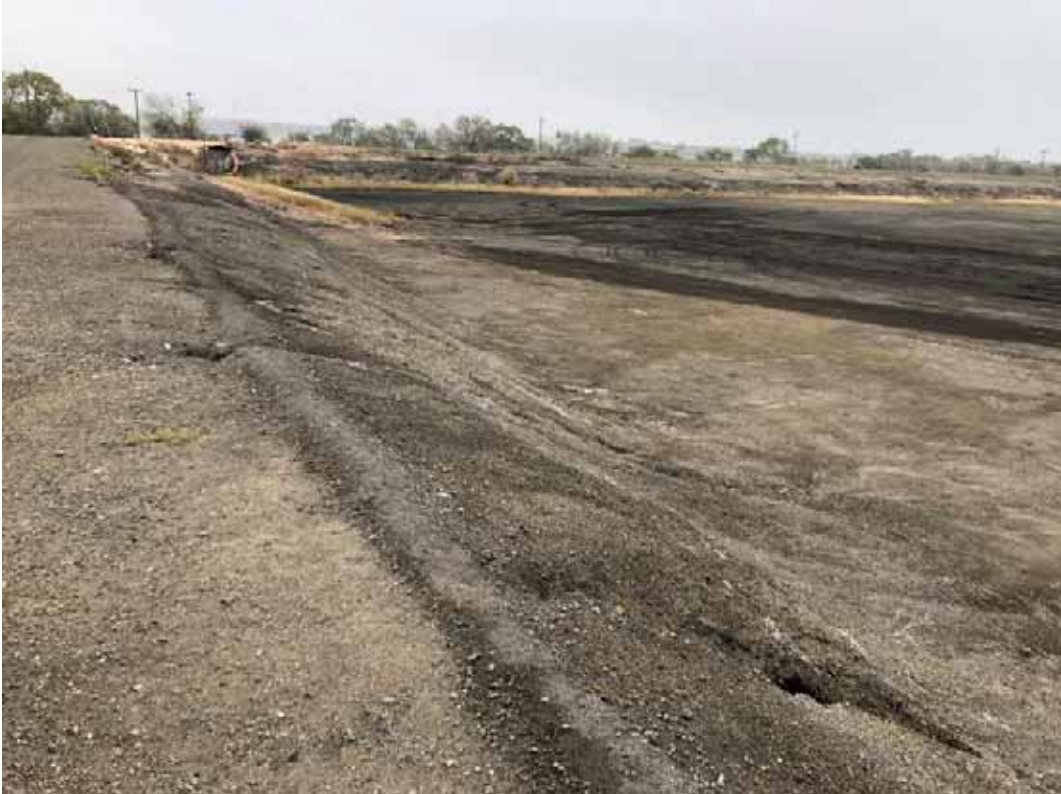
Photograph: 18 North Bottom Ash Pond – standing on northwest corner – facing east. Photo taken 12/14/2021.

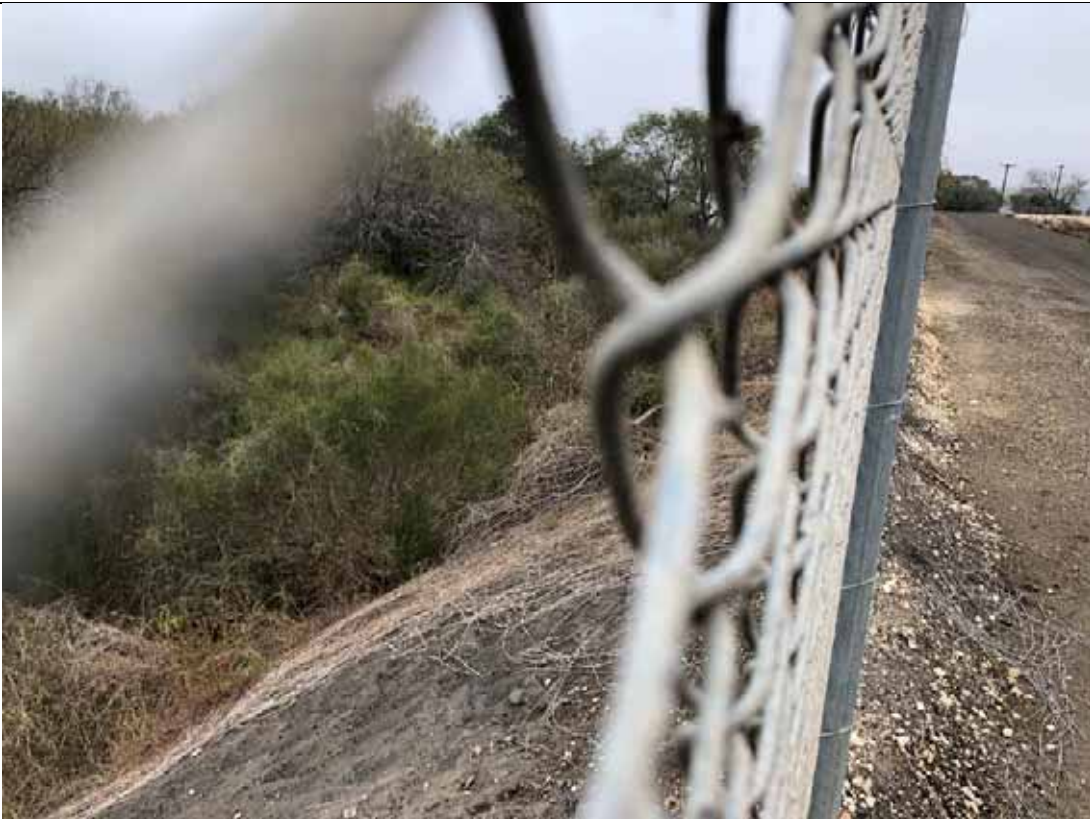
Photograph: 19 North Bottom Ash Pond – standing on northwest corner – facing east.
Photo taken 12/14/2021.

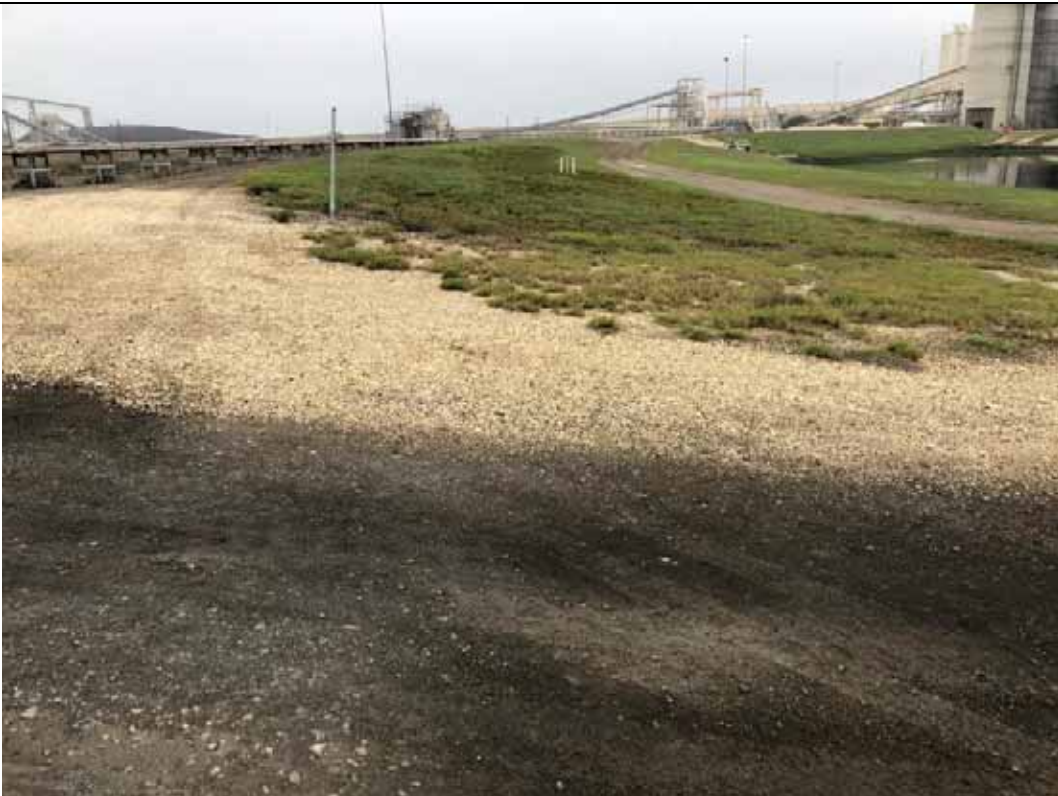
Photograph: 20 North Bottom Ash Pond – standing on northwest corner – facing southwest. Photo taken 12/14/2021.

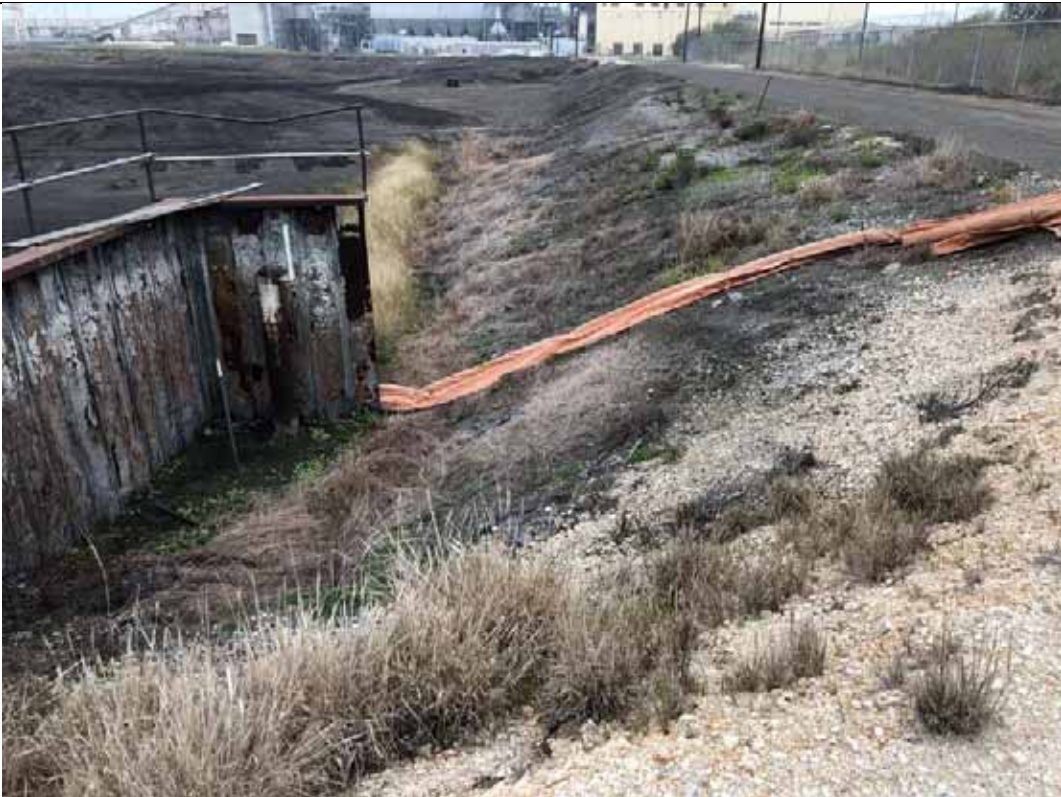
Photograph: 21 North Bottom Ash Pond – standing on northeast corner – facing west.
Photo taken 12/14/2021.

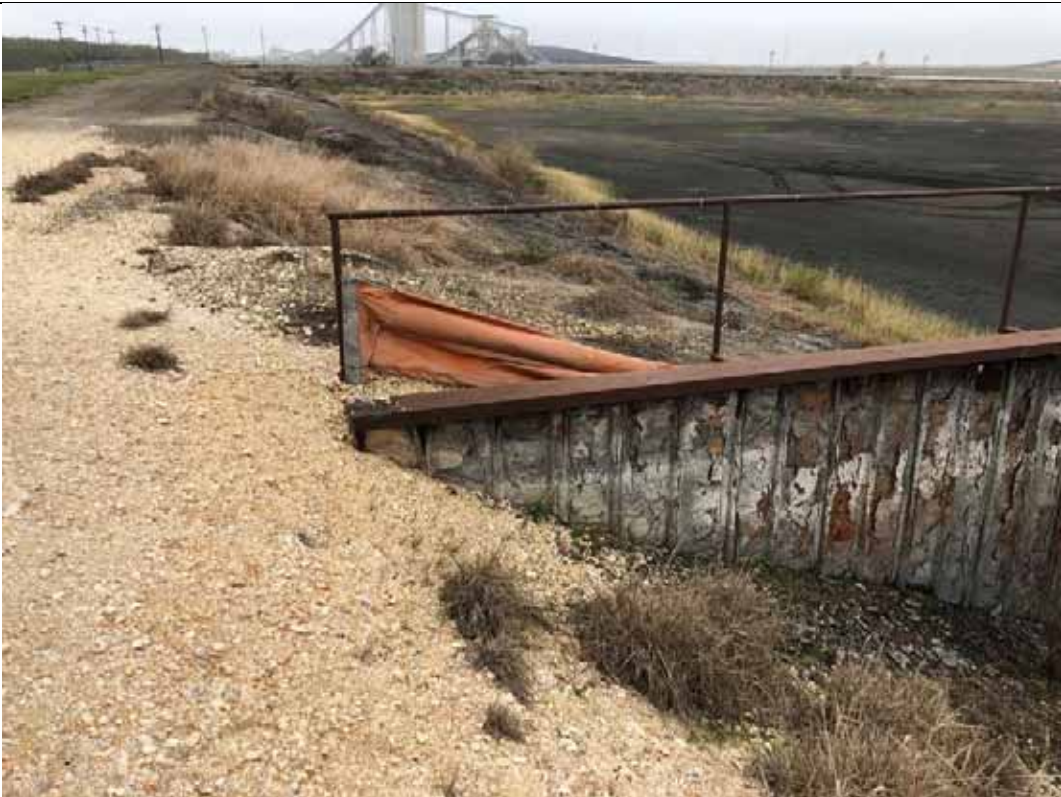
Photograph: 22 North Bottom Ash Pond – standing on northeast corner – facing south.
Photo taken 12/14/2021.

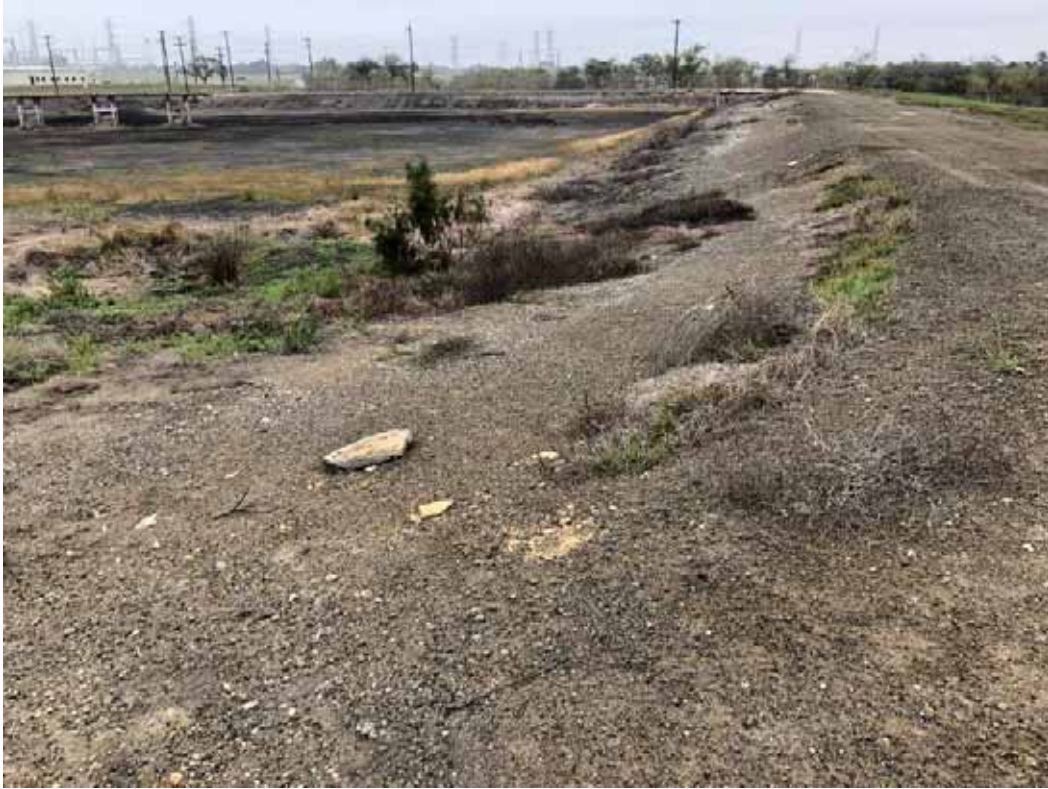
Photograph: 23 North Bottom Ash Pond – standing on southeast corner – facing north.
Photo taken 12/14/2021.

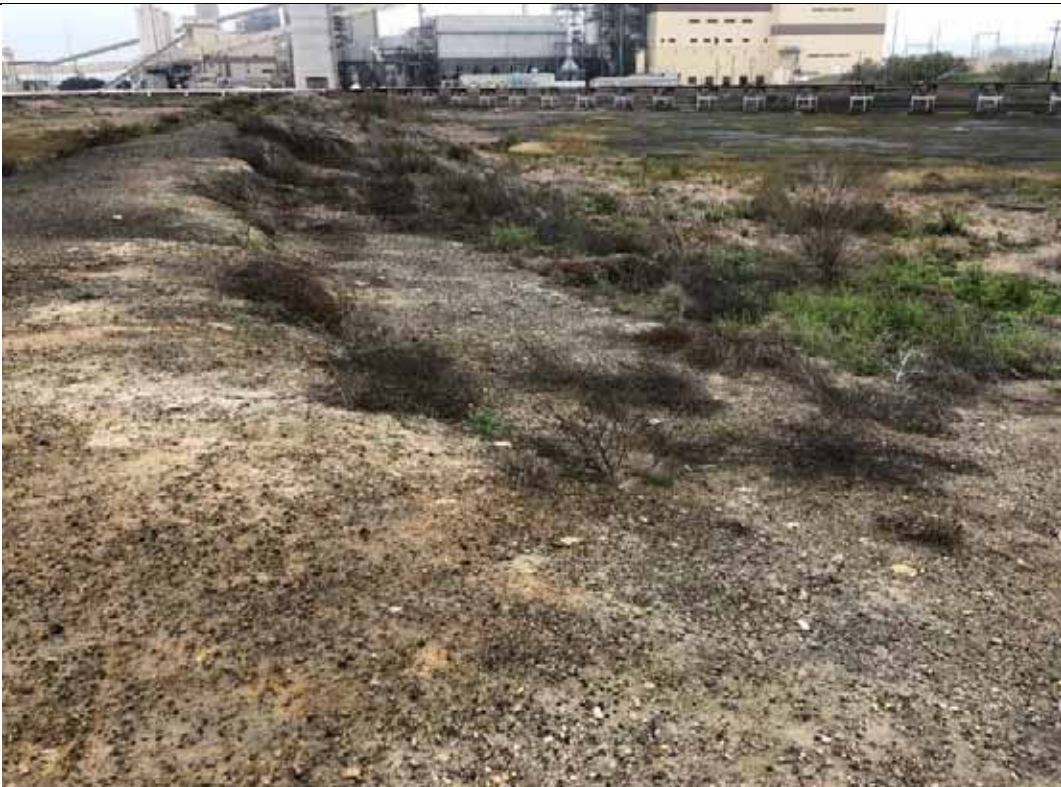
Photograph: 24 North Bottom Ash Pond – standing on southeast corner – facing west.
Photo taken 12/14/2021.

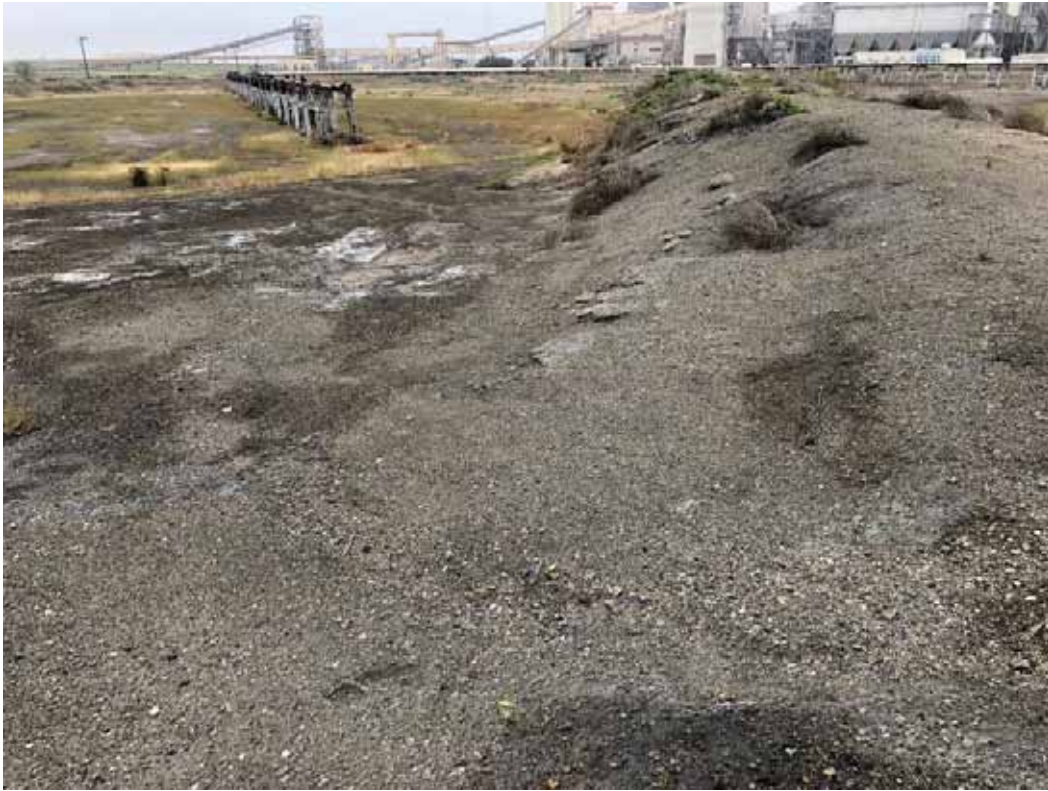
Photograph: 25 South Bottom Ash Pond – standing on northeast corner – facing west.
Photo taken 12/14/2021.

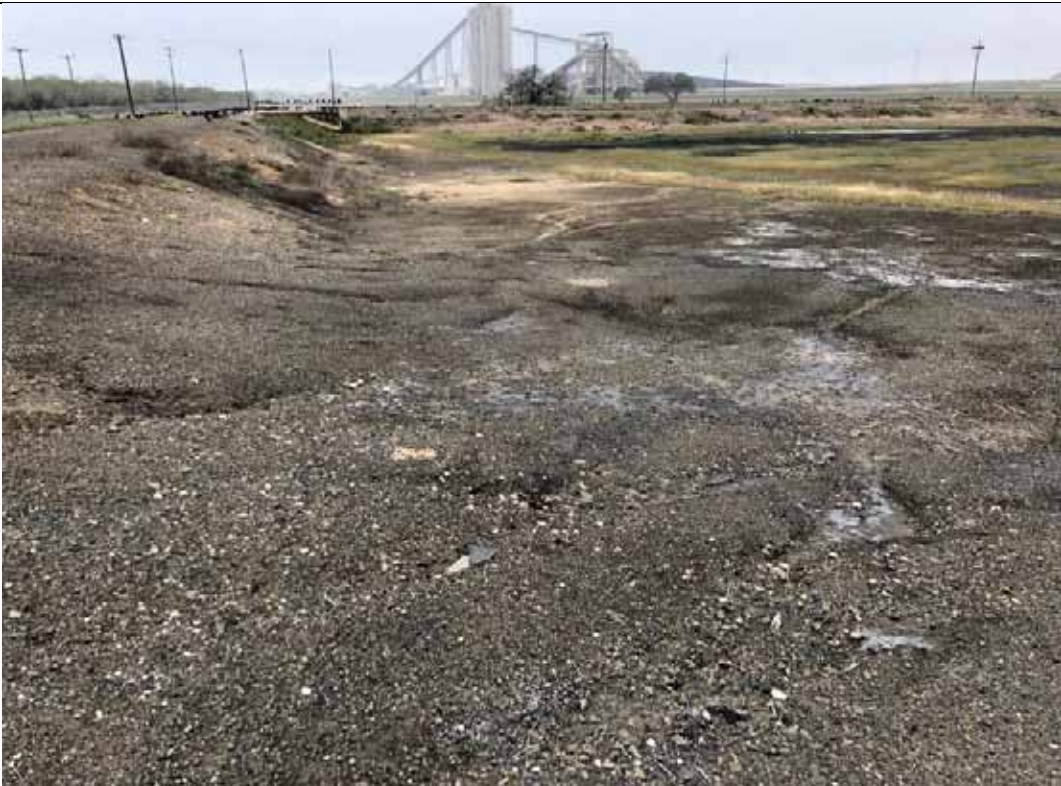
Photograph: 26 South Bottom Ash Pond – standing on northeast corner – facing south.
Photo taken 12/14/2021.
