January 27, 2022

Project No. 0352436

Subject: CCR Units – 2021 Annual Inspection and Fugitive Dust
Control Report
Calaveras Power Station
San Antonio, Texas

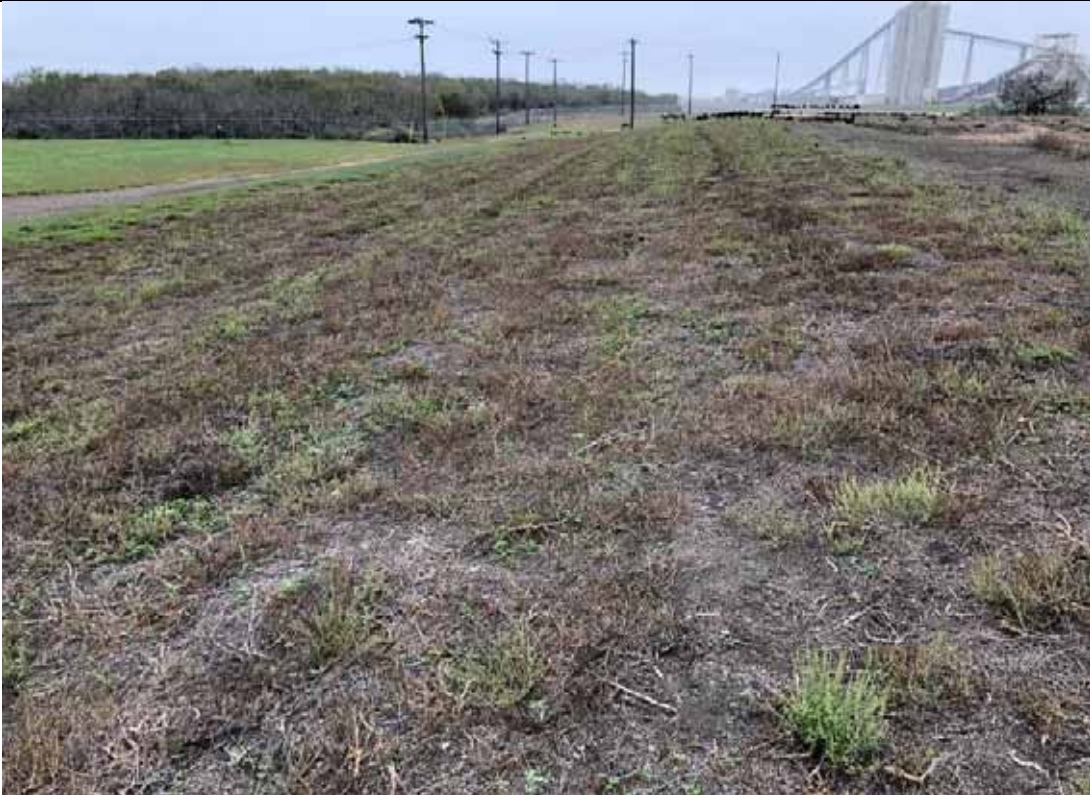
Photograph: 27 South Bottom Ash Pond – standing on northeast corner – facing south.
Photo taken 12/14/2021.

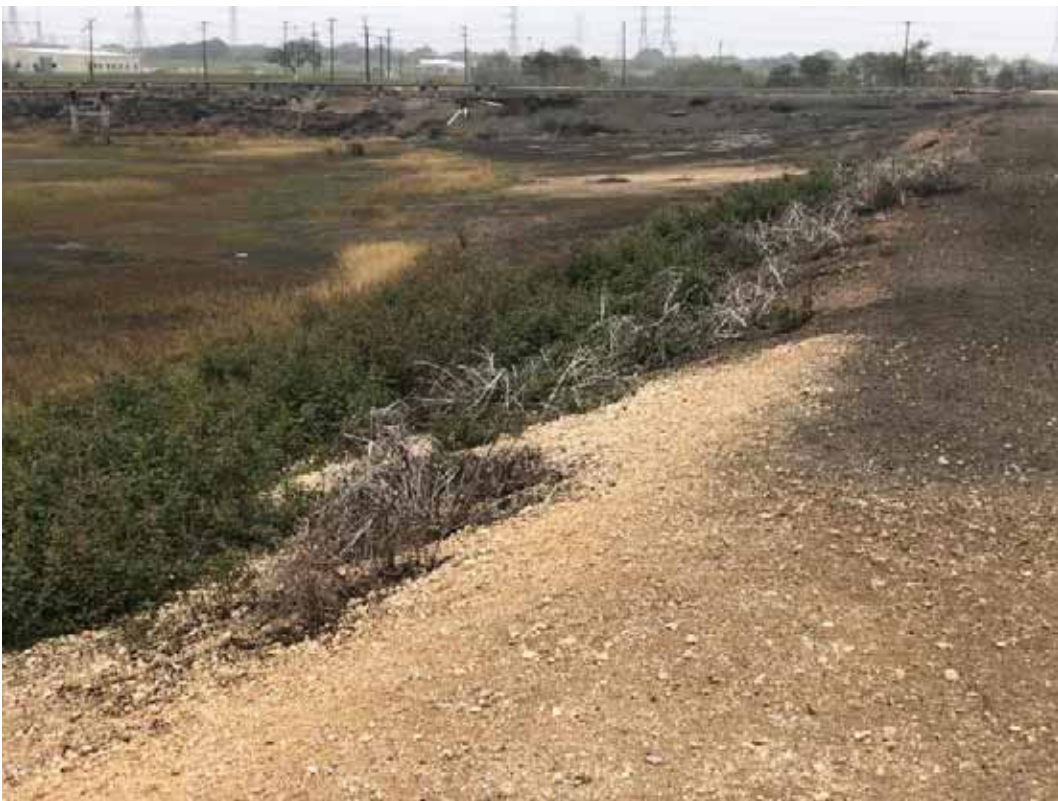
Photograph: 28 South Bottom Ash Pond – standing on southeast corner – facing north.
Photo taken 12/14/2021.

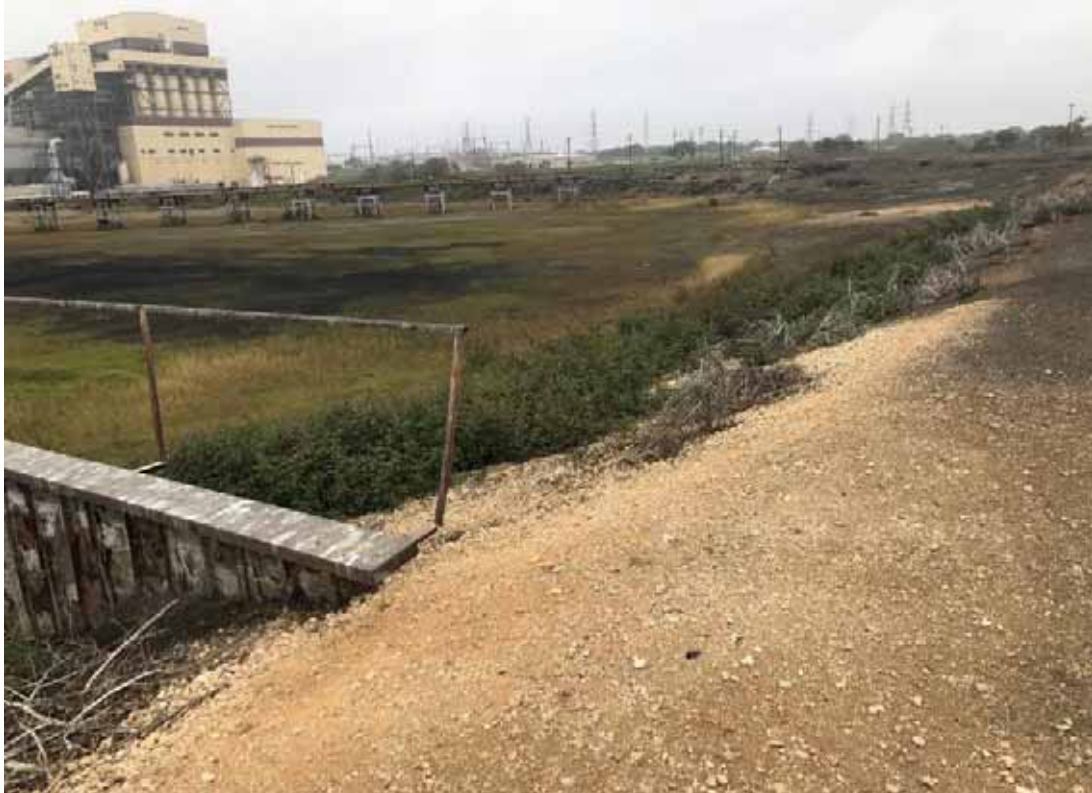
Photograph: 29 South Bottom Ash Pond – standing on southeast corner – facing northwest. Photo taken 12/14/2021.

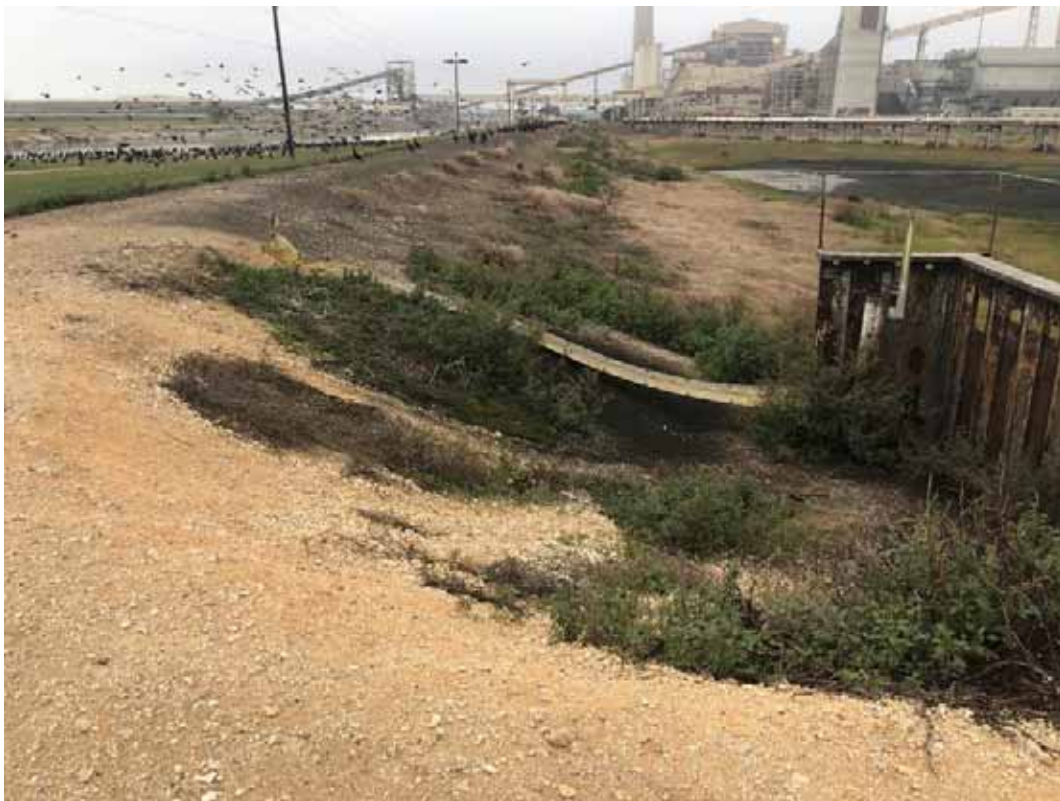
Photograph: 30 South Bottom Ash Pond – standing on southeast corner – facing west. Photo taken 12/14/2021.

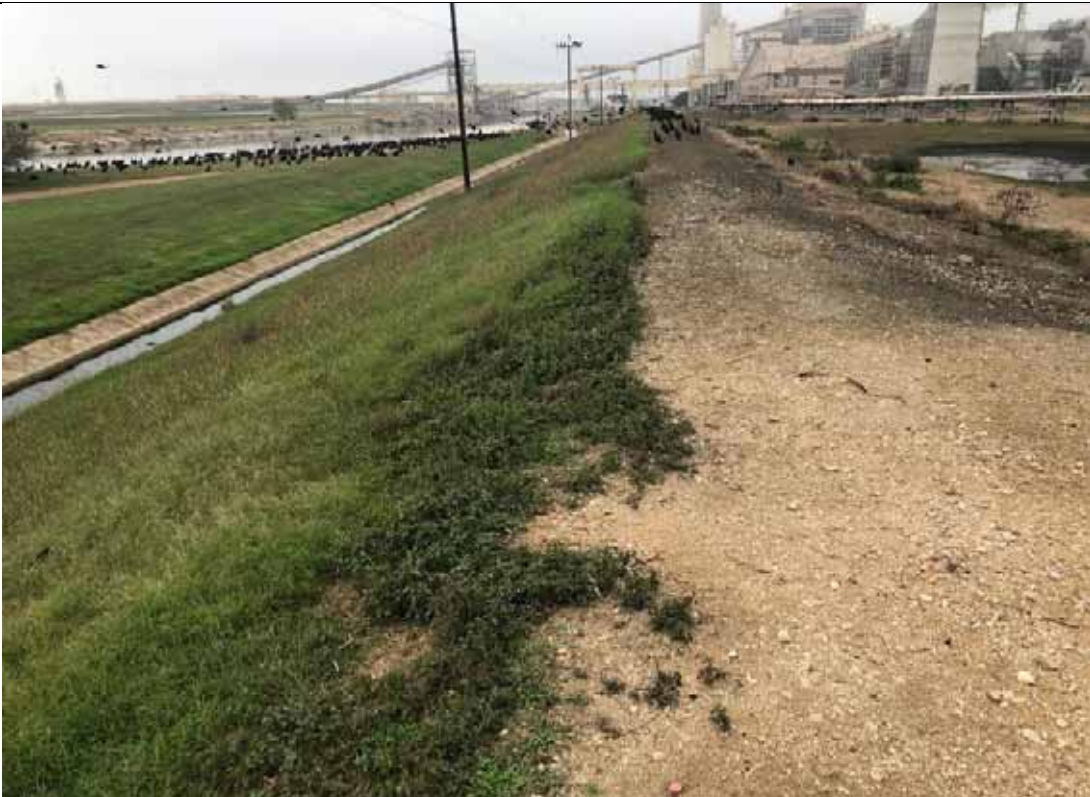
Photograph: 31 South Bottom Ash Pond – standing on southeast corner – facing west.
Photo taken 12/14/2021.

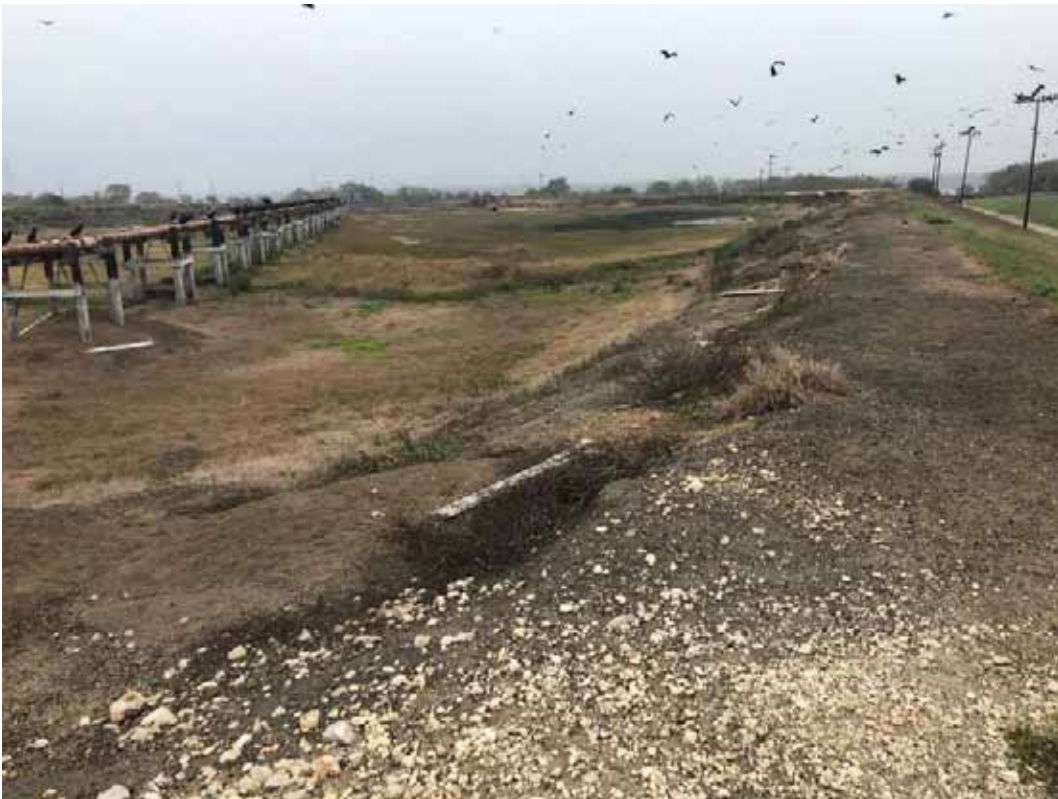
Photograph: 32 South Bottom Ash Pond – standing on southwest corner – facing east.
Photo taken 12/14/2021.

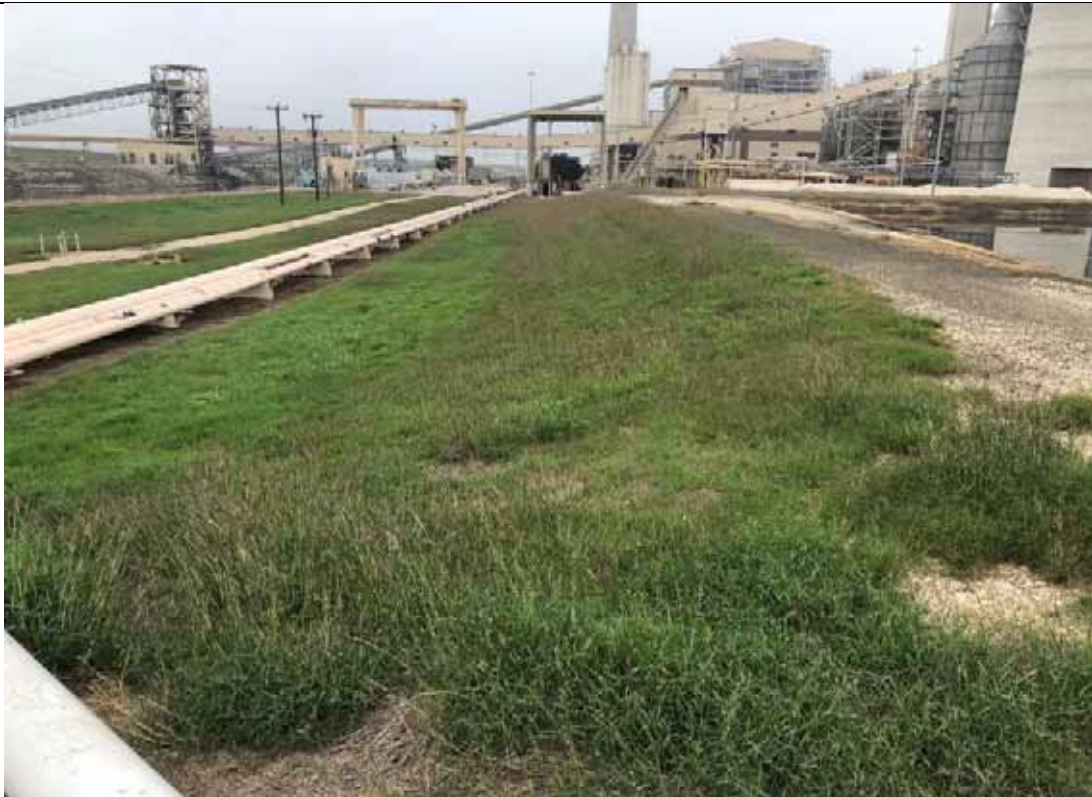
Photograph: 33 South SRH Pond – standing on the southeast corner – facing west.
Photo taken 12/14/2021.

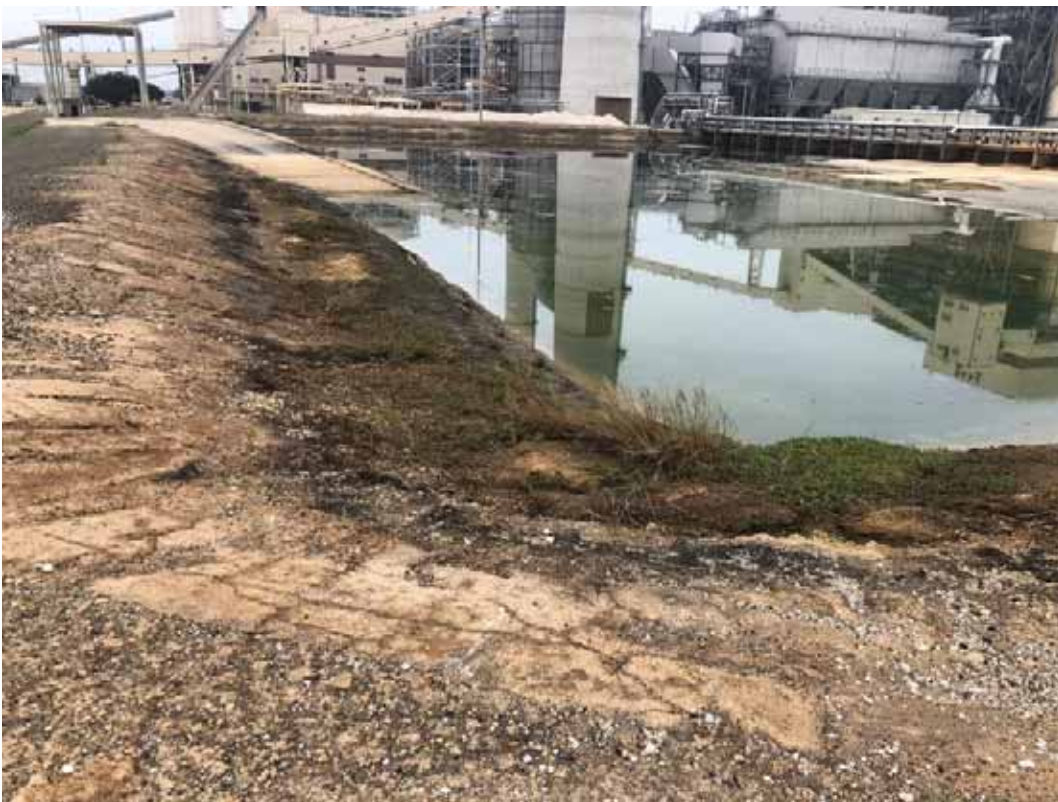
Photograph: 34 South SRH Pond – standing on the southeast corner – facing west.
Photo taken 12/14/2021.

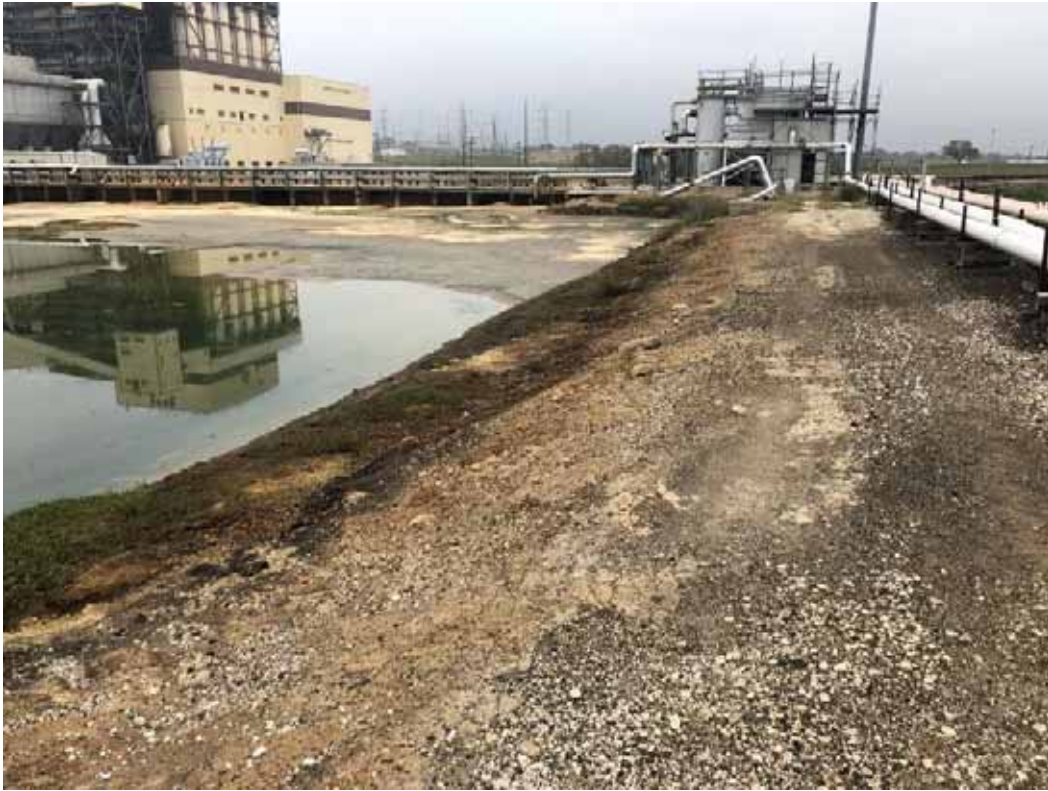
Photograph: 35 South SRH Pond – standing on the southeast corner – facing north.
Photo taken 12/14/2021.

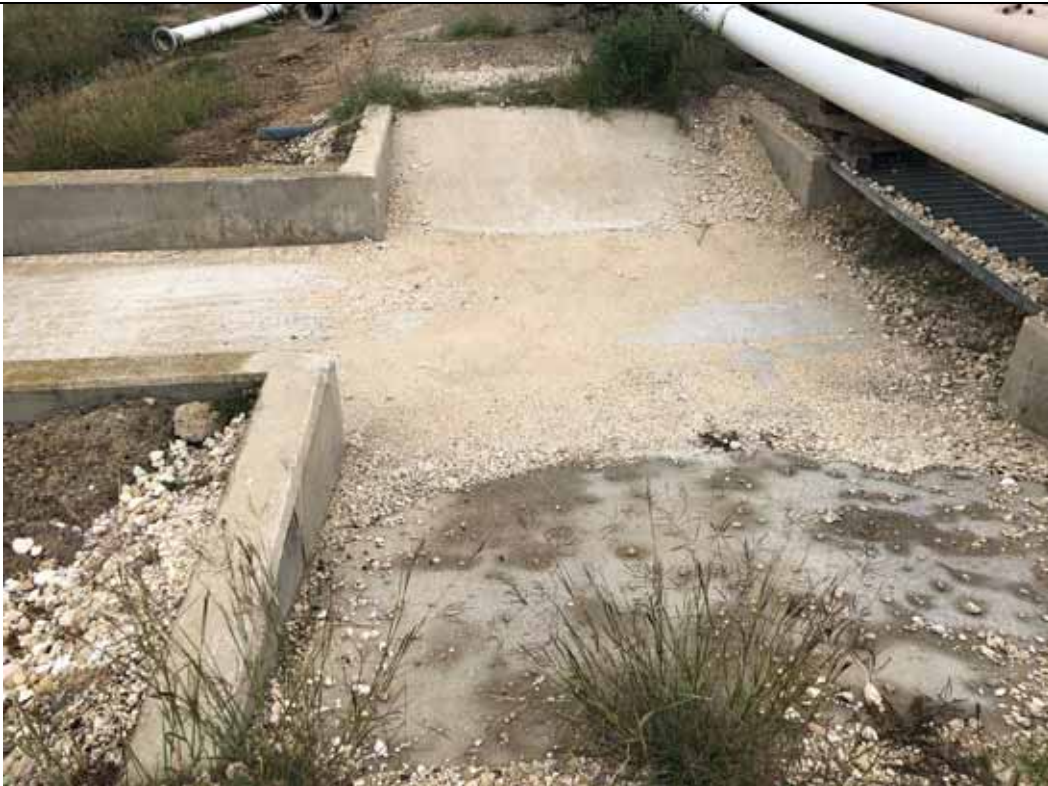
Photograph: 36 South SRH Pond – standing on the east berm – spillway structure.
Photo taken 12/14/2021.

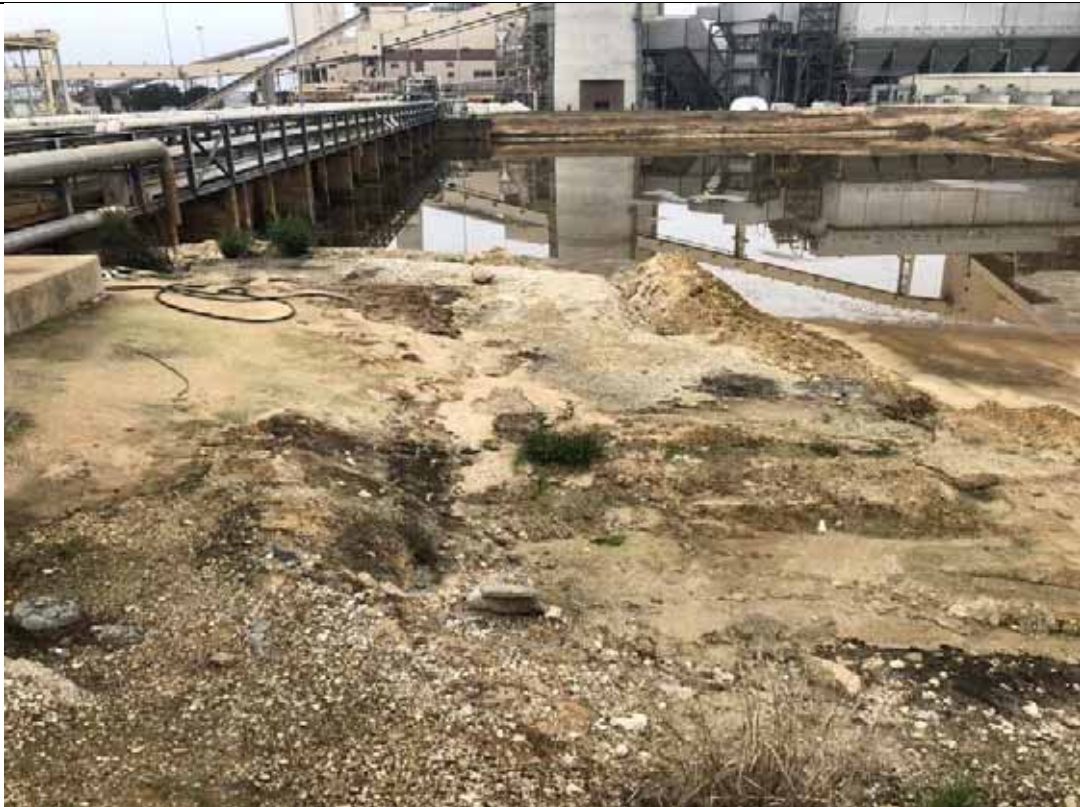
Photograph: 37 North SRH Pond – standing on the southeast corner – facing west.
Photo taken 12/14/2021.

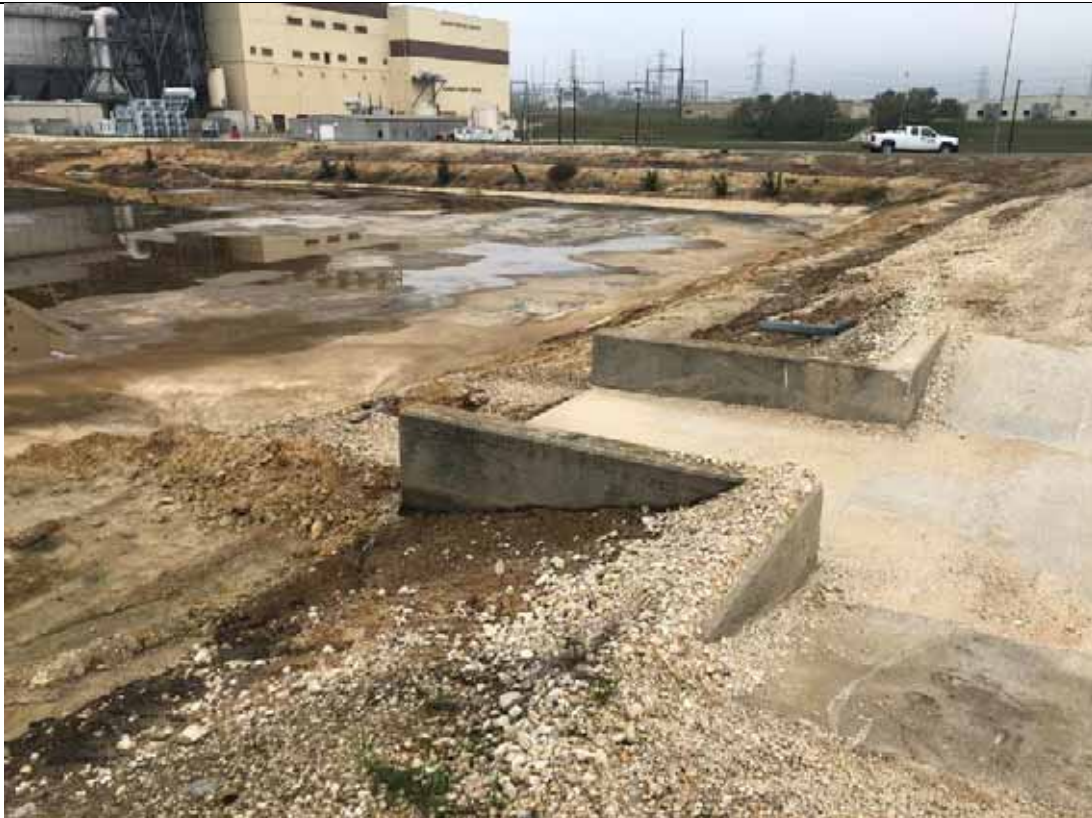
Photograph: 38 North SRH Pond – standing on the southeast corner – facing northwest.
Photo taken 12/14/2021.

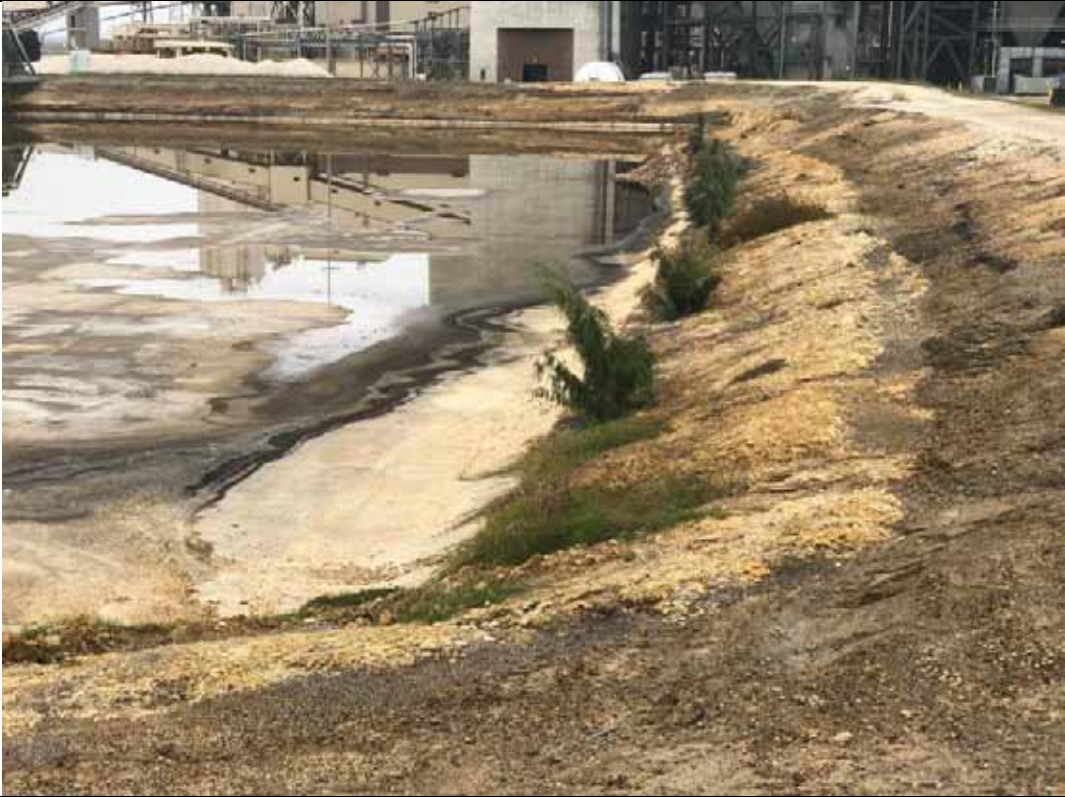
Photograph: 39 North SRH Pond – standing on the northeast corner – facing west.
Photo taken 12/14/2021.

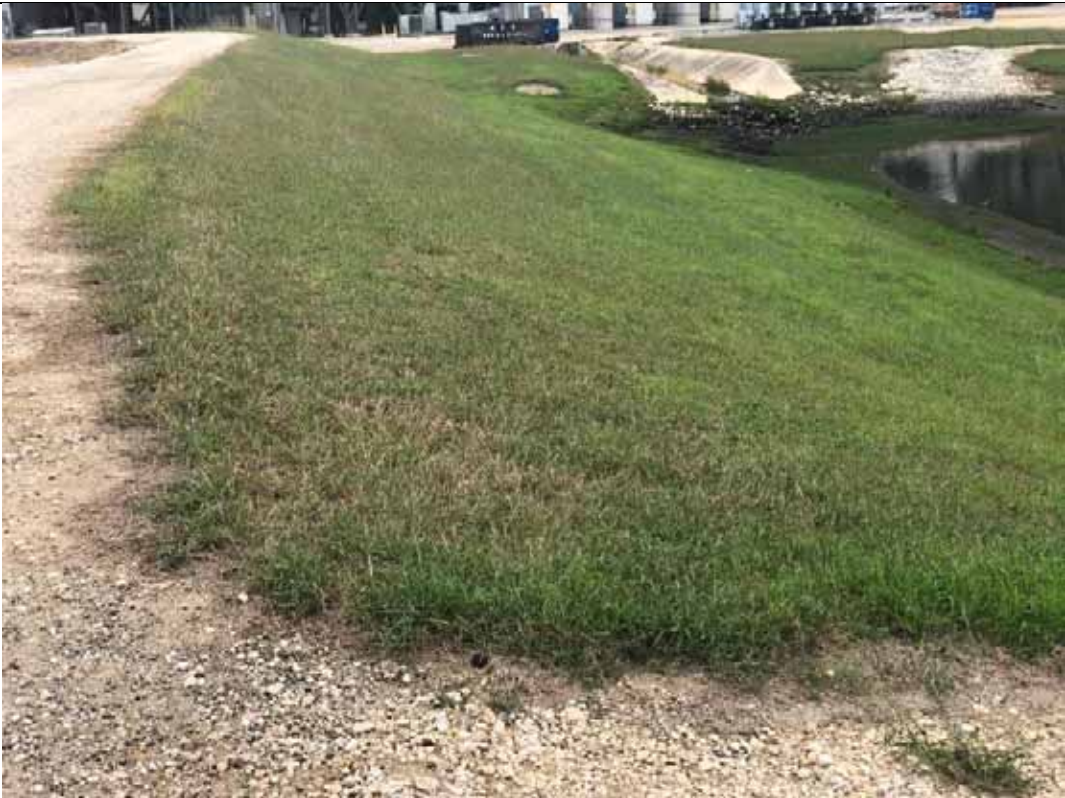
Photograph: 40 North SRH Pond – standing on the northeast corner – facing west.
Photo taken 12/14/2021.

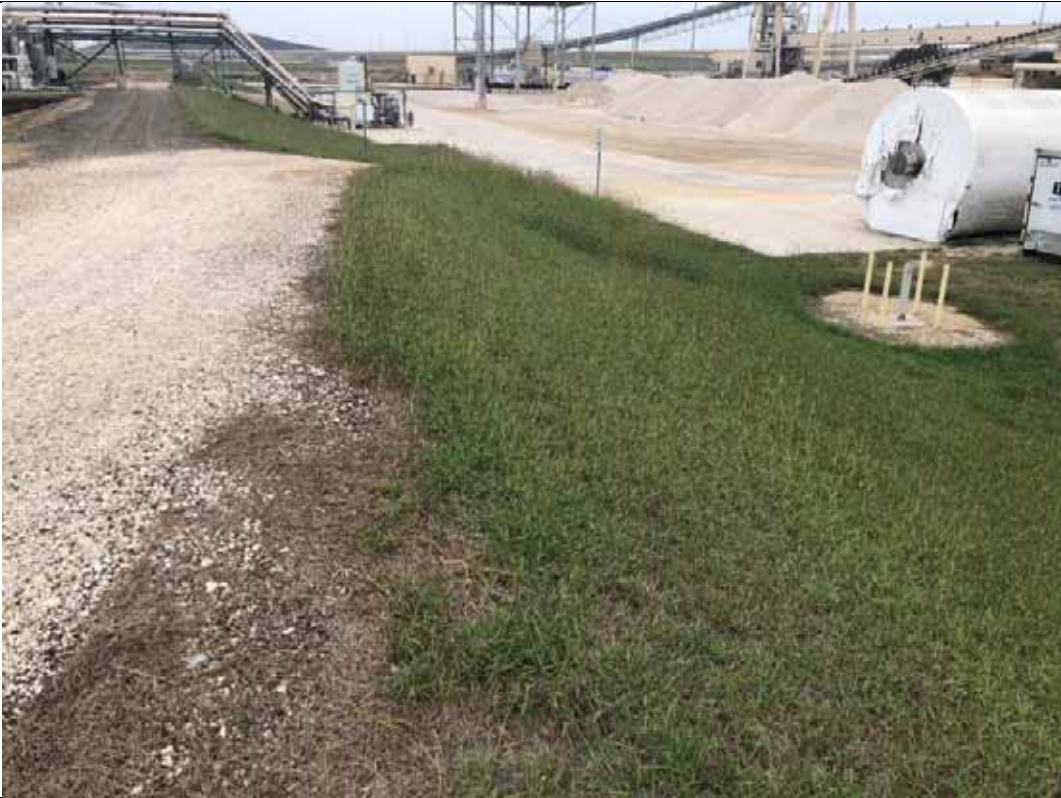
Photograph: 41 North SRH Pond – standing on the northwest corner – facing south.
Photo taken 12/14/2021.

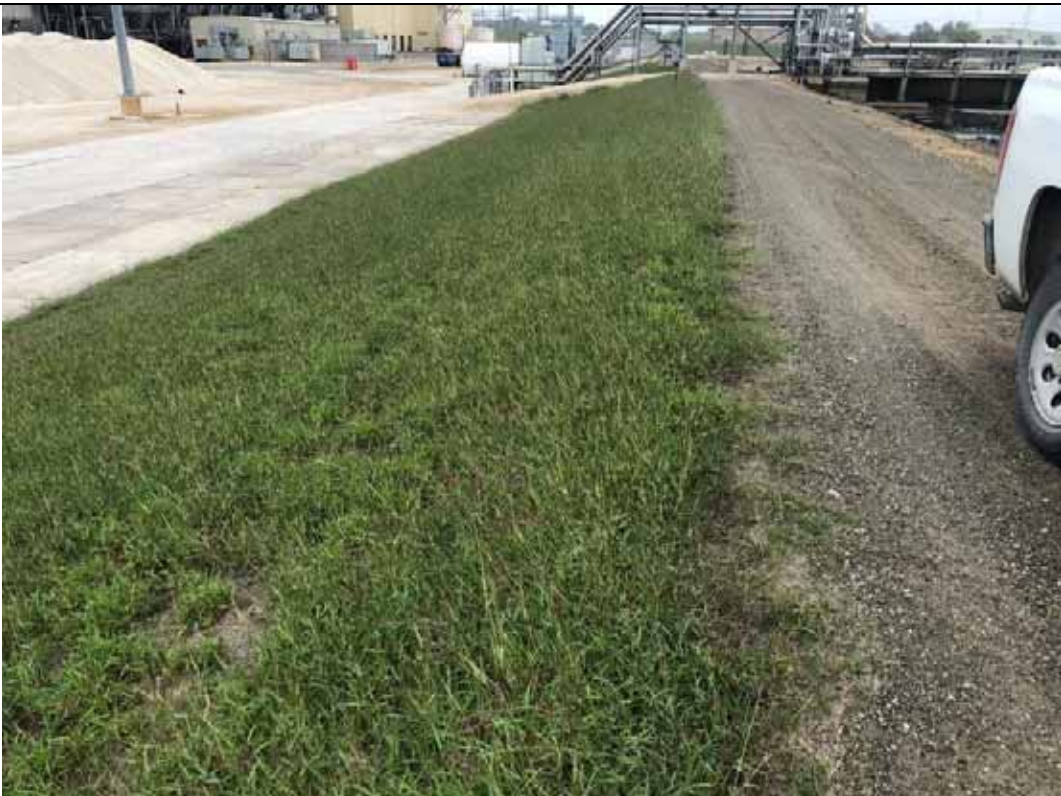
Photograph: 42 South SRH Pond – standing on the southwest corner – facing north.
Photo taken 12/14/2021.
