January 31, 2023

Reference: 0352436

Subject: CCR Units – 2022 Annual Inspection and Fugitive Dust Control Report
Calaveras Power Station
San Antonio, Texas

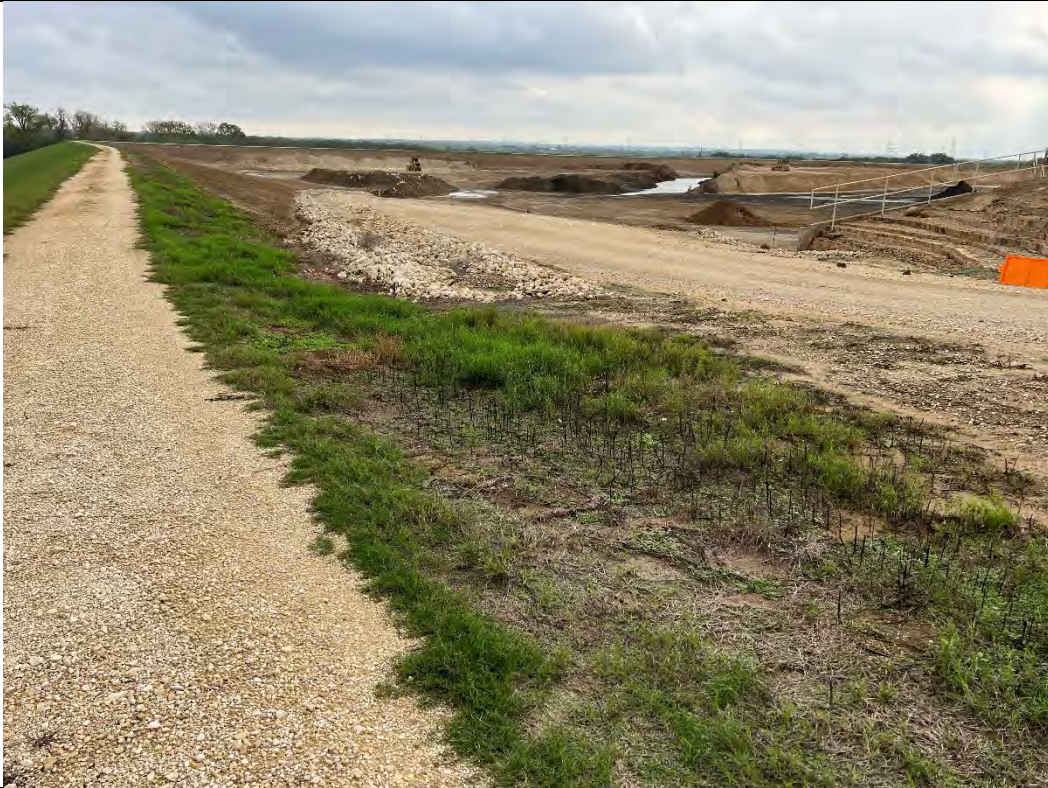
Photograph: 1 Fly Ash Landfill – standing on northwest corner – facing east.
Photo taken 12/13/2022.

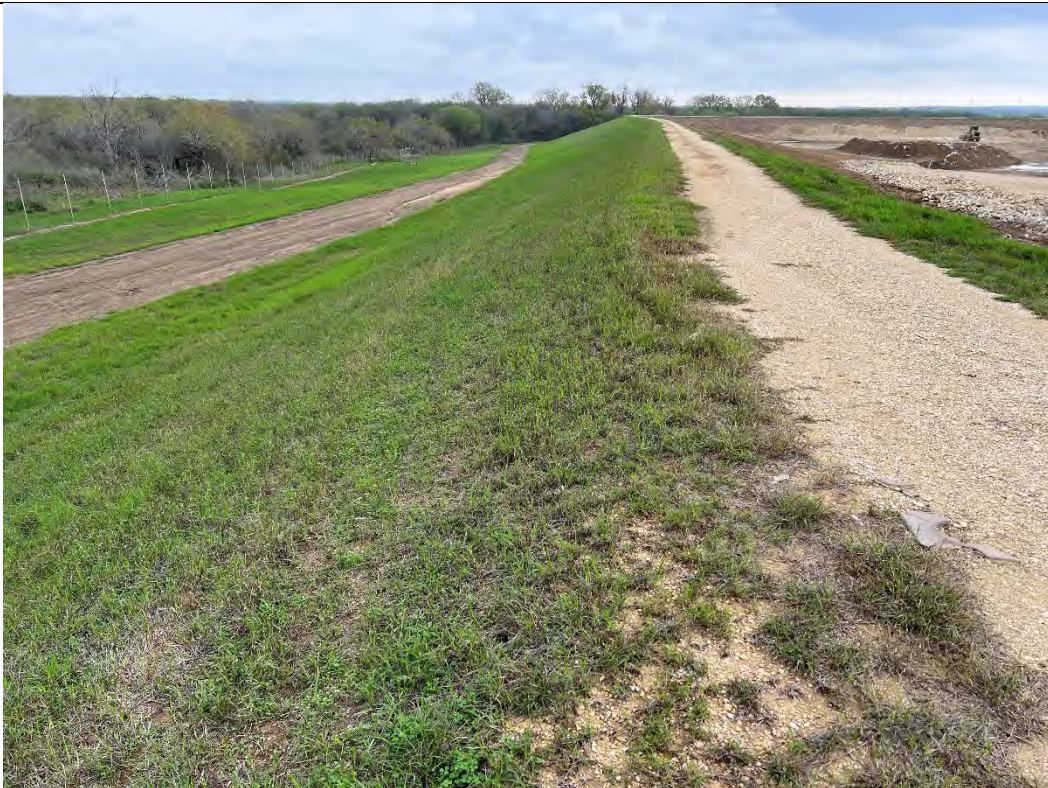
Photograph: 2 Fly Ash Landfill – standing on northwest corner – facing east.
Photo taken 12/13/2022.

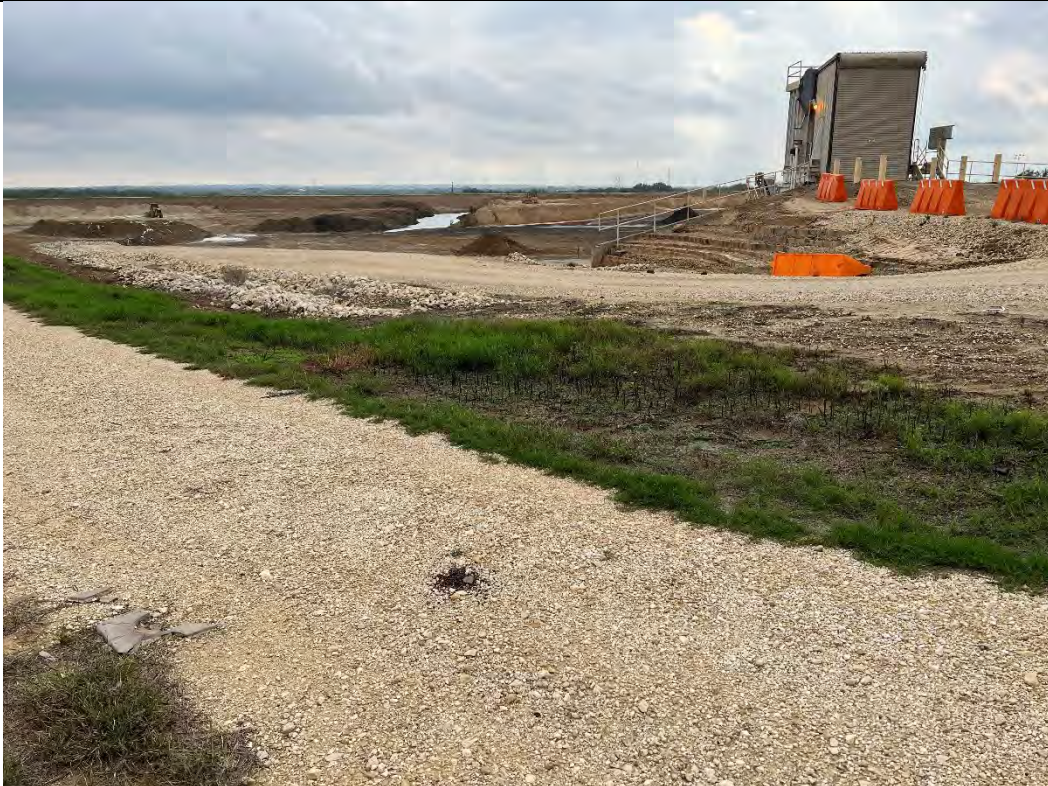
Photograph: 3 Fly Ash Landfill – standing on northwest corner – facing south.
Photo taken 12/13/2022.

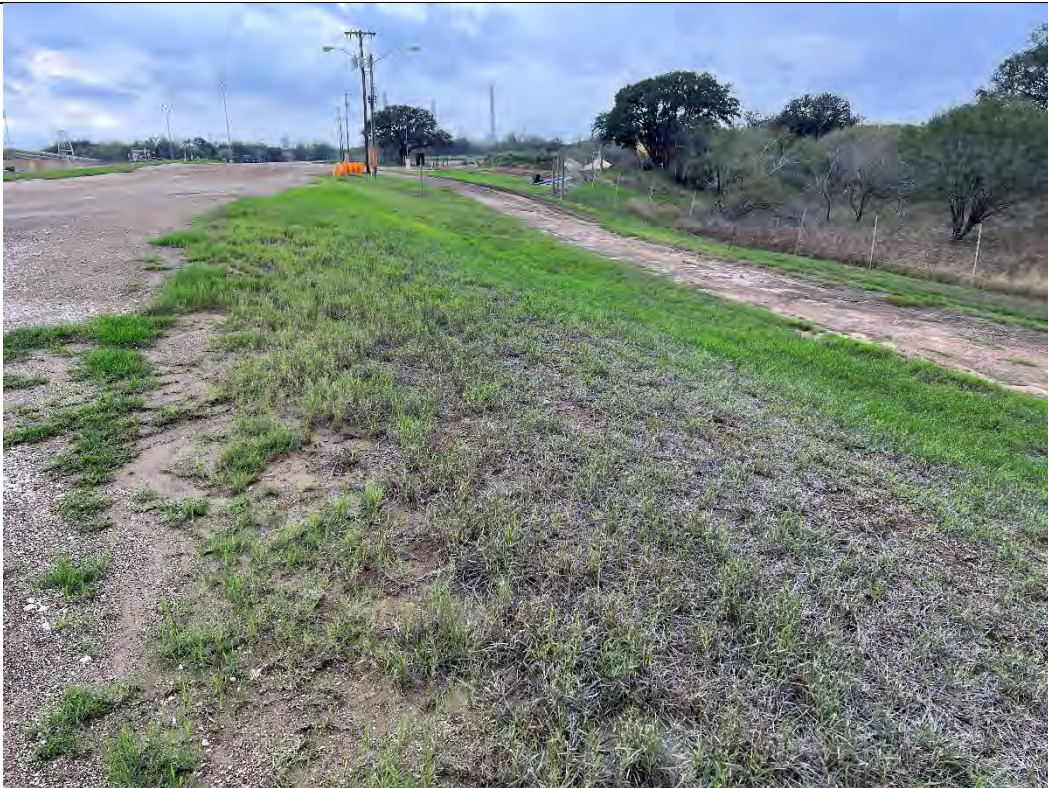
Photograph: 4 Fly Ash Landfill – standing on northwest corner – facing south.
Photo taken 12/13/2022.

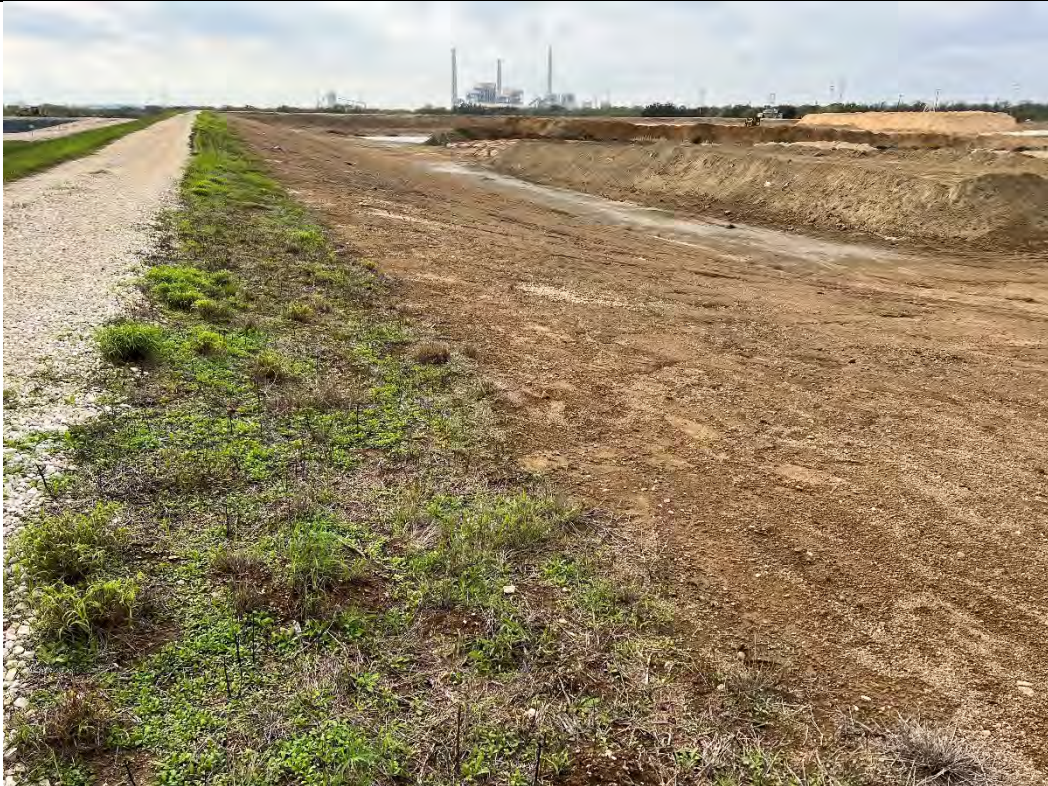
Photograph: 5 Fly Ash Landfill – standing on northeast corner – facing south.
Photo taken 12/13/2022.

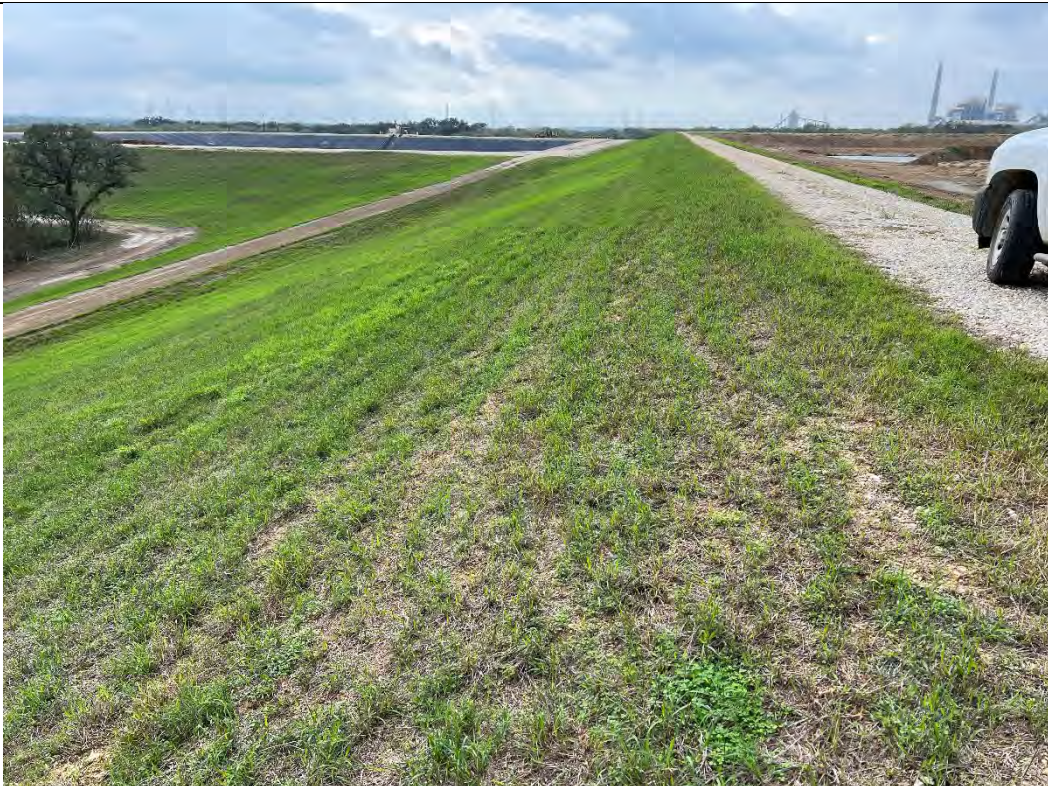
Photograph: 6 Fly Ash Landfill – standing on northeast corner – facing south.
Photo taken 12/13/2022.

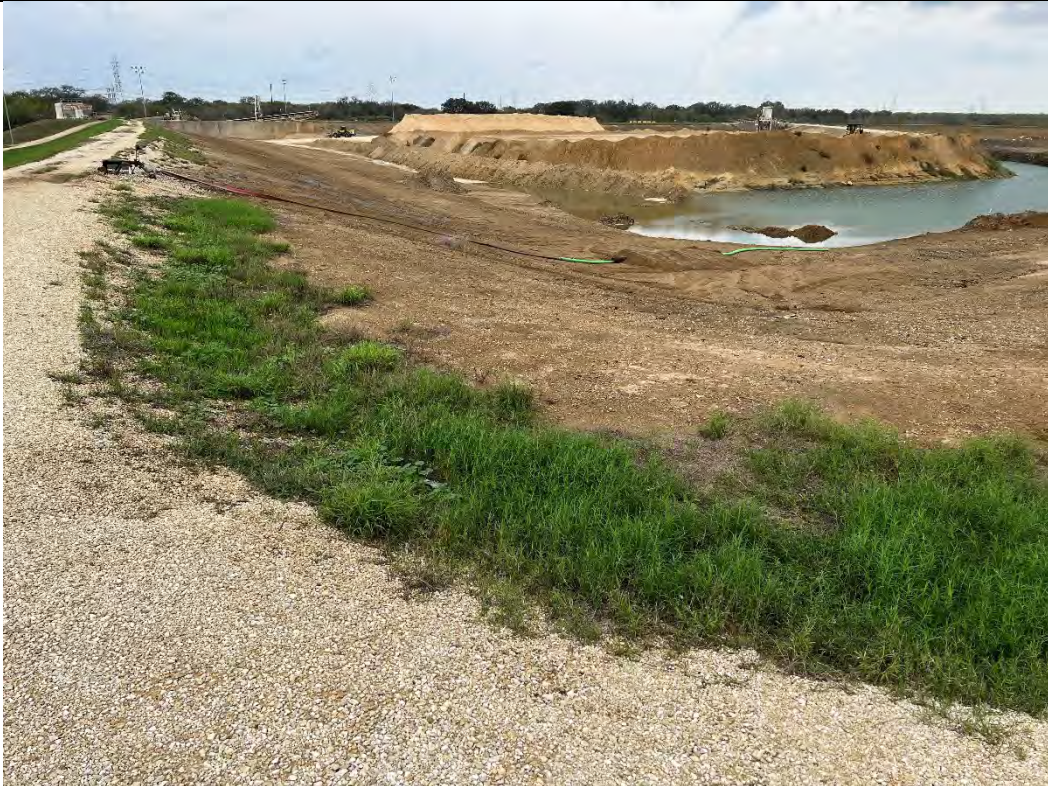
Photograph: 7 Fly Ash Landfill – standing on southeast corner – facing west. Radial stacker located in southwest corner and stormwater discharge piping in southeast corner of landfill. Photo taken 12/13/2022.

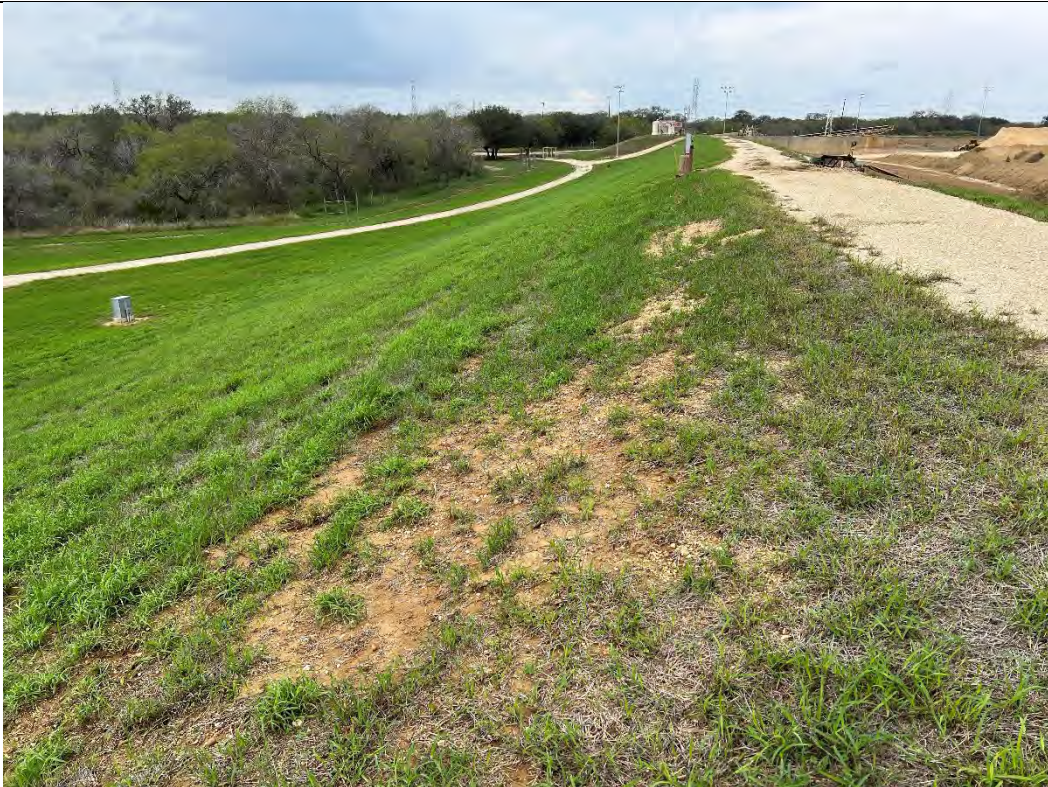
Photograph: 8 Fly Ash Landfill – standing on southeast corner – facing west. Radial stacker located in southwest corner and stormwater discharge piping in southeast corner of landfill. Photo taken 12/13/2022.

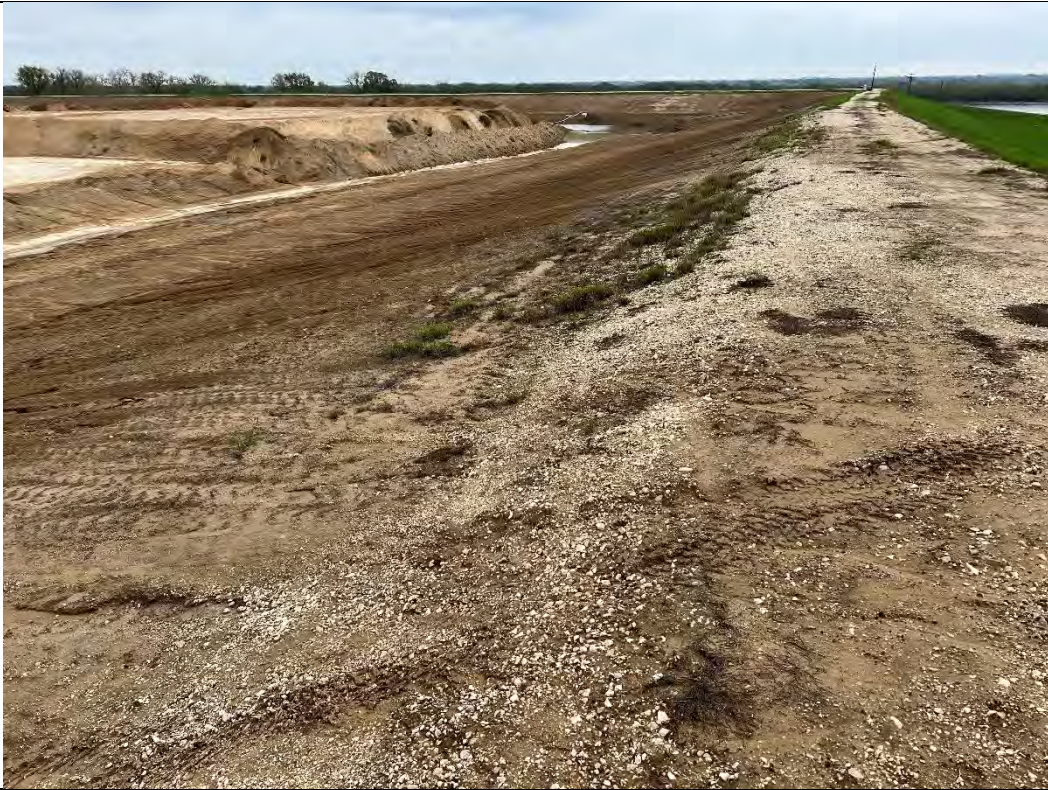
Photograph: 9 Fly Ash Landfill – standing on southwest corner – facing east.
Photo taken 12/13/2022.

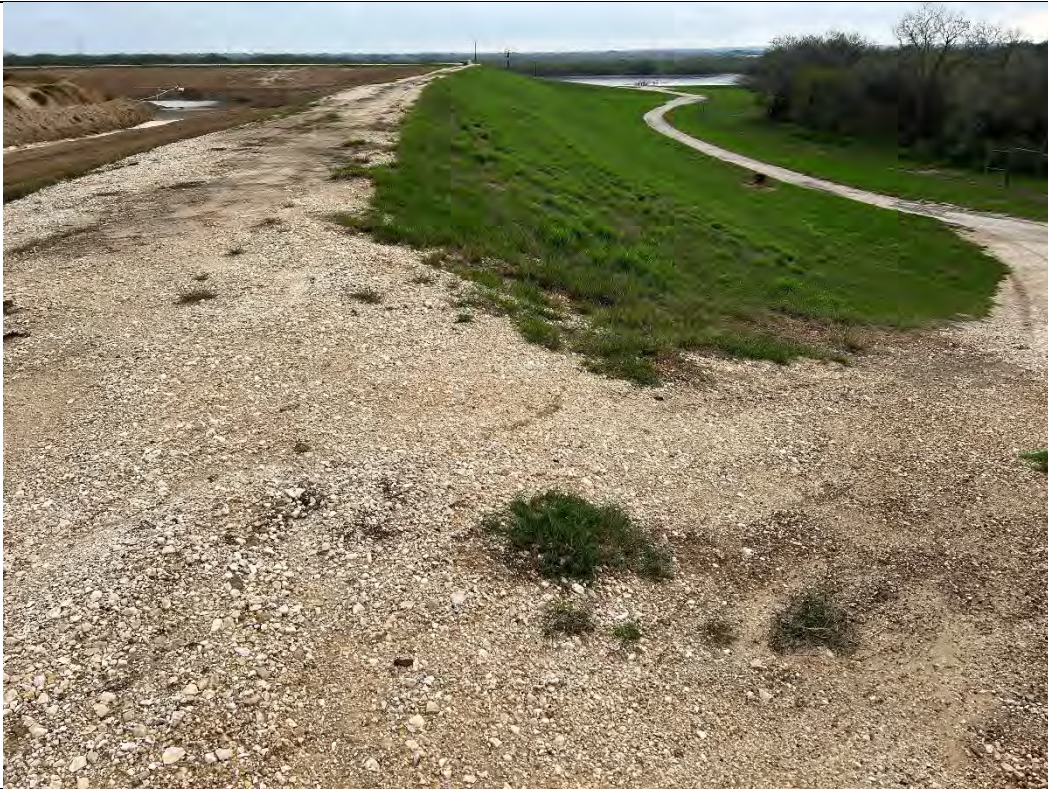
Photograph: 10 Fly Ash Landfill – standing on southwest corner – facing east.
Photo taken 12/13/2022.

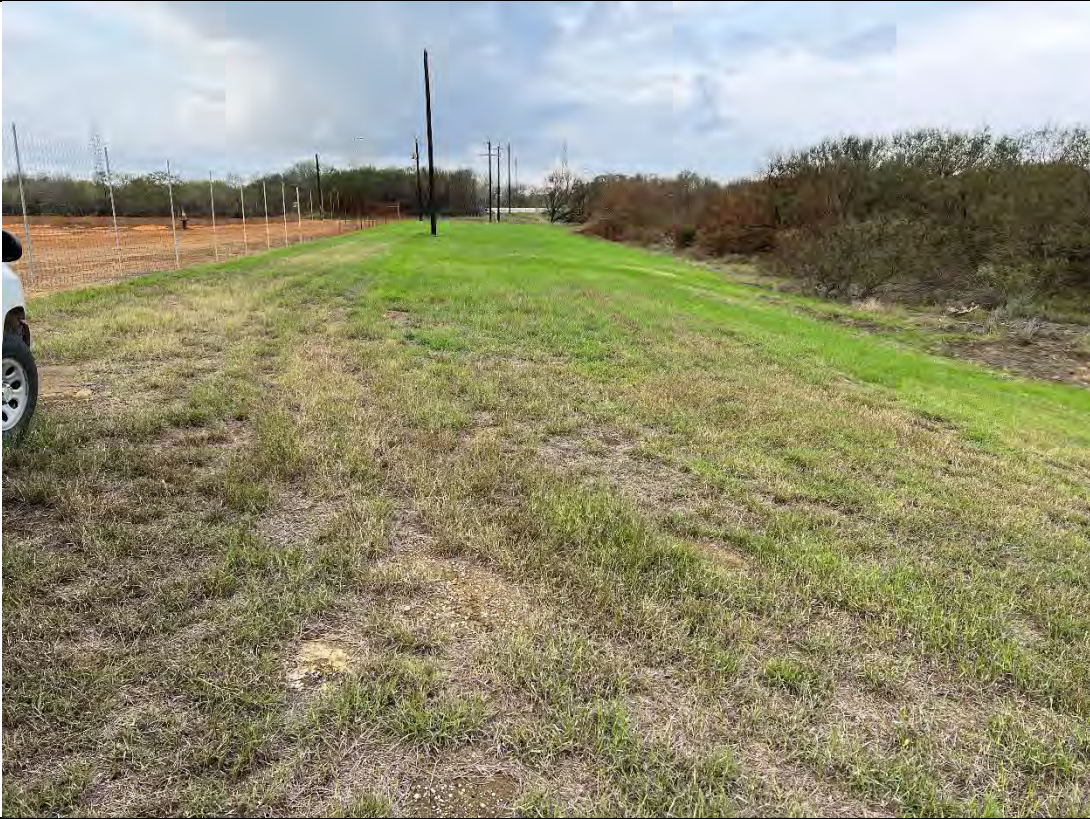
Photograph: 11 Evaporation Pond – standing on the northeast corner – facing west.
Photo taken 12/13/2022.

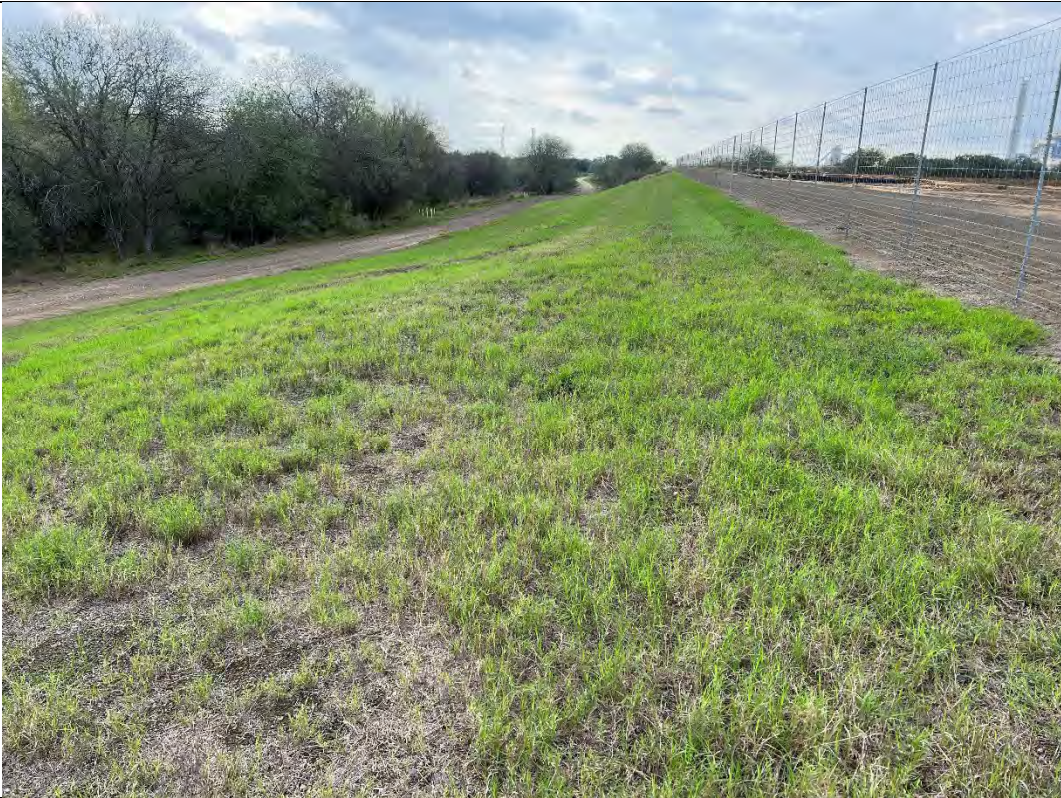
Photograph: 12 Evaporation Pond – standing on the northeast corner – facing south.
Photo taken 12/13/2022.

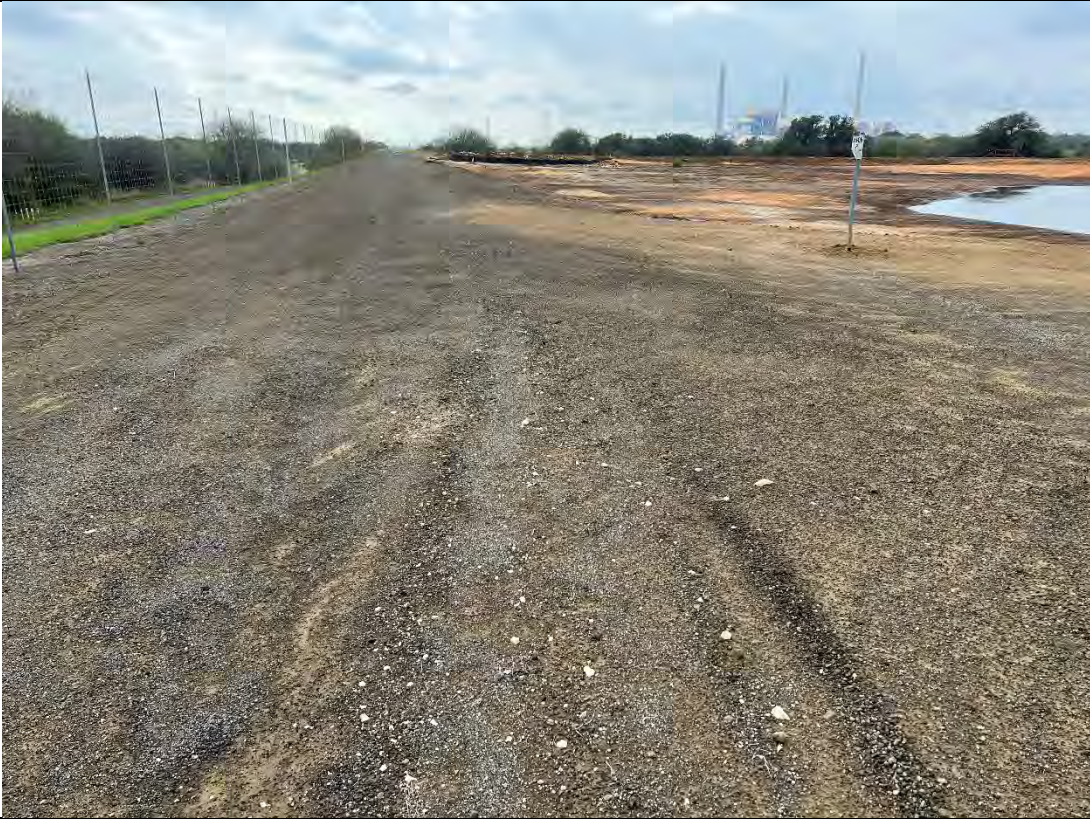
Photograph: 13 Evaporation Pond – standing on the northeast corner – facing south.
Photo taken 12/13/2022.

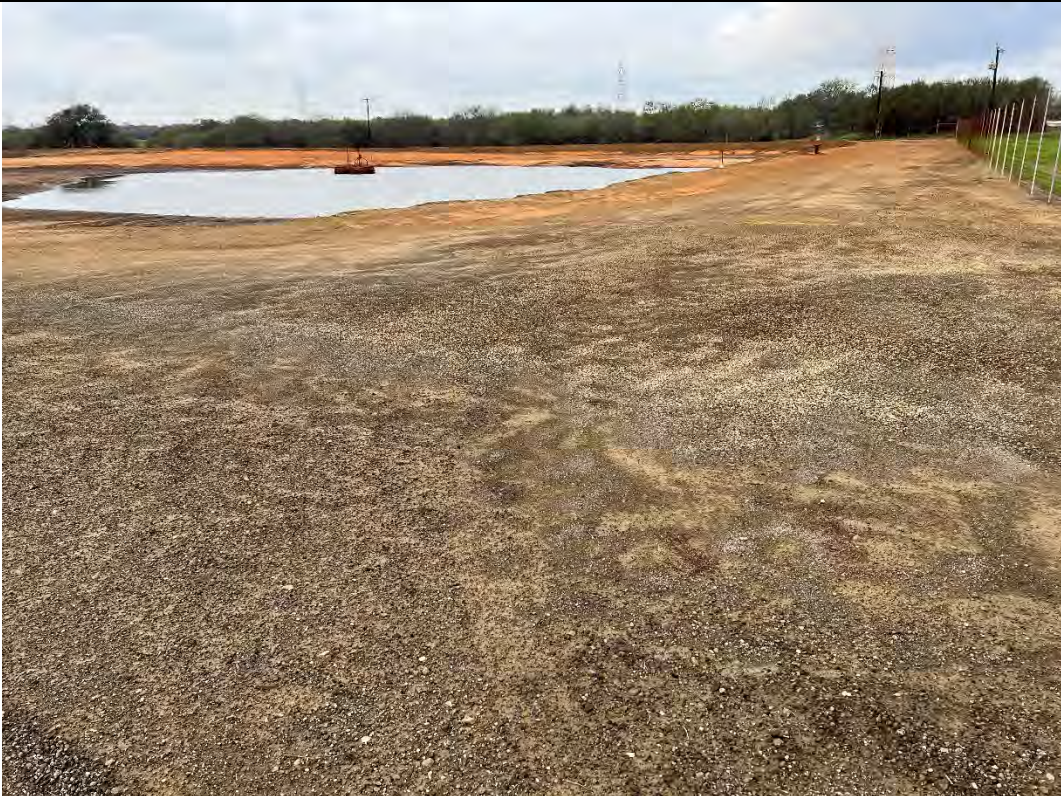
Photograph: 14 Evaporation Pond – standing on the northeast corner – facing west.
Photo taken 12/13/2022.

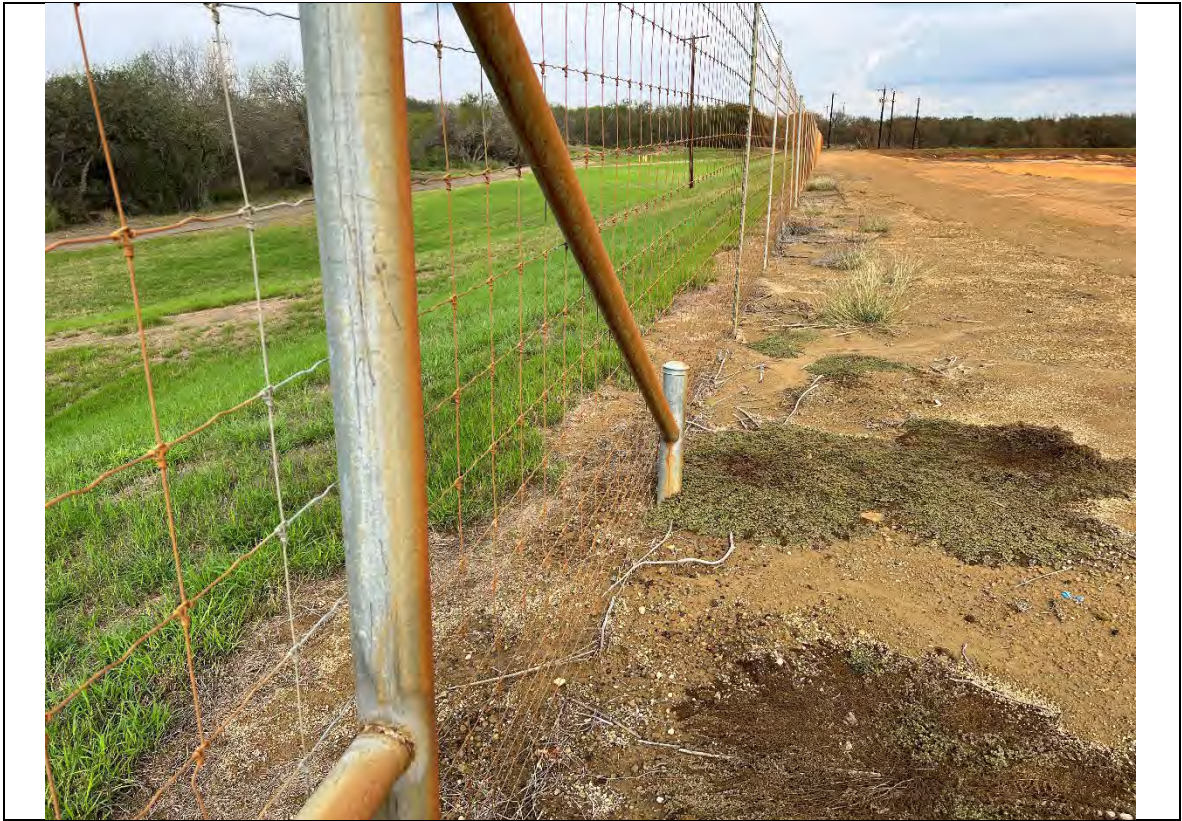
Photograph: 15 Evaporation Pond – standing on the southwest corner – facing north.
Photo taken 12/13/2022.

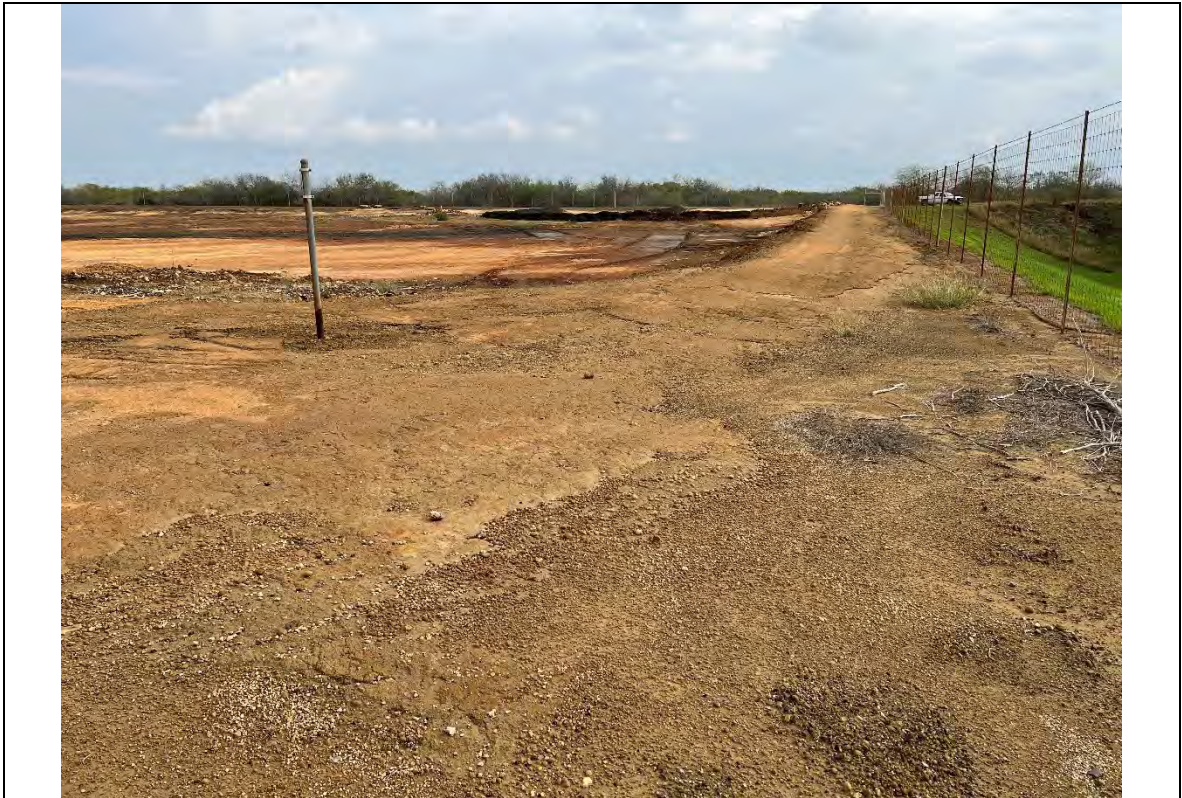
Photograph: 16 Evaporation Pond – standing on the southwest corner – facing east.
Photo taken 12/13/2022.

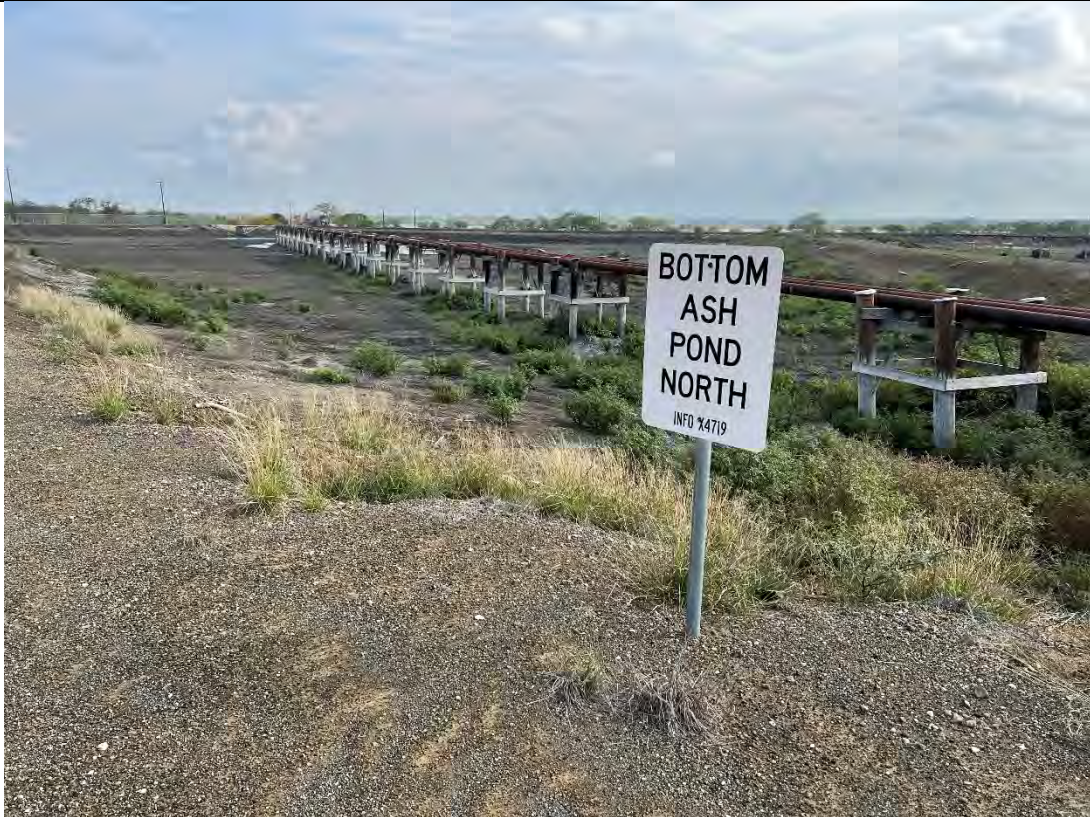
Photograph: 17 North Bottom Ash Pond – standing on southwest corner – facing northeast. Photo taken 12/13/2022.

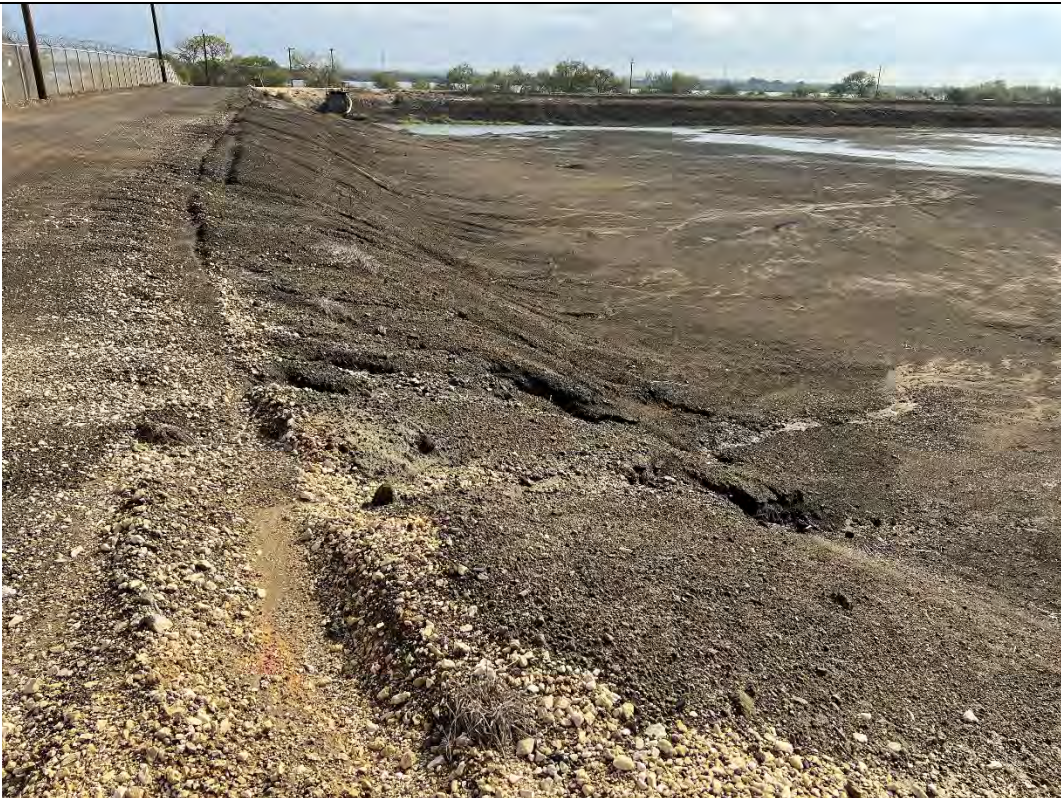
Photograph: 18 North Bottom Ash Pond – standing on northwest corner – facing east. Photo taken 12/13/2022.

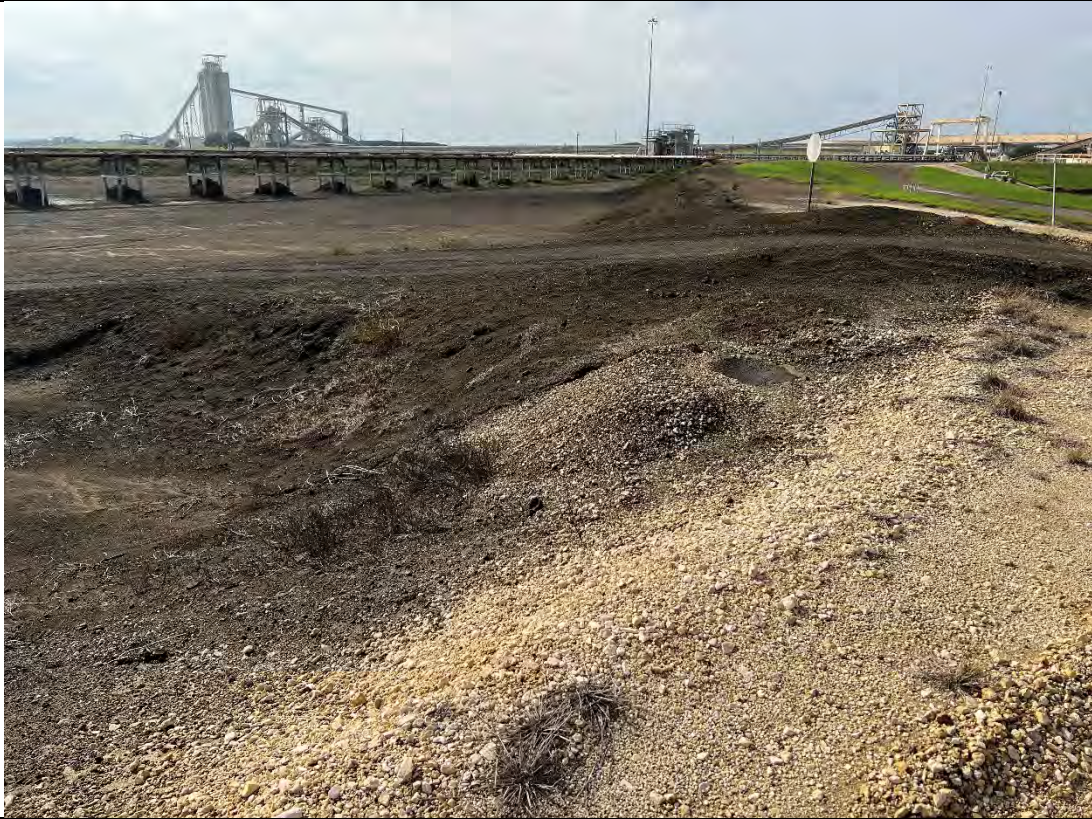
Photograph: 19 North Bottom Ash Pond – standing on northwest corner – facing south.
Photo taken 12/13/2022.

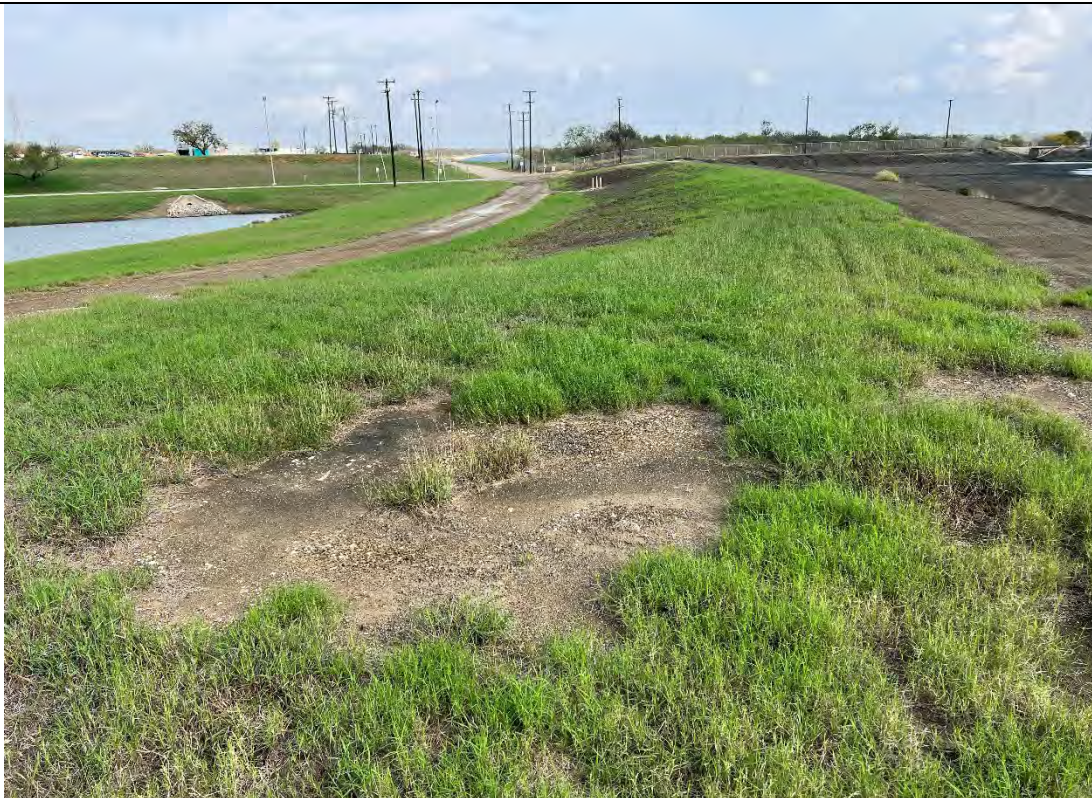
Photograph: 20 North Bottom Ash Pond – standing on southwest corner – facing northeast.
Photo taken 12/13/2022.

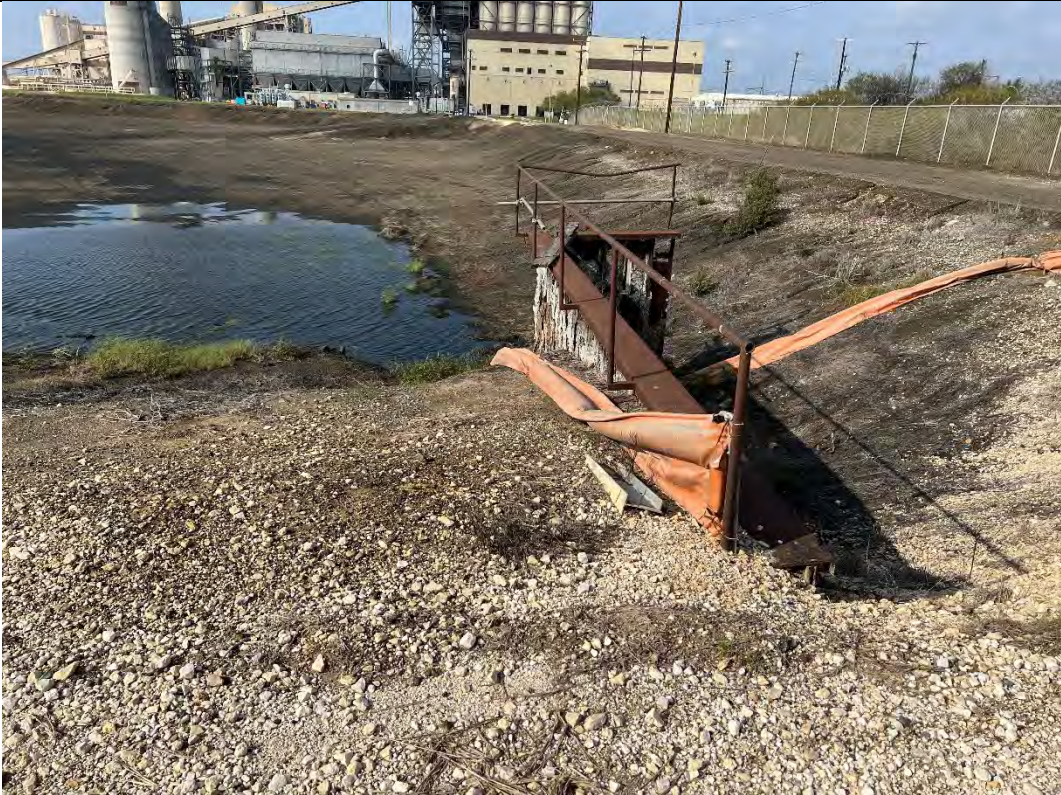
Photograph: 21 | North Bottom Ash Pond – standing on northeast corner – facing west.
Photo taken 12/13/2022.

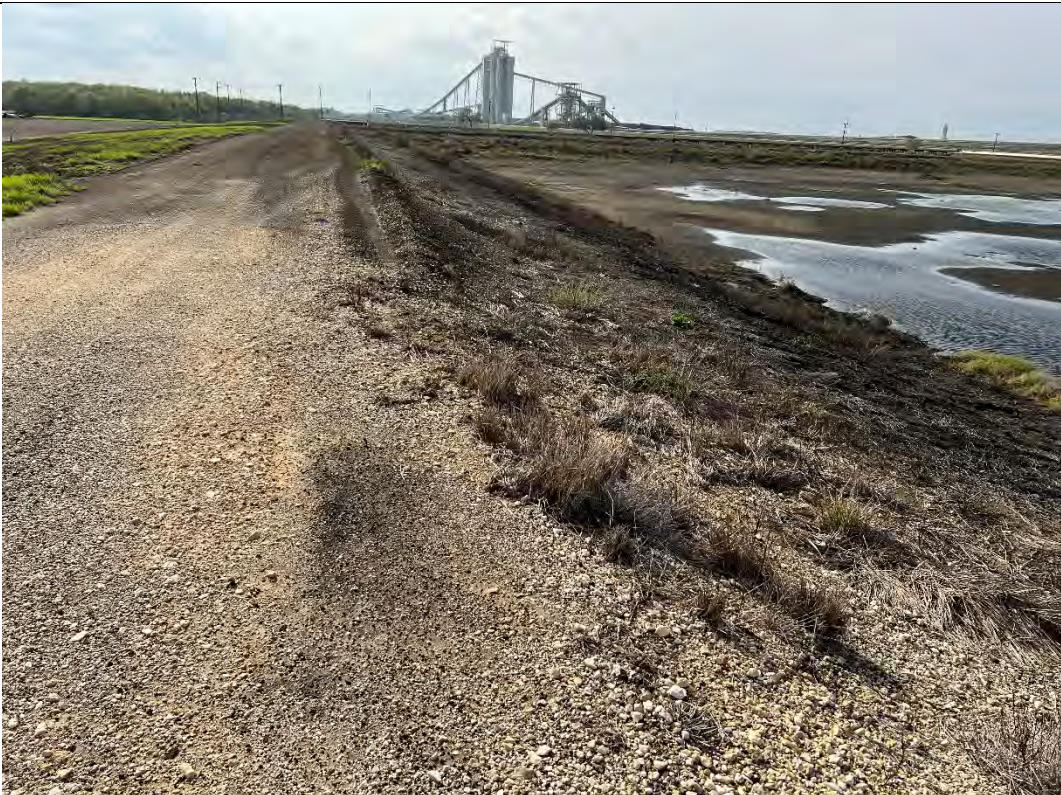
Photograph: 22 | North Bottom Ash Pond – standing on northeast corner – facing south.
Photo taken 12/13/2022.

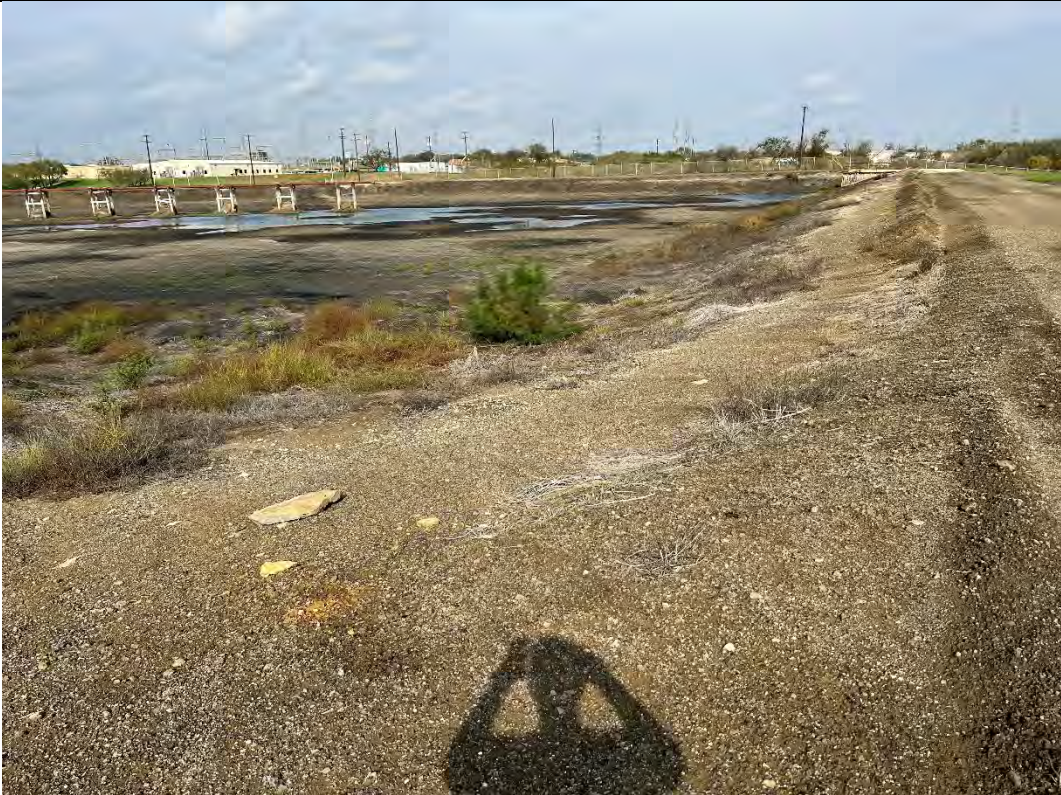
Photograph: 23 | North Bottom Ash Pond – standing on southeast corner – facing north.
Photo taken 12/13/2022.

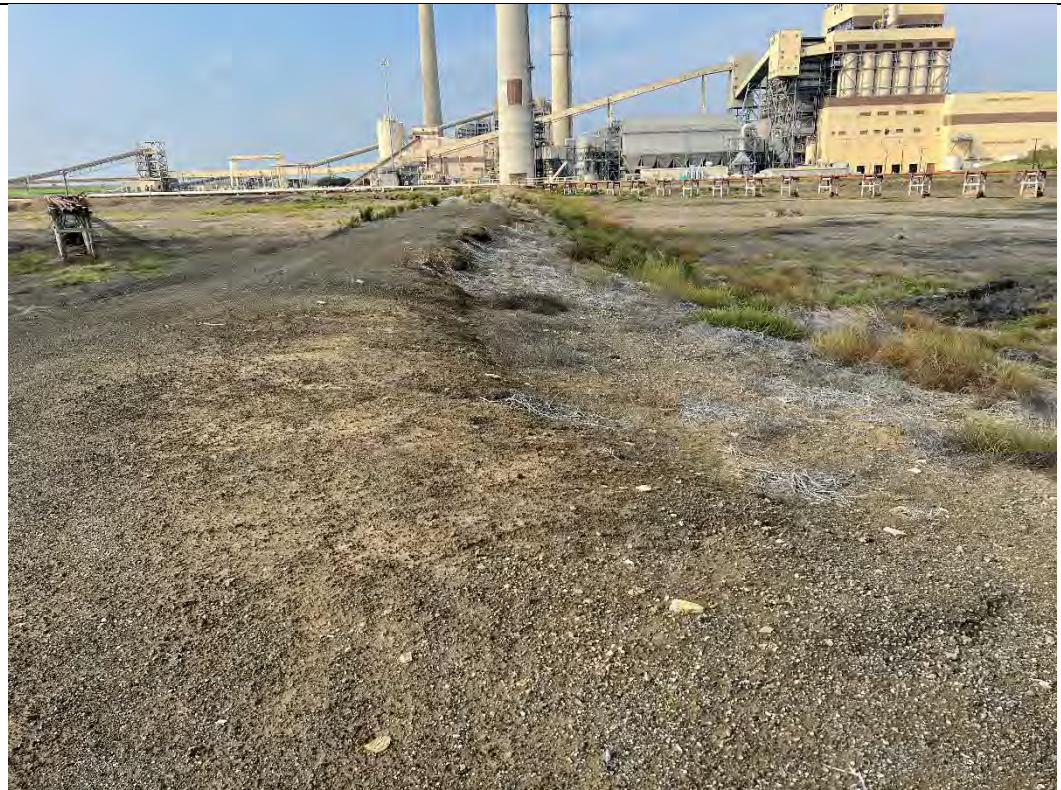
Photograph: 24 | North Bottom Ash Pond – standing on southeast corner – facing west.
Photo taken 12/13/2022.

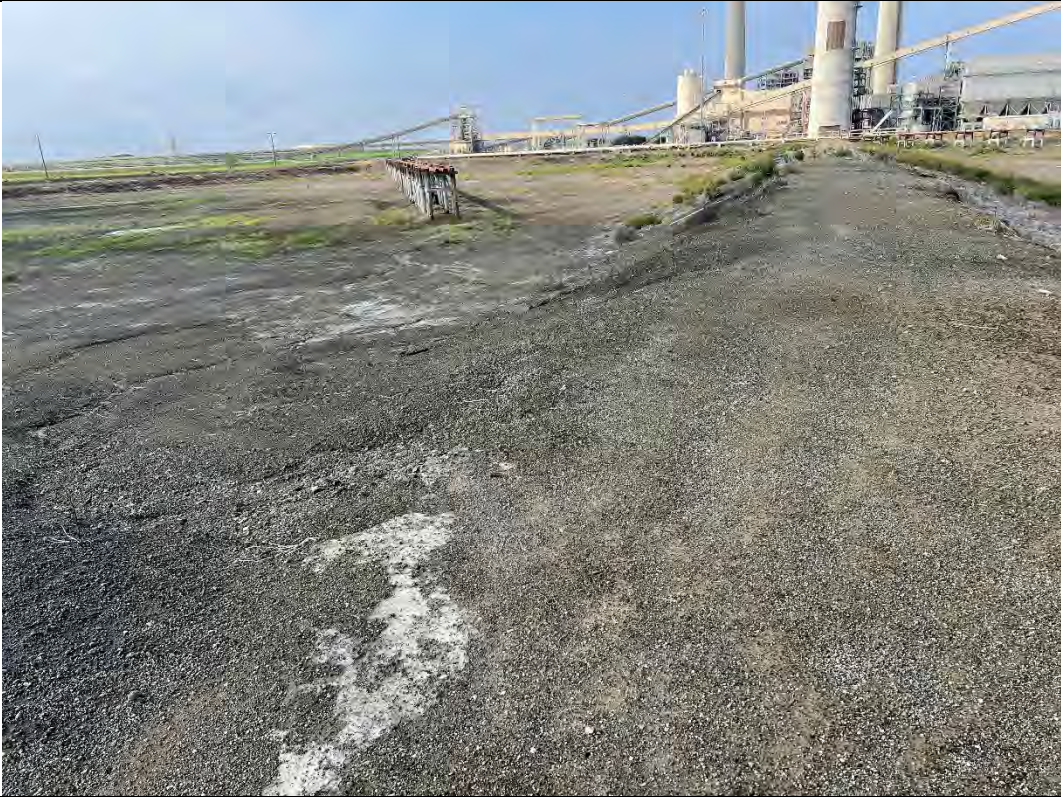
Photograph: 25 South Bottom Ash Pond – standing on northeast corner – facing west.
Photo taken 12/13/2022.

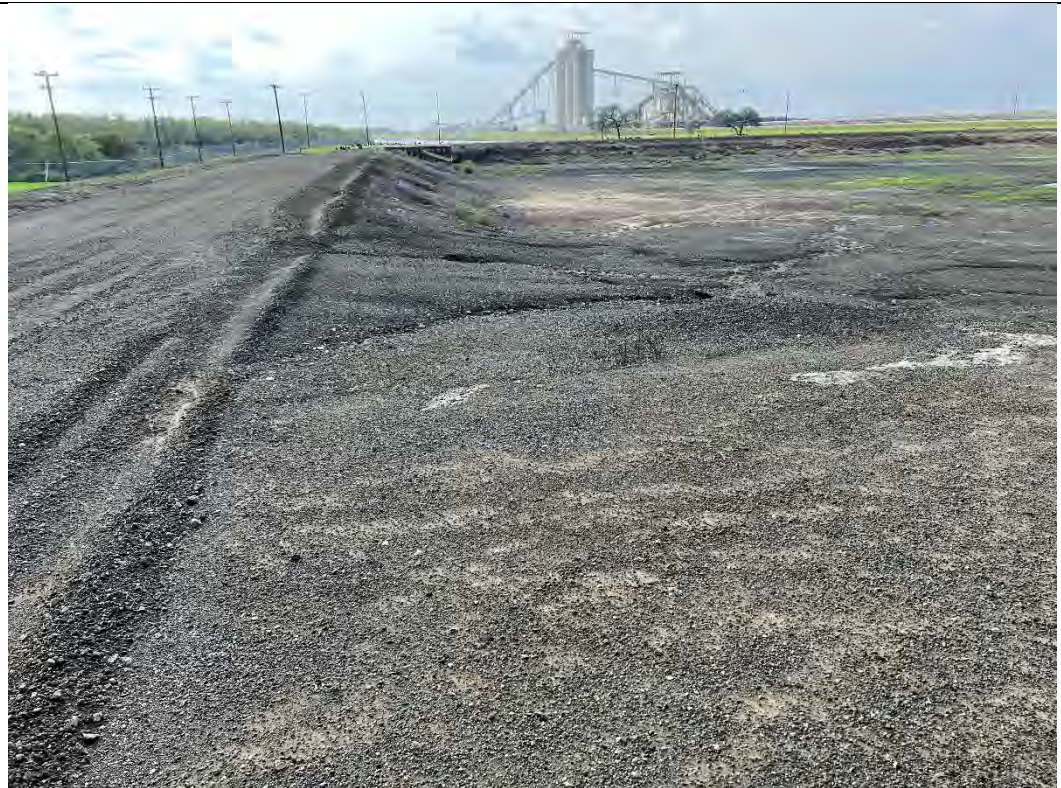
Photograph: 26 South Bottom Ash Pond – standing on northeast corner – facing south.
Photo taken 12/13/2022.
