January 31, 2023

Reference: 0352436

Subject: CCR Units – 2022 Annual Inspection and Fugitive Dust Control Report
Calaveras Power Station
San Antonio, Texas

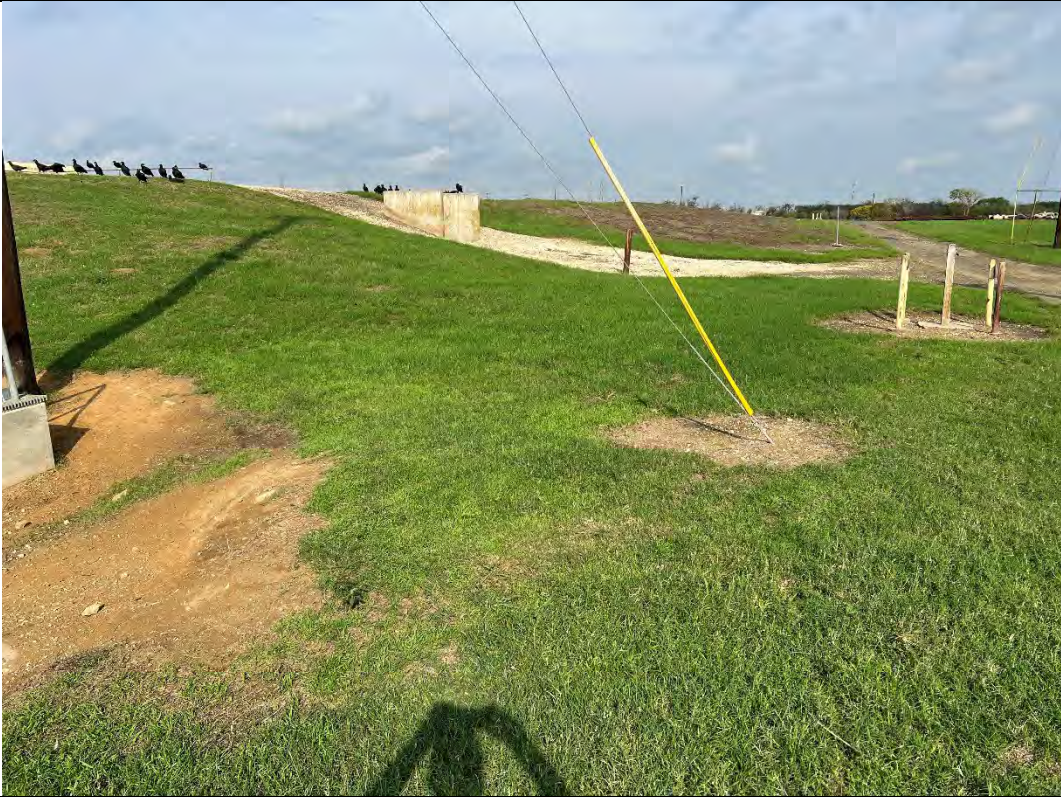
Photograph: 27 South Bottom Ash Pond – standing on southeast corner – facing north.
Photo taken 12/13/2022.

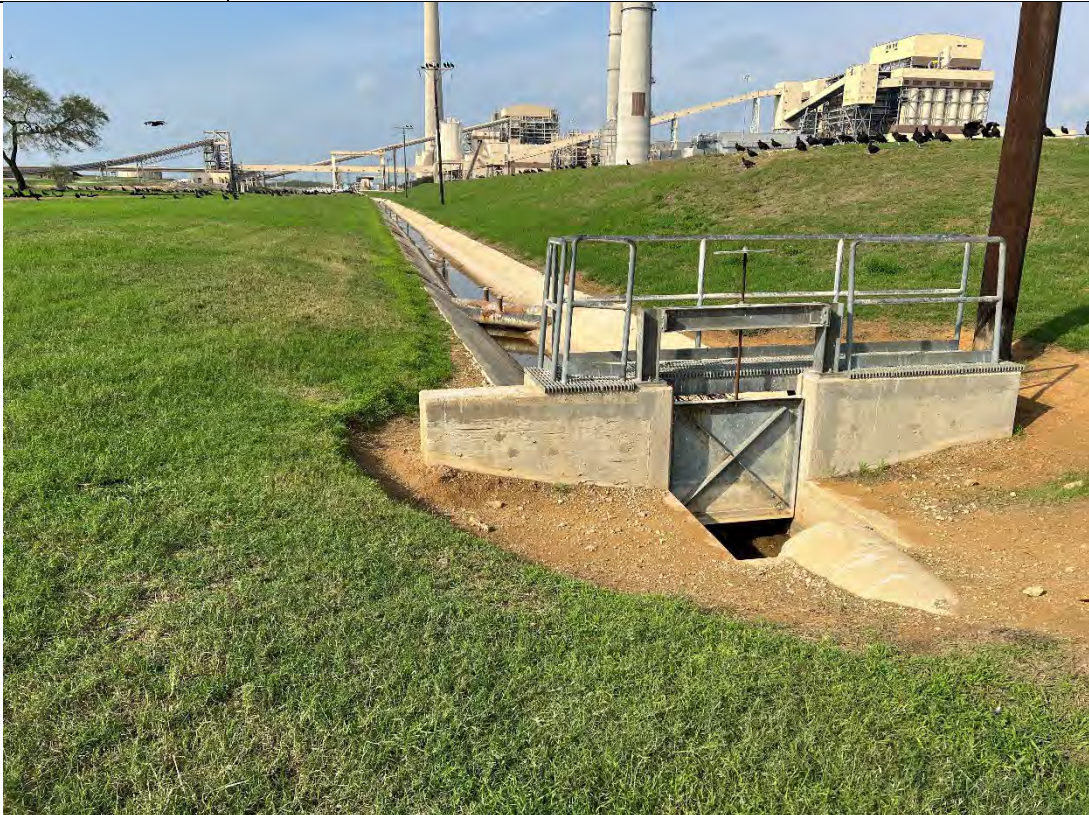
Photograph: 28 South Bottom Ash Pond – standing on southeast corner – facing west.
Photo taken 12/13/2022.

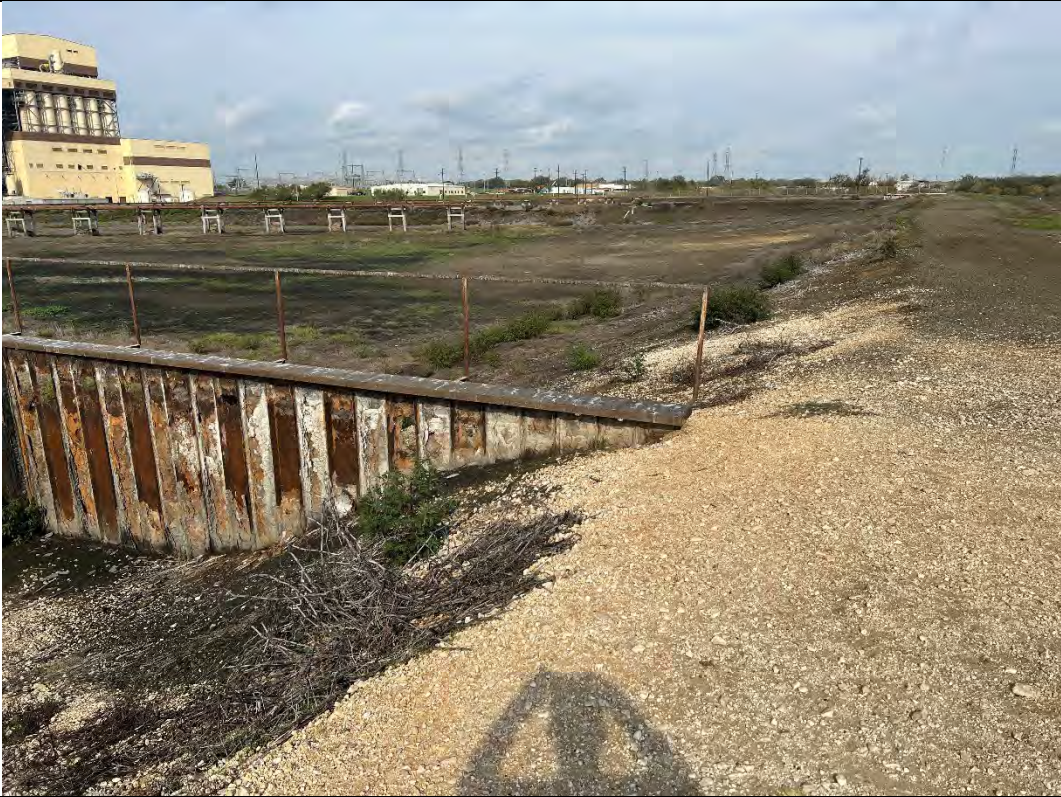
Photograph: 29 | South Bottom Ash Pond – standing on southeast corner – facing northwest. Photo taken 12/13/2022.

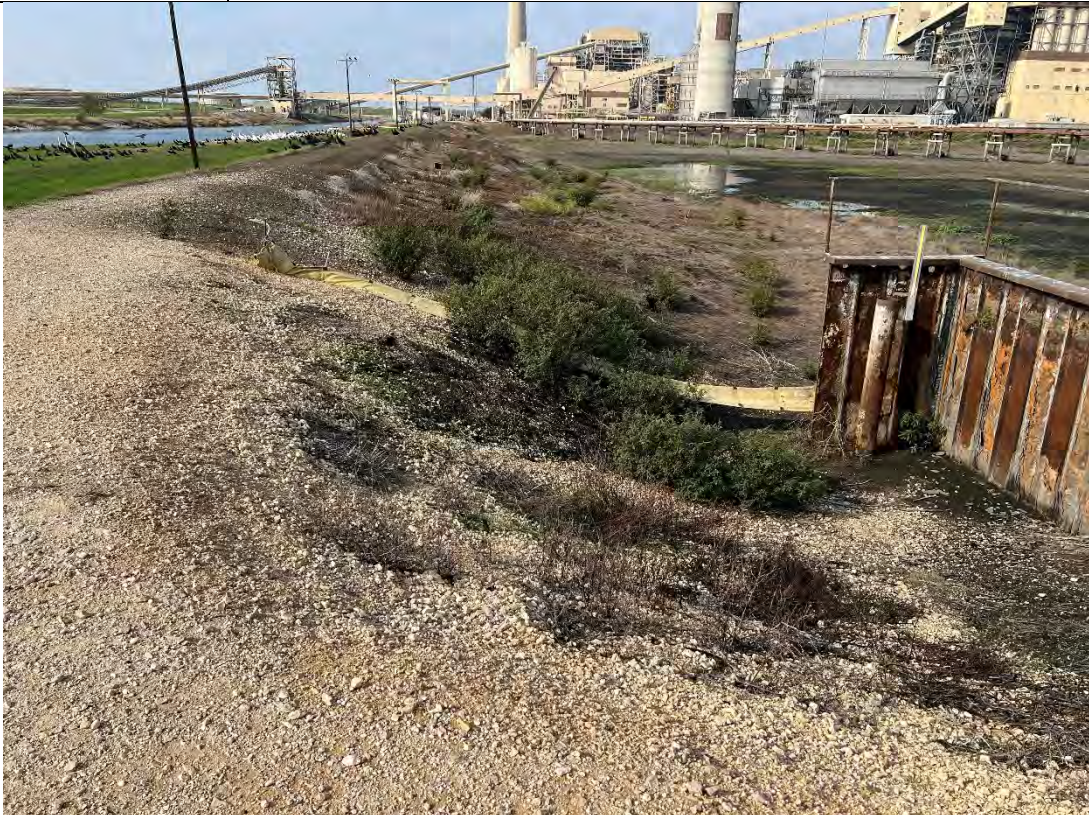
Photograph: 30 | South Bottom Ash Pond – standing on southeast corner – facing west. Photo taken 12/13/2022.

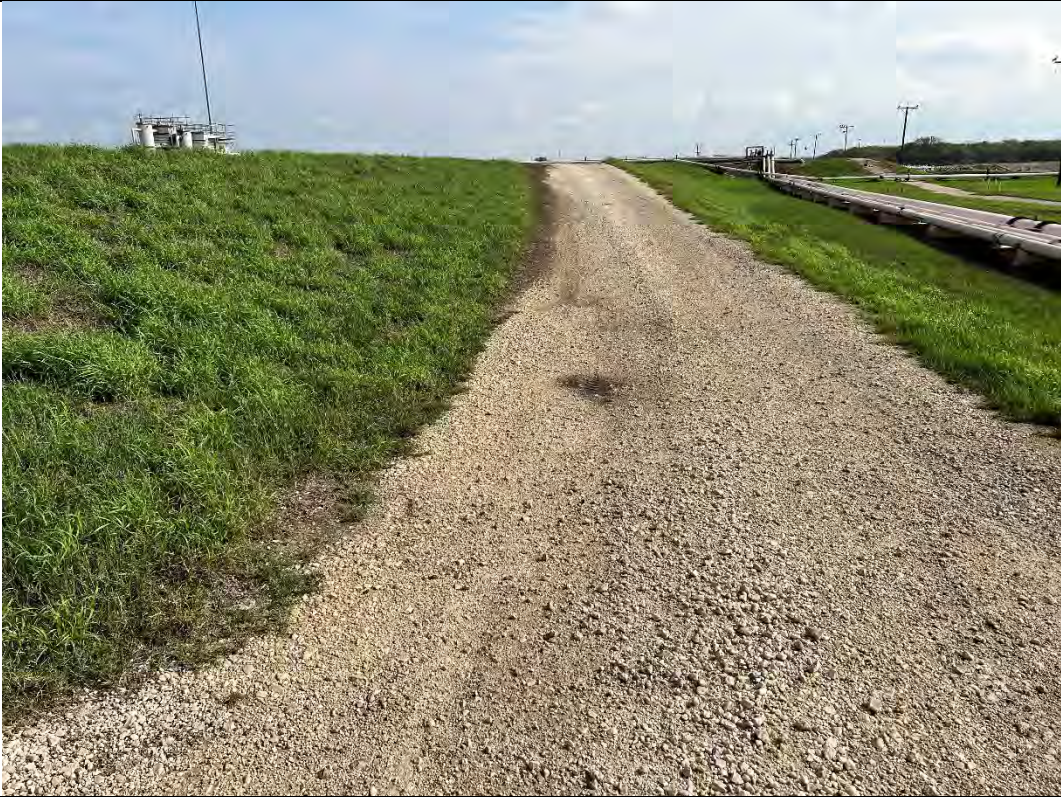
Photograph: 31 South SRH Pond – standing on the southwest corner – facing east.
Photo taken 12/13/2022.

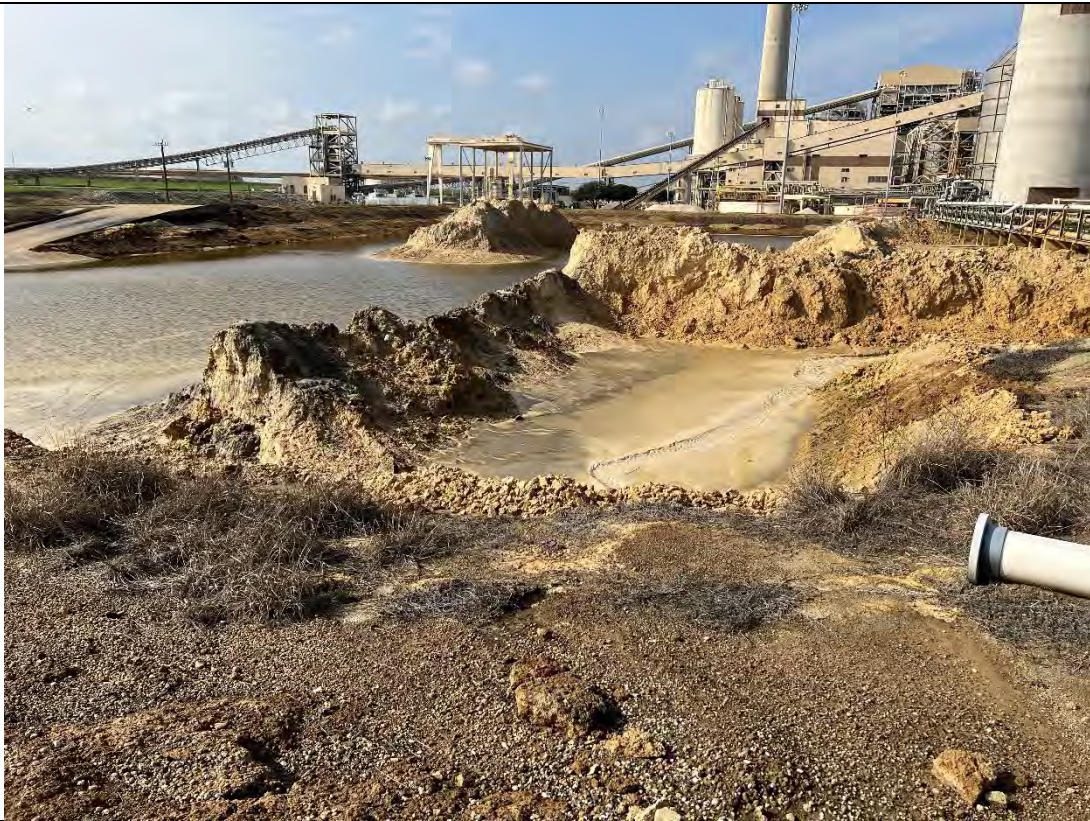
Photograph: 32 South SRH Pond – standing on the northeast corner – facing southwest.
Photo taken 12/13/2022.

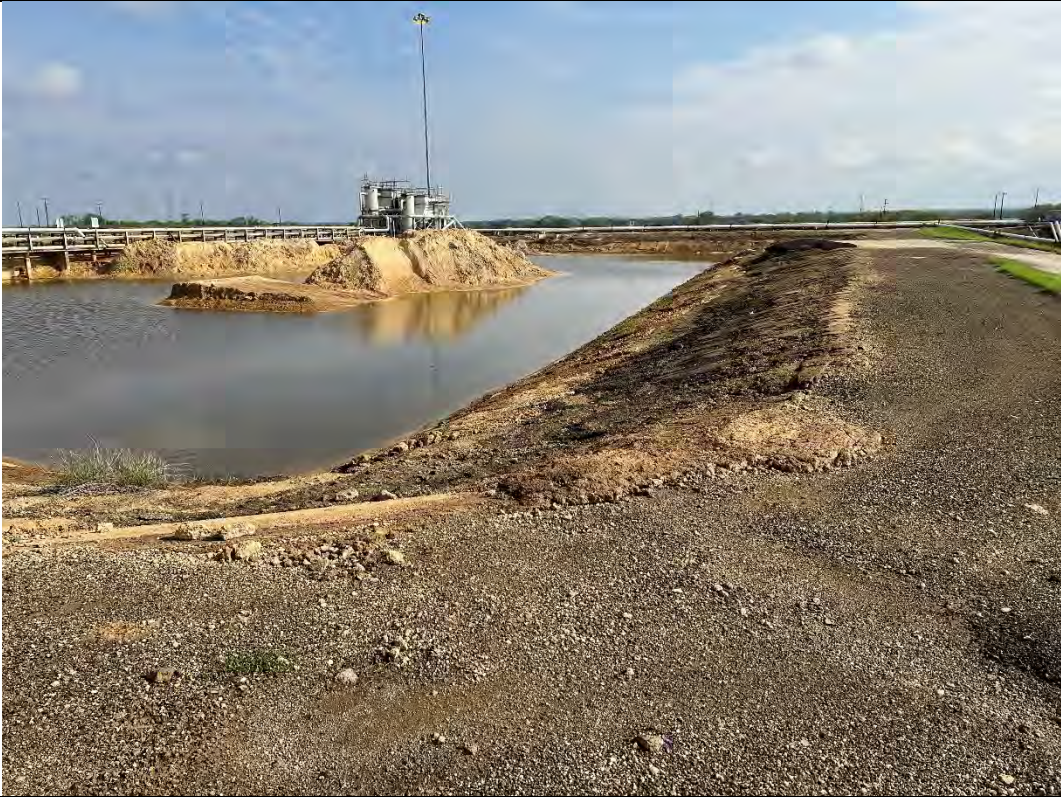
Photograph: 33 South SRH Pond – standing on the southwest corner – facing east.
Photo taken 12/13/2022.

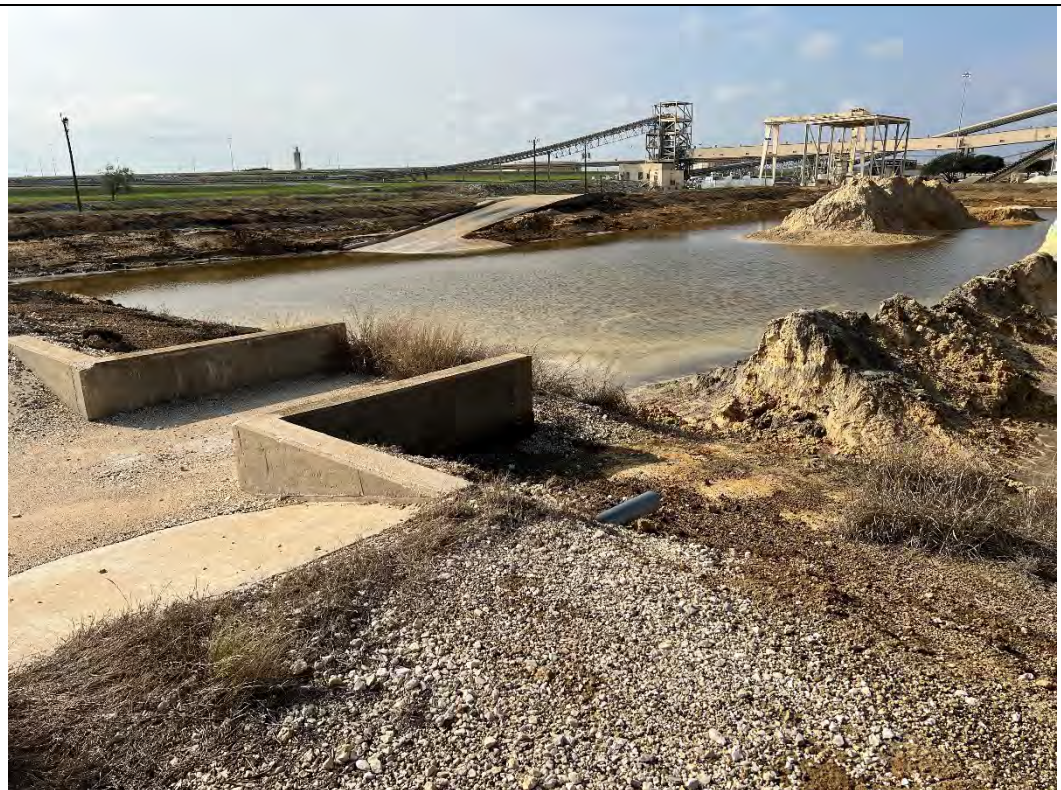
Photograph: 34 South SRH Pond – standing on the northeast corner facing southwest – spillway structure. Photo taken 12/13/2022.

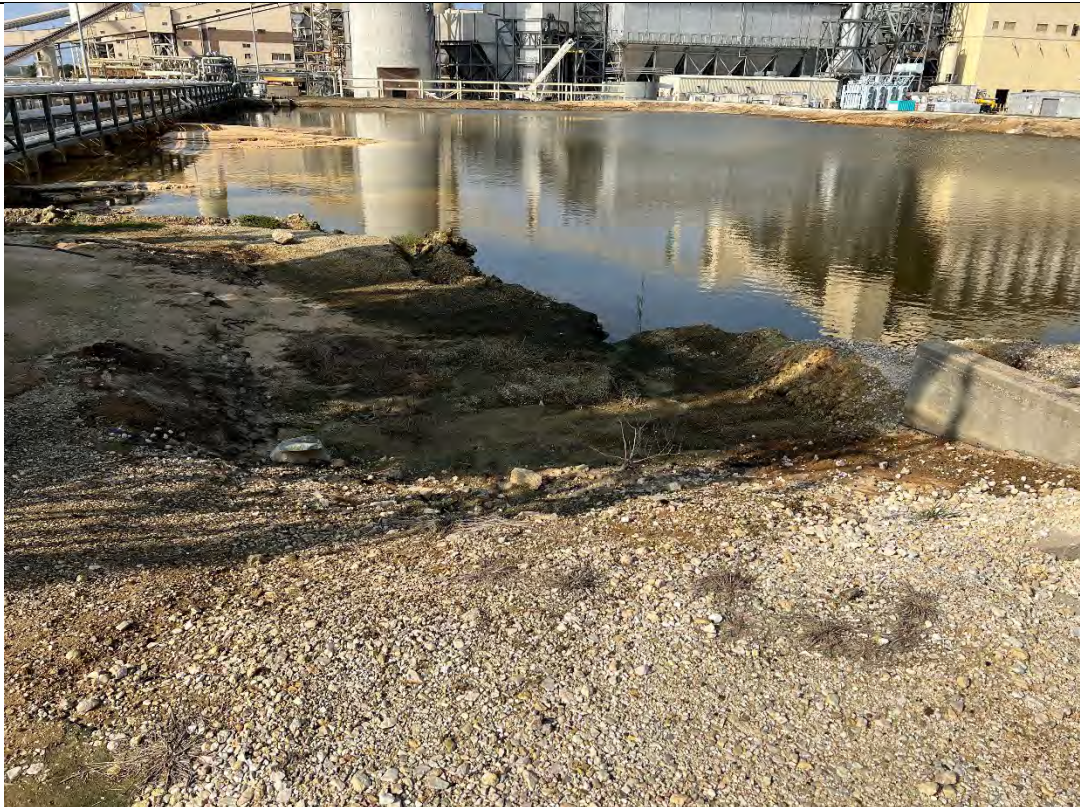
Photograph: 35 North SRH Pond – standing on the southeast corner – facing west.
Photo taken 12/13/2022.

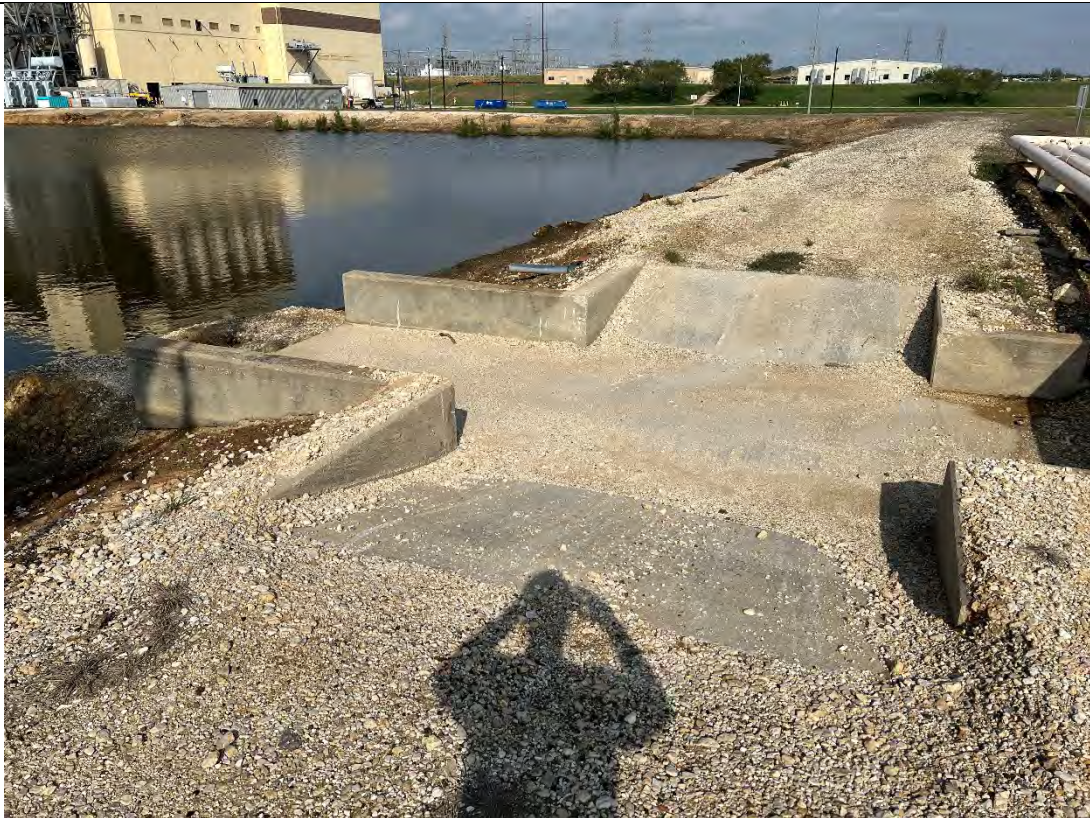
Photograph: 36 North SRH Pond – standing on the southeast corner – facing northwest.
Photo taken 12/13/2022.

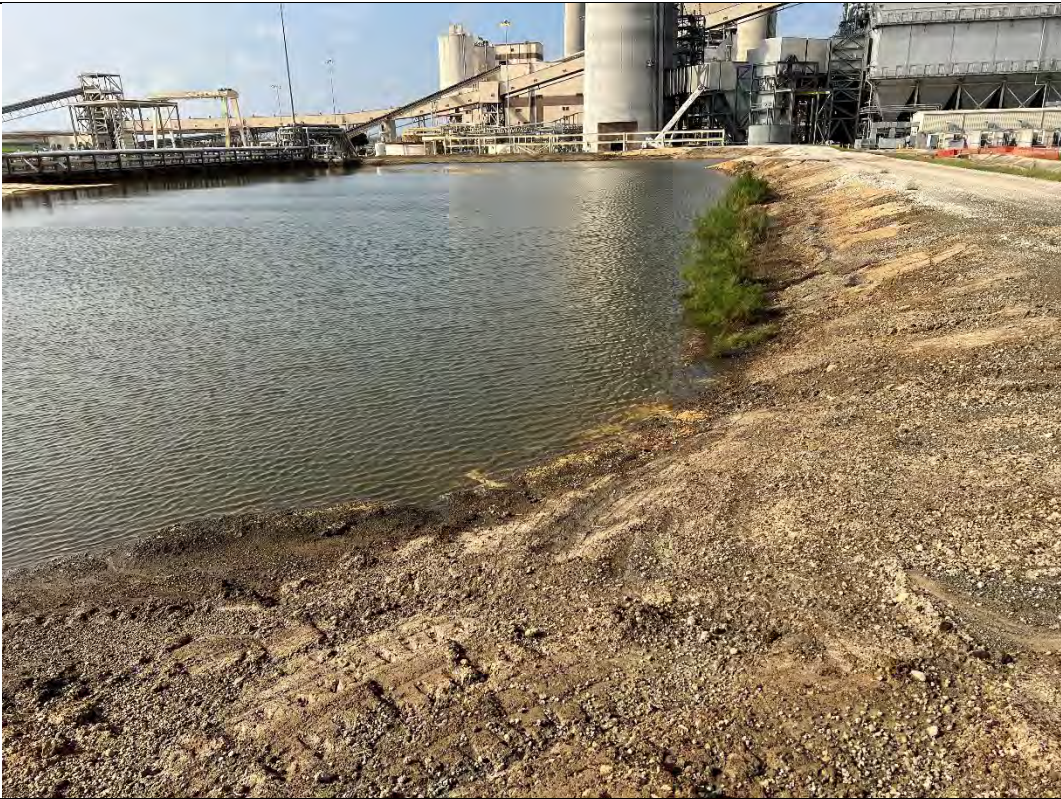
Photograph: 37 North SRH Pond – standing on the northeast corner – facing west.
Photo taken 12/13/2022.

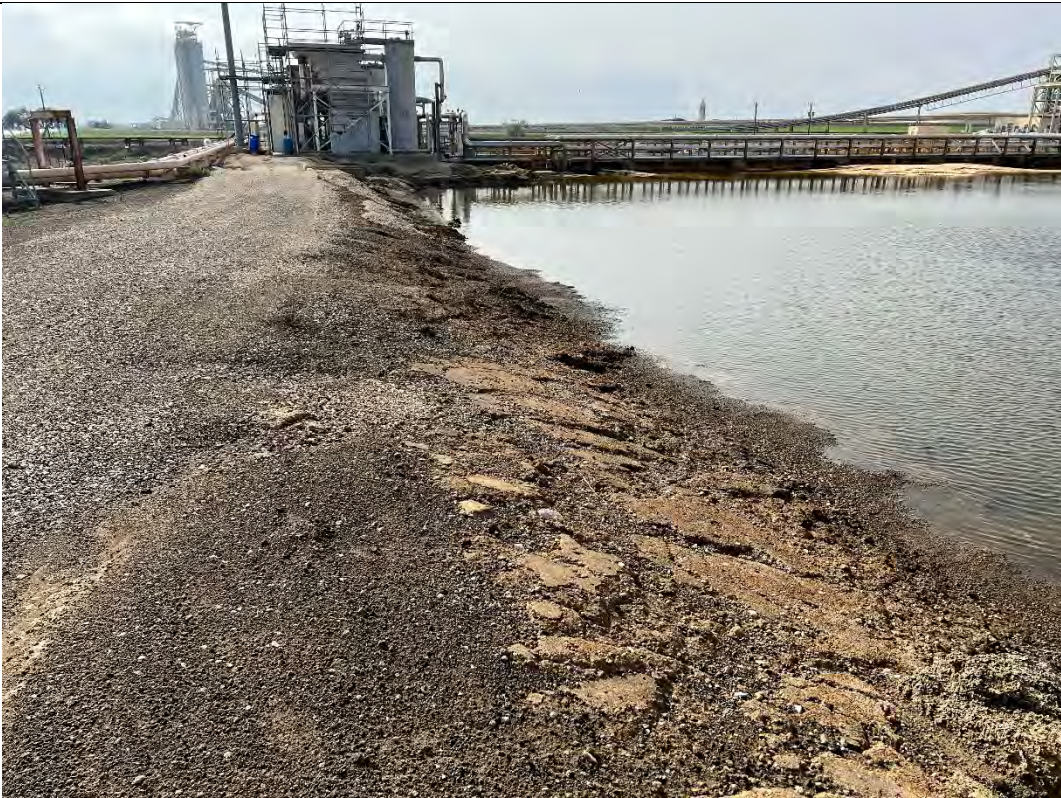
Photograph: 38 North SRH Pond – standing on the northeast corner – facing south.
Photo taken 12/13/2022.

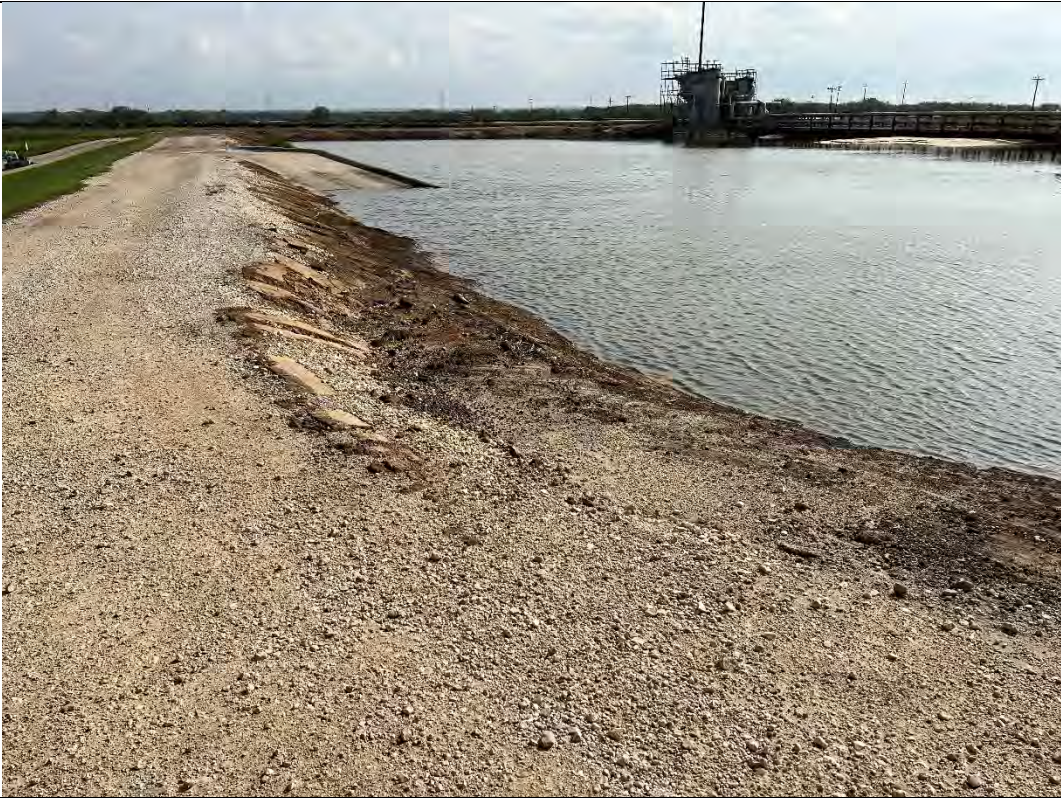
Photograph: 39 | North SRH Pond – standing on the northwest corner – facing east.
Photo taken 12/13/2022.

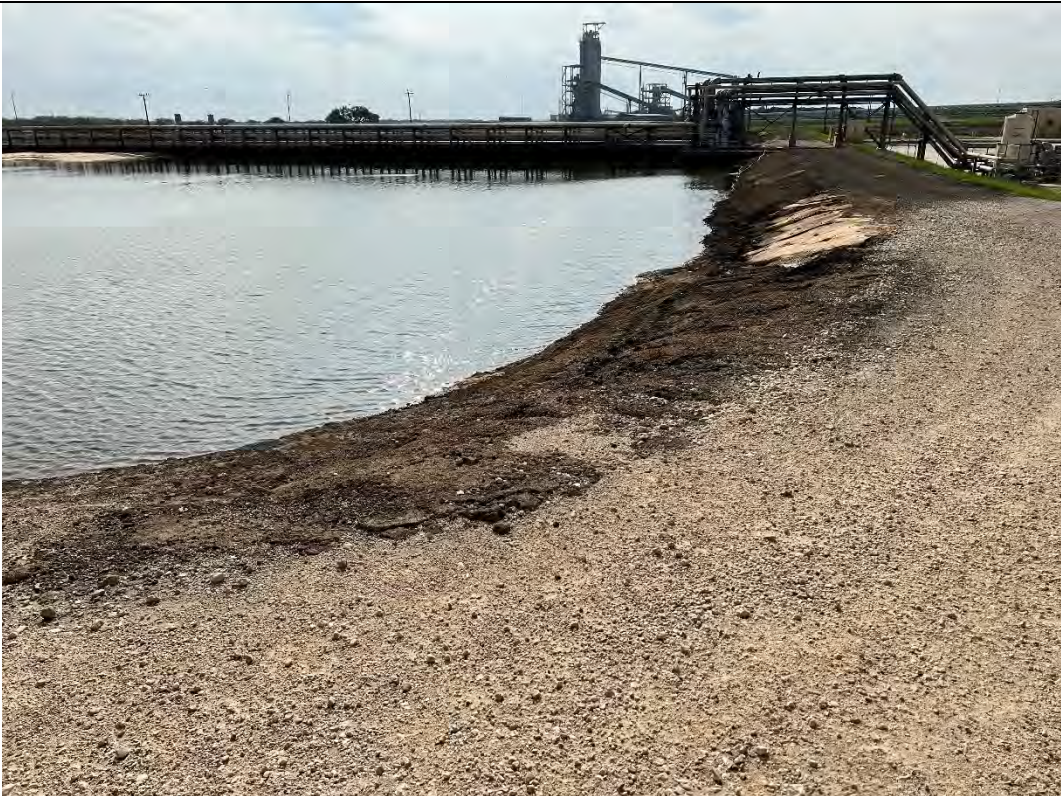
Photograph: 40 | North SRH Pond – standing on the northwest corner – facing south.
Photo taken 12/13/2022.
