Date: 30 January 2024
 Facility Name: Calaveras Plant Site
 Permit or Registration No.: CCR102

SUBJECT
CCR Units – 2023 Annual Inspection
and Fugitive Dust Control Report
Calaveras Power Station
San Antonio, Texas

The annual inspection was conducted by Mr. Charles Johnson, P.E., on November 16, 2023. Photographs taken during the inspection are provided in Attachment 1. No issues were observed that indicated immediate stability or operational issues at the CCR units. Details of the observations made by Mr. Johnson are provided below.

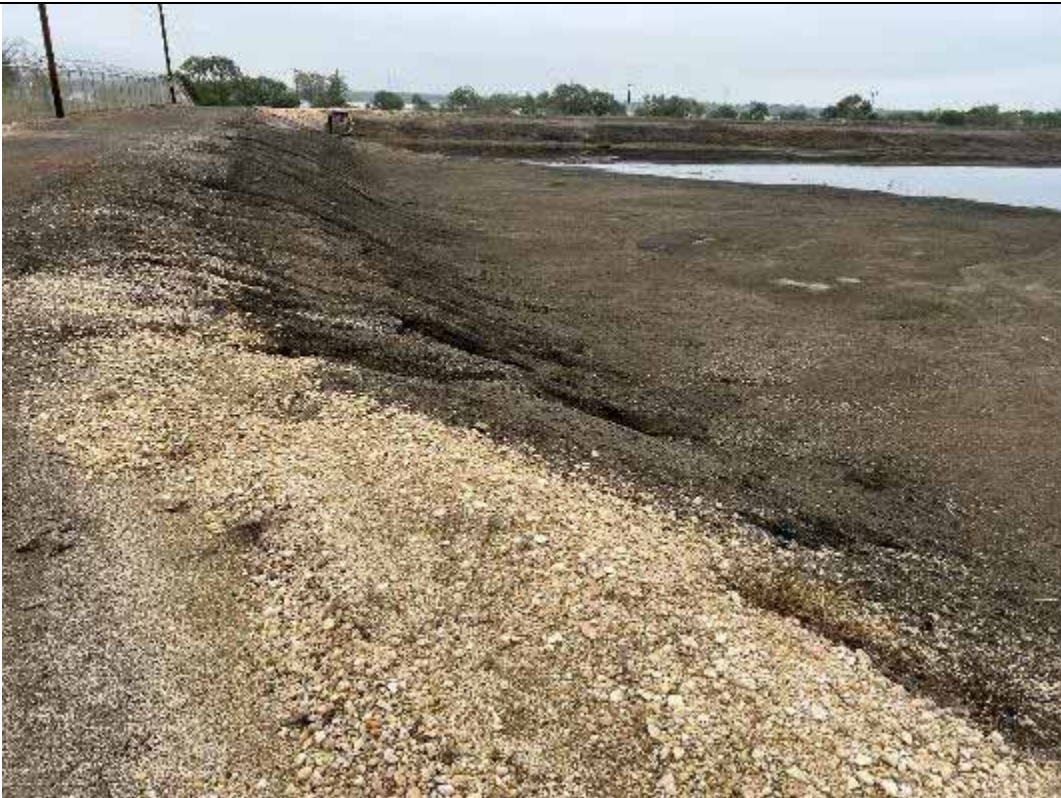
Grass along the western and eastern exterior embankment slopes was observed to be generally well maintained. Some minor erosion was observed on the north interior embankment slope. As long as the CCR unit is inactive, substantially empty of CCR, and maintained dry, minor erosion of interior side slopes does not present a substantial risk to stability or operation of the unit. No significant rutting, erosion, animal burrows, seepage, or other problems were observed at the time of the annual inspection.

Photograph: 20 North Bottom Ash Pond – standing on northwest corner – facing east. Minor erosion noted on the north interior slope. Photo taken 11/16/2023.

Weekly inspection records from January 3, 2023 through December 28, 2023 reported young trees starting to grow in the interior and the need for mowing. These items should be addressed and maintained until unit closure is completed.

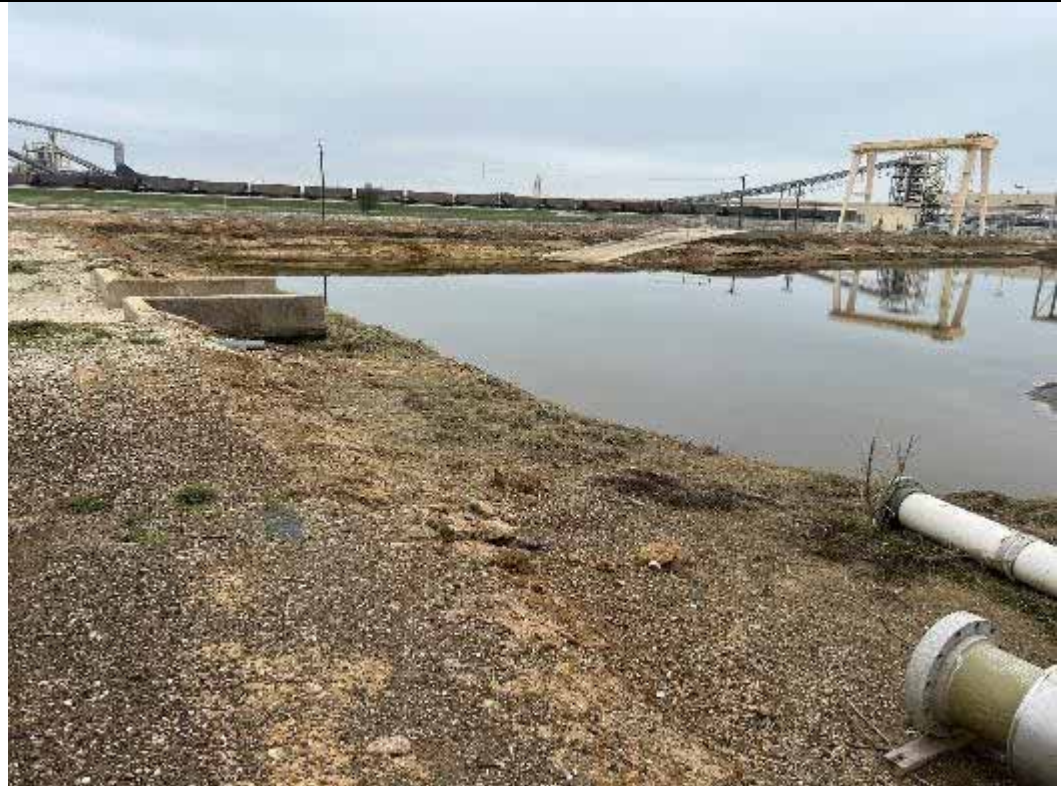
Weekly inspection records from January 3, 2023 through December 28, 2023 reported the growth of young trees on the interior embankments, the need for mowing, and blockage of emergency spillways by gravel. Some accumulated gravel was observed in the spillways at the time of inspection, but does not pose a threat to stability or operation of the CCR unit as it is no longer in operation.

Photograph: 36 South SRH Pond – standing on the northeast corner facing southwest – spillway structure. Photo taken 11/16/2023.
