# Alternative Capacity Infeasibility Demonstration

Sludge Recycle Holding (SRH) Pond  
CPS Energy Calaveras Power Station  
Bexar County, Texas

30 November 2020

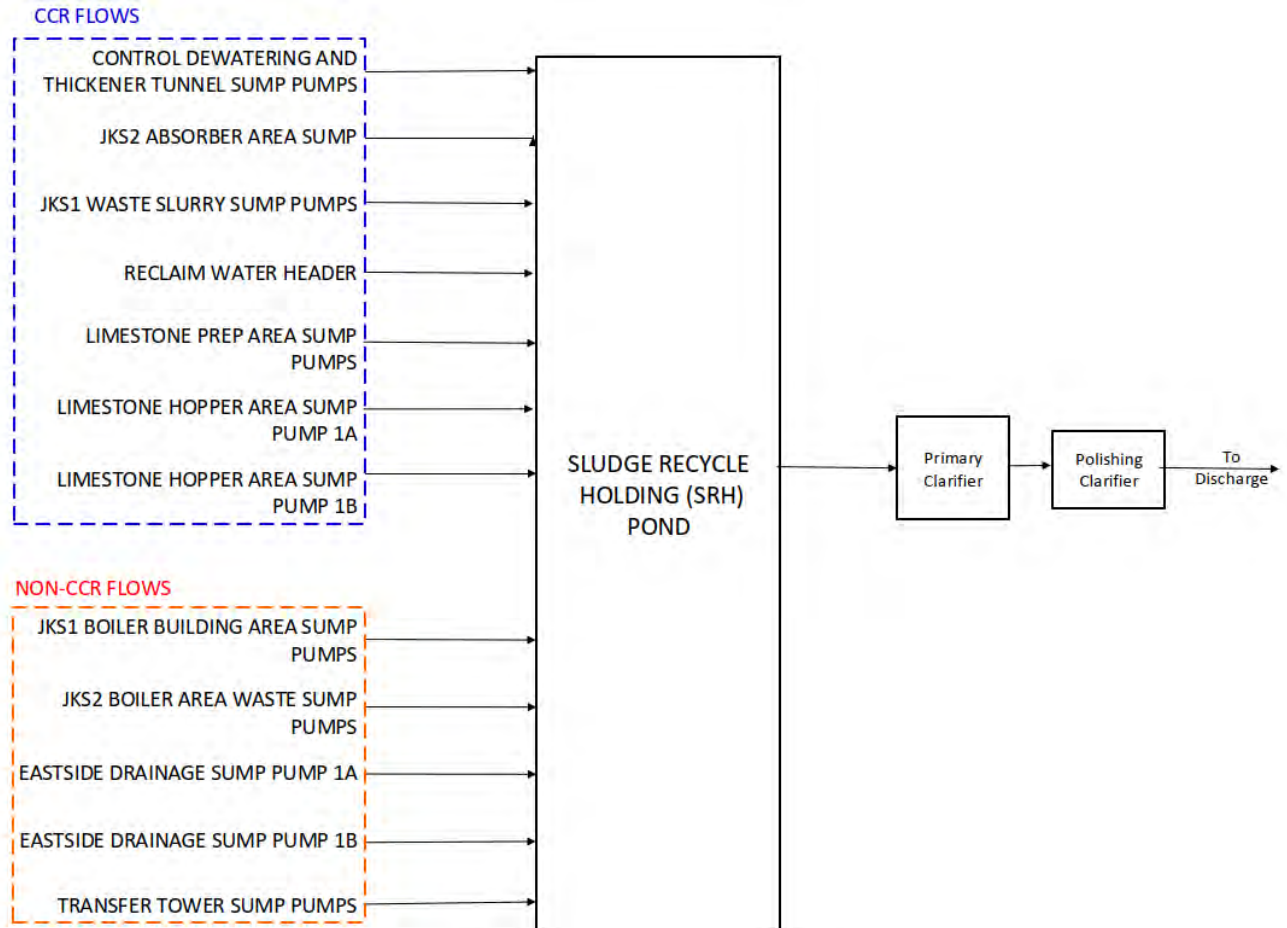
### Exhibit 3.2 – Process Flow Diagram of Current Flows to the SRH Pond

The SRH Pond receives all the FGD system wastewater and various process discharge streams. It also receives low volume waste (LVW) streams that include area runoff, boiler quench water and washdown water collected in plant sumps. The FGD system must be in operation for the J.K. Spruce Plant to comply with regulatory permits and air emission limits for sulfur dioxide. Wastewater must be discharged from the FGD system on a regular basis when the plant is in service. In addition, other FGD system streams are also periodically discharged to the SRH Pond during system upset conditions and to support operations and maintenance activities.

The overall flow to the SRH Pond averages between 100 and 700 gpm, but is highly variable with potential flowrates as high as 6,000 gpm. The solids content in these flows also varies dependent on plant operating conditions and maintenance activities. Some non-CCR flows, such as stormwater runoff, are independent of the plant operating status and can increase significantly in a short period of time. During typical operating conditions, the flow to the SRH Pond ranges between 200,000 and 1,000,000 gallons per day (gpd).

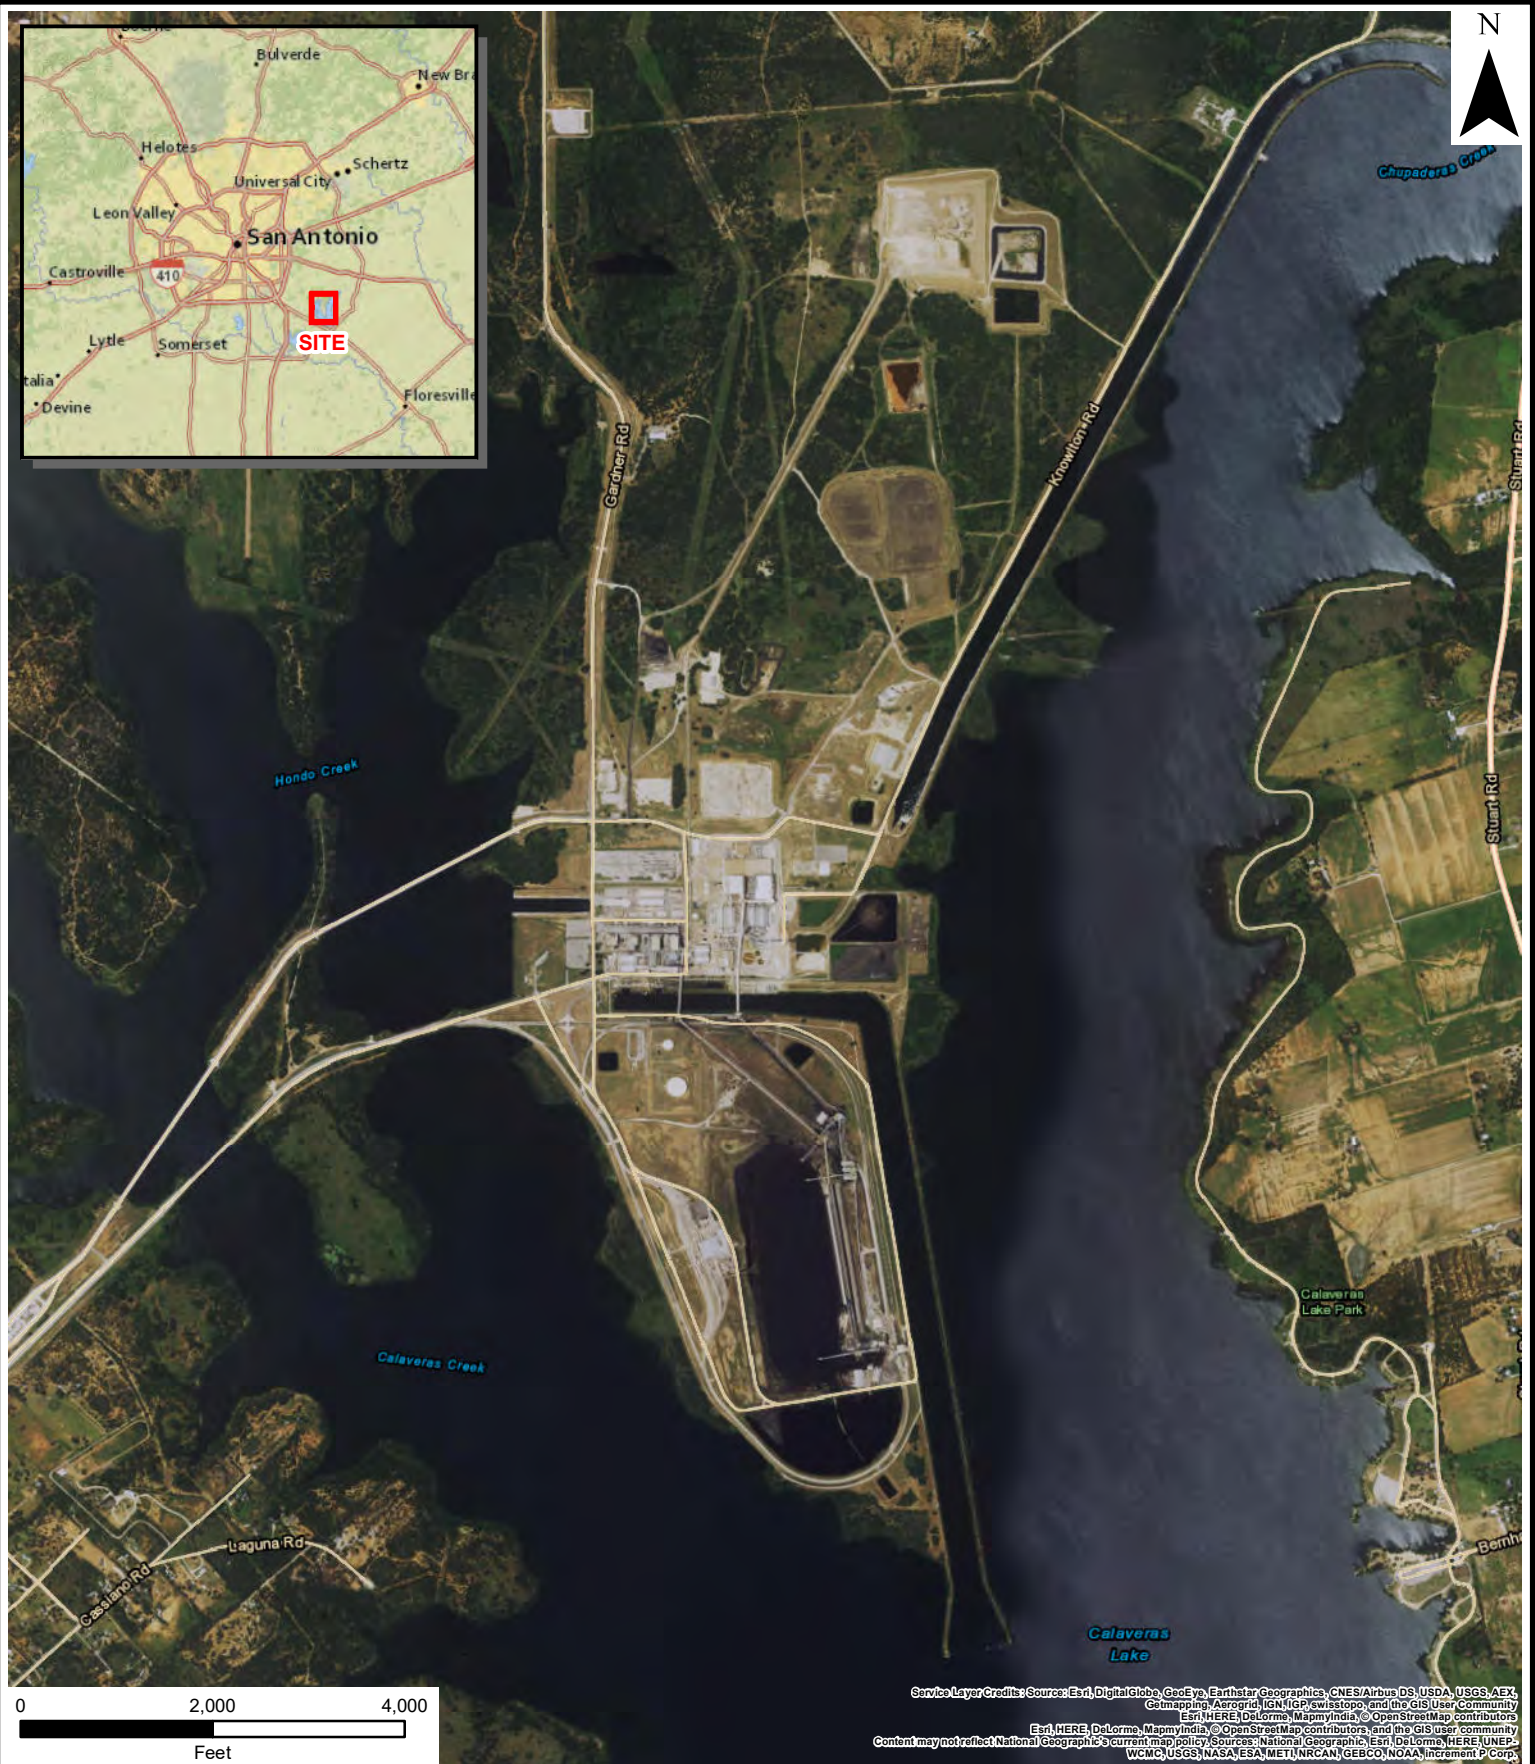
FIGURE 2.1  
FACILITY LOCATION MAP

CPS Energy owns and operates the Calaveras Power Station located at 12940 U.S. Highway 181 South in San Antonio, Texas. A Facility Location Map is provided as Figure 2.1. The Calaveras Power Station consists of three power plants of which two plants (J.T. Deely and J.K. Spruce) are subject to regulation under the CCR Rule. Specifically, CPS Energy operates three CCR units at the Power Station: Evaporation Pond, Fly Ash Landfill, and the SRH Pond. Although the J.T. Deely Power Plant ceased operation at the end of December 2018 and sluiced bottom ash is no longer being received at the Bottom Ash Ponds (BAPs), the BAPs will continue to be monitored until the units have undergone closure. A CCR Unit Location Map is provided as Figure 2.2.

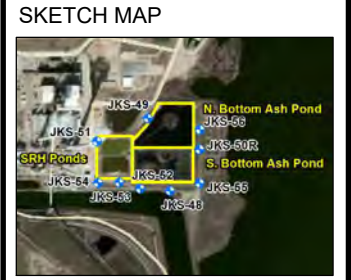
JKS-53  
DRILLING LOG

Proj. No. 0366643 Boring/Well ID JKS-53 Date Drilled 2016-09-02  
 Project Ground Water Investigation - Phase II Owner CPS Energy  
 Location Calaveras Power Station - San Antonio Boring T.D. 27.00' Boring Diam. 8.25"  
 N. Coord. 13659757.34' E. Coord. 2185892.80' Surface Elevation 491.33' Ft. MSL Datum  
 Screen: Type Sch. 40 PVC Diam. 2.00" Length 10.00' Slot Size 0.01"  
 Casing: Type Sch. 40 PVC Diam. 2.00" Length 15.00' Sump Length 0'  
 Top of Casing Elevation 494.74' Stickup 3.41'  
 Depth to Water: 1. Ft. btoc 8.50 ( 2016-05-21 ) 2. Ft. \_\_\_\_\_ ( \_\_\_\_\_ )  
 Drilling Company Strata Core Services, LLC Driller Ryan Spaust  
 Drilling Method Hollow-Stem Auger Log By Andrew Henry

Elevation (Ft MSL)	Depth (Feet)	Graphic Log	Well Construction	Recovery (%)	Lab Sample Data	Description Interval (Feet)	Description/Soil Classification (Color, Texture, Structure)
470	20			100	JKS-53_20-21 USCS: Clayey Sand (SC) AL: 27 / 14 / 13 - #200: 37.6	20-25	CLAYEY SAND: Gray with tannish orange staining; saturated; loose; non-plastic. Non-cohesive grab sample collected from 20'-21' bgs. At 22-22.5' bgs: Color change to orangish light brown; moist. At 22.5-25' bgs: Saturated.
465	25			100		25-27	SAND: Reddish brown mixed with light gray; damp; medium dense; non-plastic; dry and crumbly with depth.  Boring terminated at 27' bgs.
460	30						
455	35						
40	40

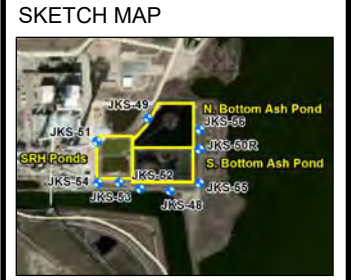
JKS-55  
DRILLING LOG

Proj. No. 0366643 Boring/Well ID JKS-55 Date Drilled 2016-09-06  
 Project Ground Water Investigation - Phase II Owner CPS Energy  
 Location Calaveras Power Station - San Antonio Boring T.D. 25.00' Boring Diam. 8.25"  
 N. Coord. 13659749.76' E. Coord. 2186840.46' Surface Elevation 490.13' Ft. MSL Datum  
 Screen: Type Sch. 40 PVC Diam. 2.00" Length 10.00' Slot Size 0.01"  
 Casing: Type Sch. 40 PVC Diam. 2.00" Length 15.00' Sump Length 0'  
 Top of Casing Elevation 493.81' Stickup 3.68'  
 Depth to Water: 1. Ft. btoc 8.36 ( 2016-05-21 ) 2. Ft. \_\_\_\_\_ ( \_\_\_\_\_ )  
 Drilling Company Strata Core Services, LLC Driller Ryan Spaust  
 Drilling Method Hollow-Stem Auger Log By Andrew Henry

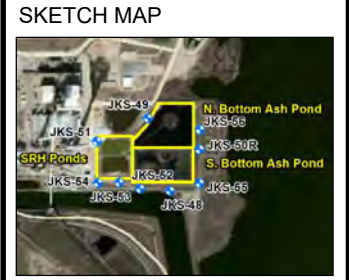
JKS-56  
DRILLING LOG

Proj. No. 0366643 Boring/Well ID JKS-56 Date Drilled 2016-09-06  
 Project Ground Water Investigation - Phase II Owner CPS Energy  
 Location Calaveras Power Station - San Antonio Boring T.D. 25.00' Boring Diam. 8.25"  
 N. Coord. 13660382.47' E. Coord. 2186847.61' Surface Elevation 493.07' Ft. MSL Datum  
 Screen: Type Sch. 40 PVC Diam. 2.00" Length 15.00' Slot Size 0.01"  
 Casing: Type Sch. 40 PVC Diam. 2.00" Length 10.00' Sump Length 0'  
 Top of Casing Elevation 496.66' Stickup 3.59'  
 Depth to Water: 1. Ft. btoc 11.20 ( 2016-05-21 ) 2. Ft. \_\_\_\_\_ ( \_\_\_\_\_ )  
 Drilling Company Strata Core Services, LLC Driller Ryan Spaust  
 Drilling Method Hollow-Stem Auger Log By Andrew Henry

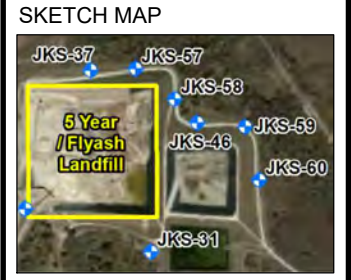
JKS-57  
DRILLING LOG

Proj. No. 0366643 Boring/Well ID JKS-57 Date Drilled 2016-09-07  
 Project Ground Water Investigation - Phase II Owner CPS Energy  
 Location Calaveras Power Station - San Antonio Boring T.D. 27.50' Boring Diam. 0.00"  
 N. Coord. 13668235.72' E. Coord. 2187486.38' Surface Elevation 503.83' Ft. MSL Datum  
 Screen: Type Sch. 40 PVC Diam. 2.00" Length 15.00' Slot Size 0.01"  
 Casing: Type Sch. 40 PVC Diam. 2.00" Length 12.00' Sump Length 0'  
 Top of Casing Elevation 506.91' Stickup 3.08'  
 Depth to Water: 1. Ft. btoc 20.07 ( 2016-05-21 ) 2. Ft. \_\_\_\_\_ ( \_\_\_\_\_ )  
 Drilling Company Strata Core Services, LLC Driller Ryan Spaust  
 Drilling Method Hollow-Stem Auger Log By Andrew Henry

Elevation (Ft MSL)	Depth (Feet)	Graphic Log	Well Construction	Recovery (%)	Lab Sample Data	Description Interval (Feet)	Description/Soil Classification (Color, Texture, Structure)
480	20	[Graphic Log]	[Well Construction]	100			At 20-21' bgs: Mostly sand with yellow and trace iron-oxide staining. At 21-21.5' bgs: 2" thick layer of reddish brown, hard-packed sand; 4" thick layer of tan, very fine grained, loose sand. At 21.5-25' bgs: Mostly dark gray clay; At 22.5' bgs: Reddish brown coloration;
475	25	[Graphic Log]	[Well Construction]	100		25-25.5 25.5-27	At 24-25' bgs: Color is brownish gray with redox stippling. SAND: Gray; fine grained; dry; medium dense; low plasticity. At 25.5' bgs: Very thin (1/8" thick) brownish red coloration. INTERBEDDED CLAY AND SAND: Brownish gray clay interbedded with fine grained sand; dense; hard-packed.
470	30	[Graphic Log]	[Well Construction]			27-27.5	At 26.6' bgs: Thin, tan, dry, very fine grained, sand. SAND: Highly cemented; reddish brown nodules present. Refusal encountered at 27.5' bgs.

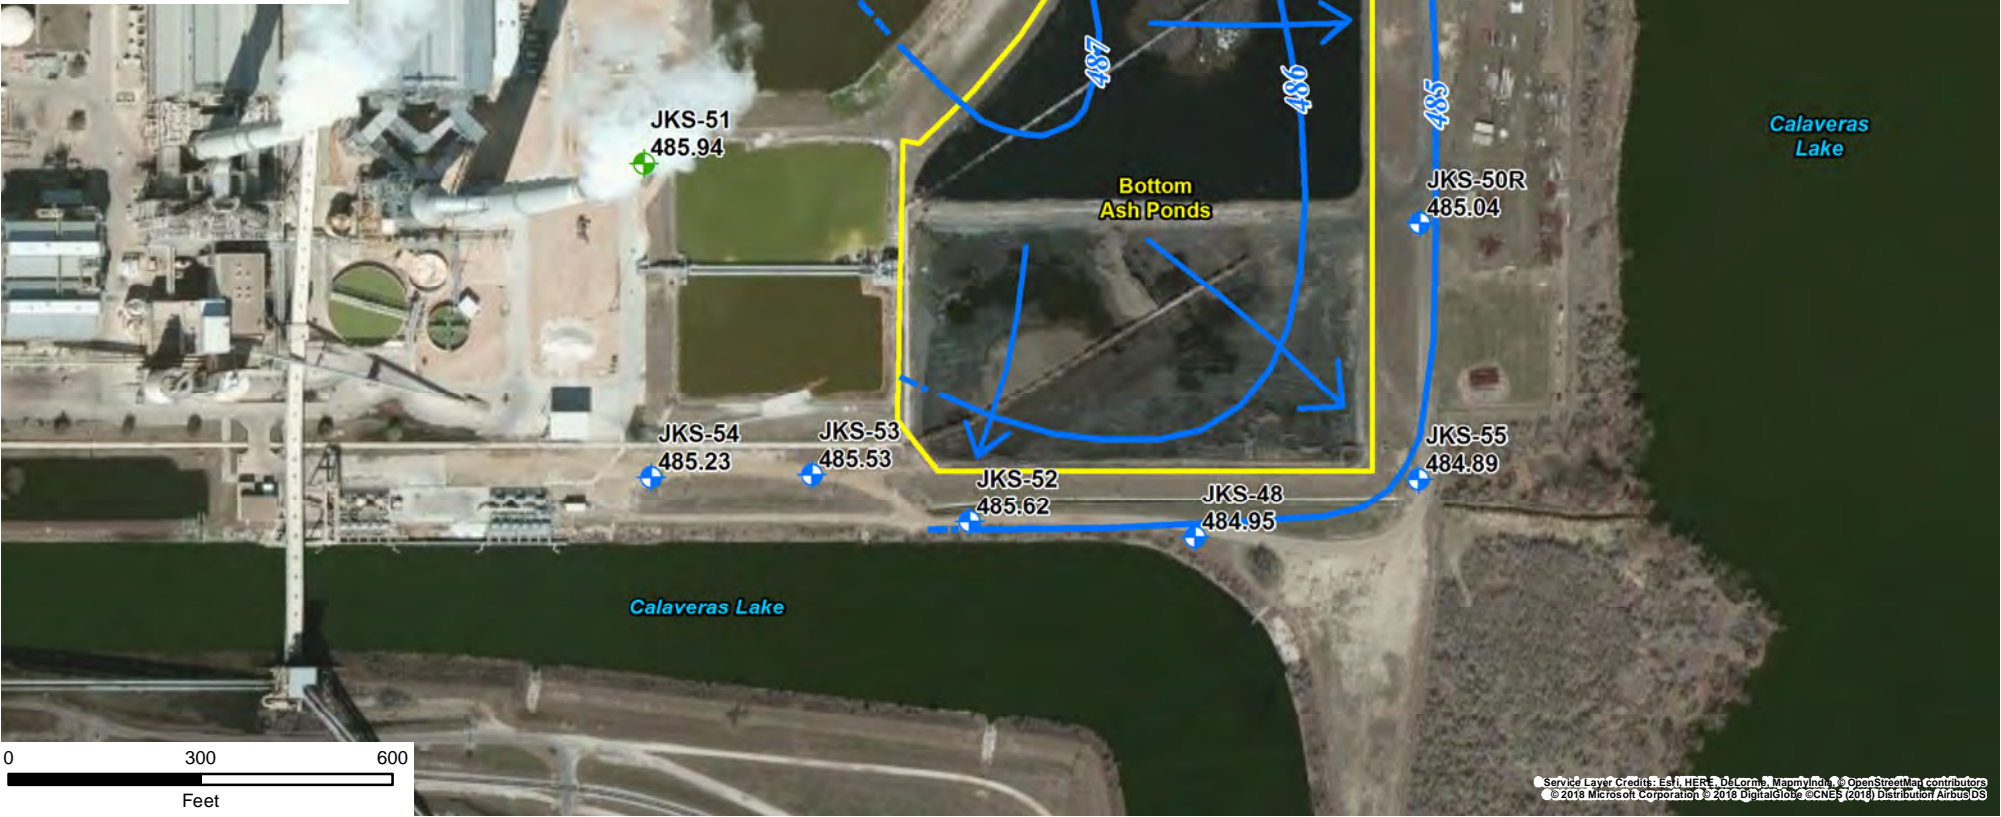
POTENTIOMETRIC SURFACE MAP -  
OCTOBER 2017  
Bottom Ash Ponds CCR Unit  
CPS Energy - Calaveras Power Station  
San Antonio, Texas

Potentiometric Surface Elevation (Feet, Mean Sea Level)

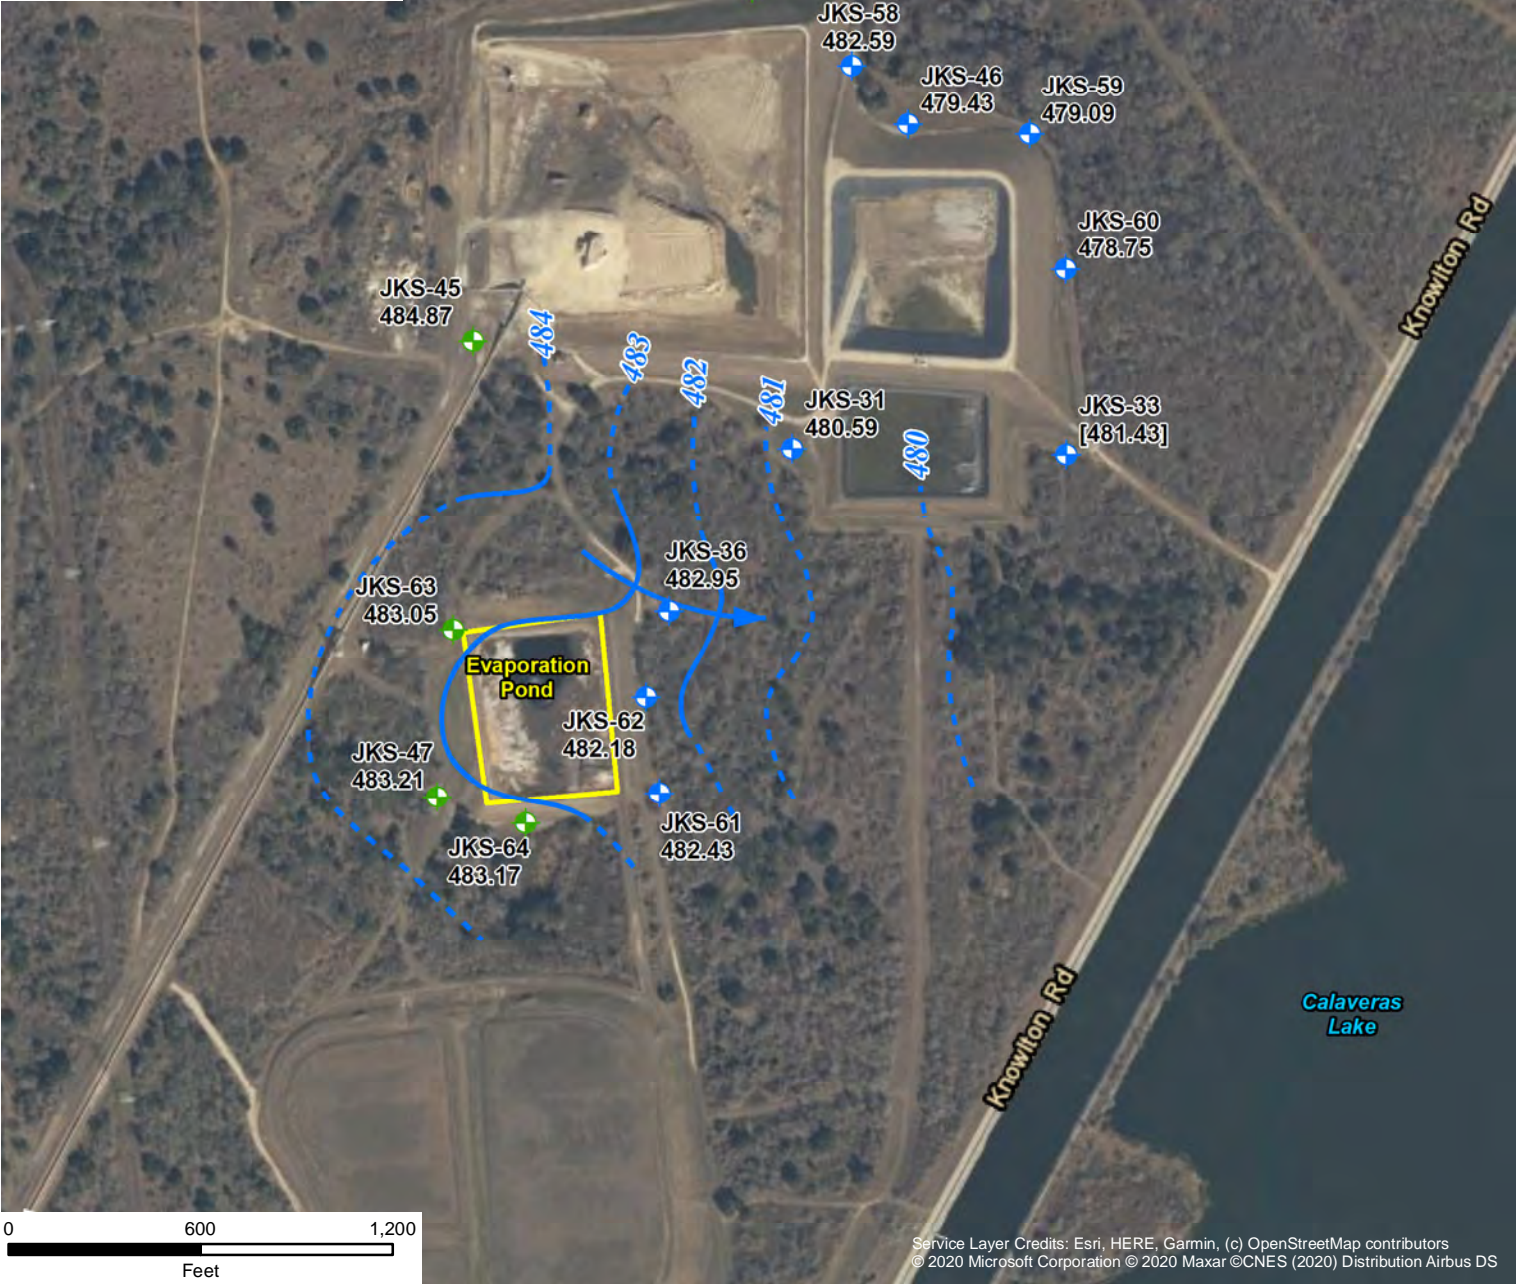
POTENTIOMETRIC SURFACE MAP -  
 APRIL 2018  
 Evaporation Pond CCR Unit  
 CPS Energy - Calaveras Power Station  
 San Antonio, Texas

Groundwater Flow Direction
  - 484.87 Potentiometric Surface Elevation (Feet, Mean Sea Level)
  - [481.43] Potentiometric Surface Elevation not considered for contouring

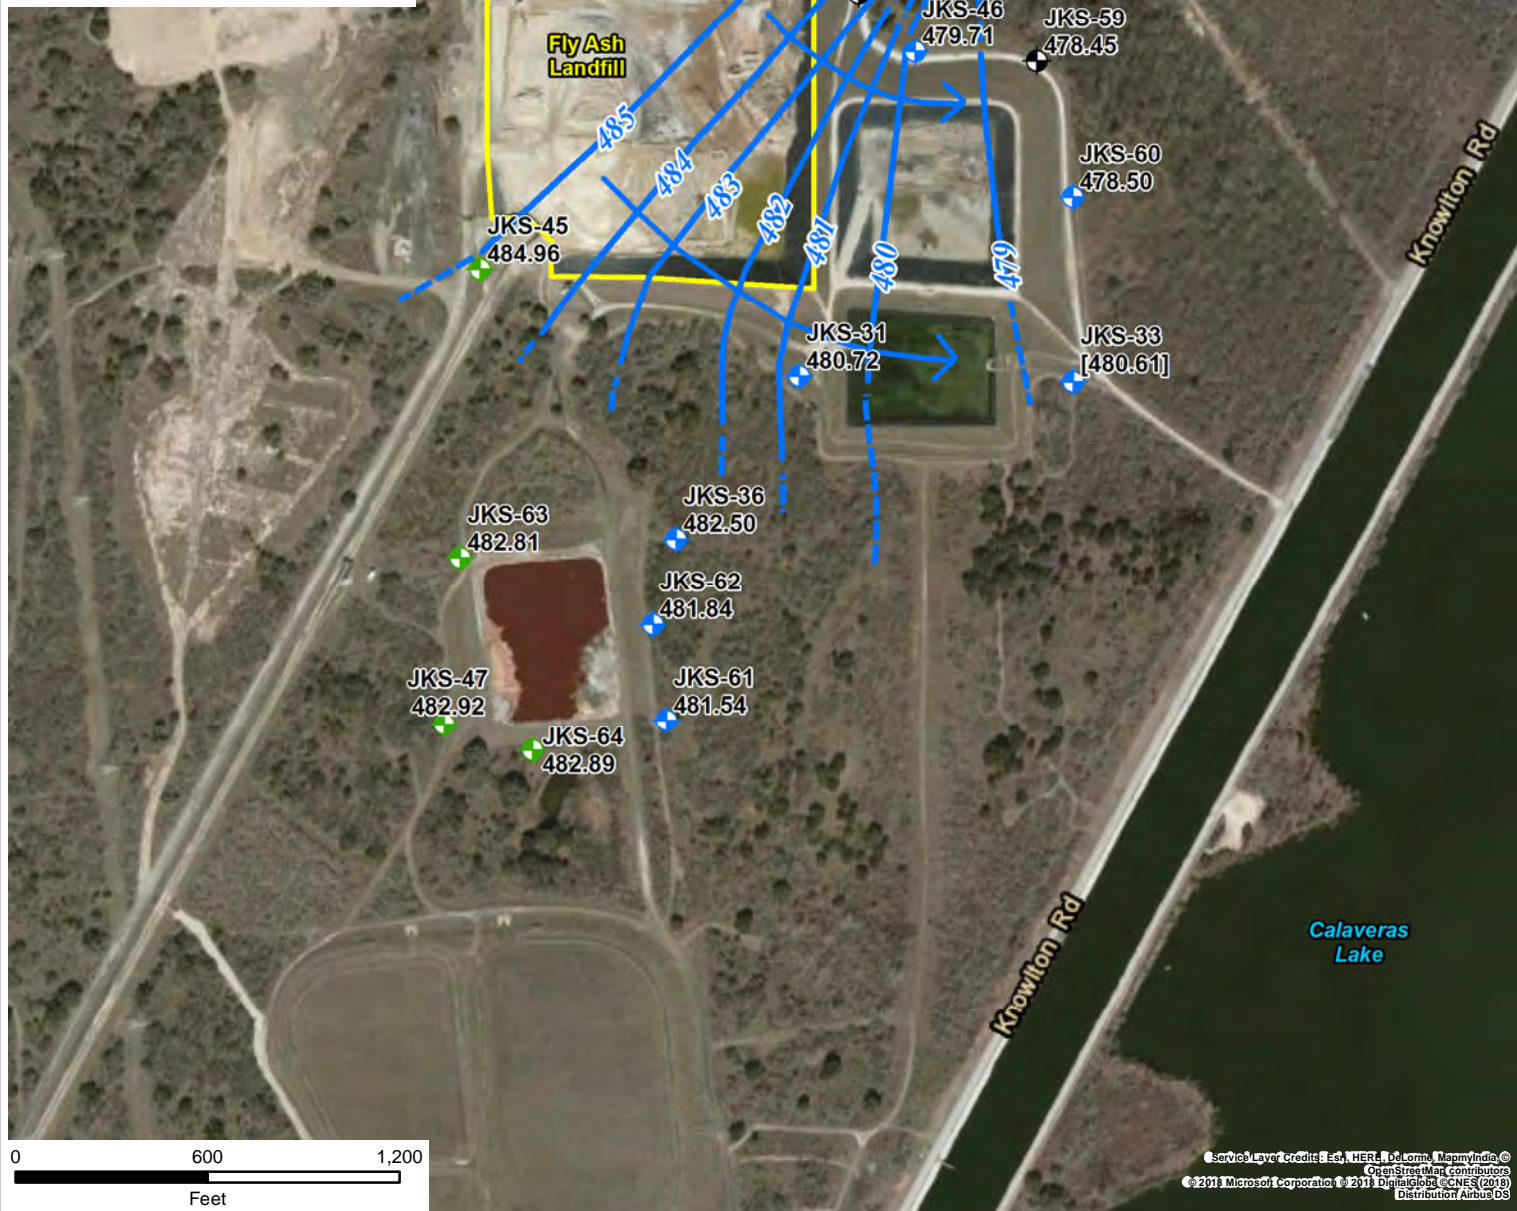
POTENTIOMETRIC SURFACE MAP -  
 OCTOBER 2017  
 Fly Ash Landfill CCR Unit  
 CPS Energy - Calaveras Power Station  
 San Antonio, Texas

Groundwater Flow Direction
- 484.96 Potentiometric Surface Elevation (Feet, Mean Sea Level)
- [480.61] Elevations in brackets were not utilized to contour potentiometric surface

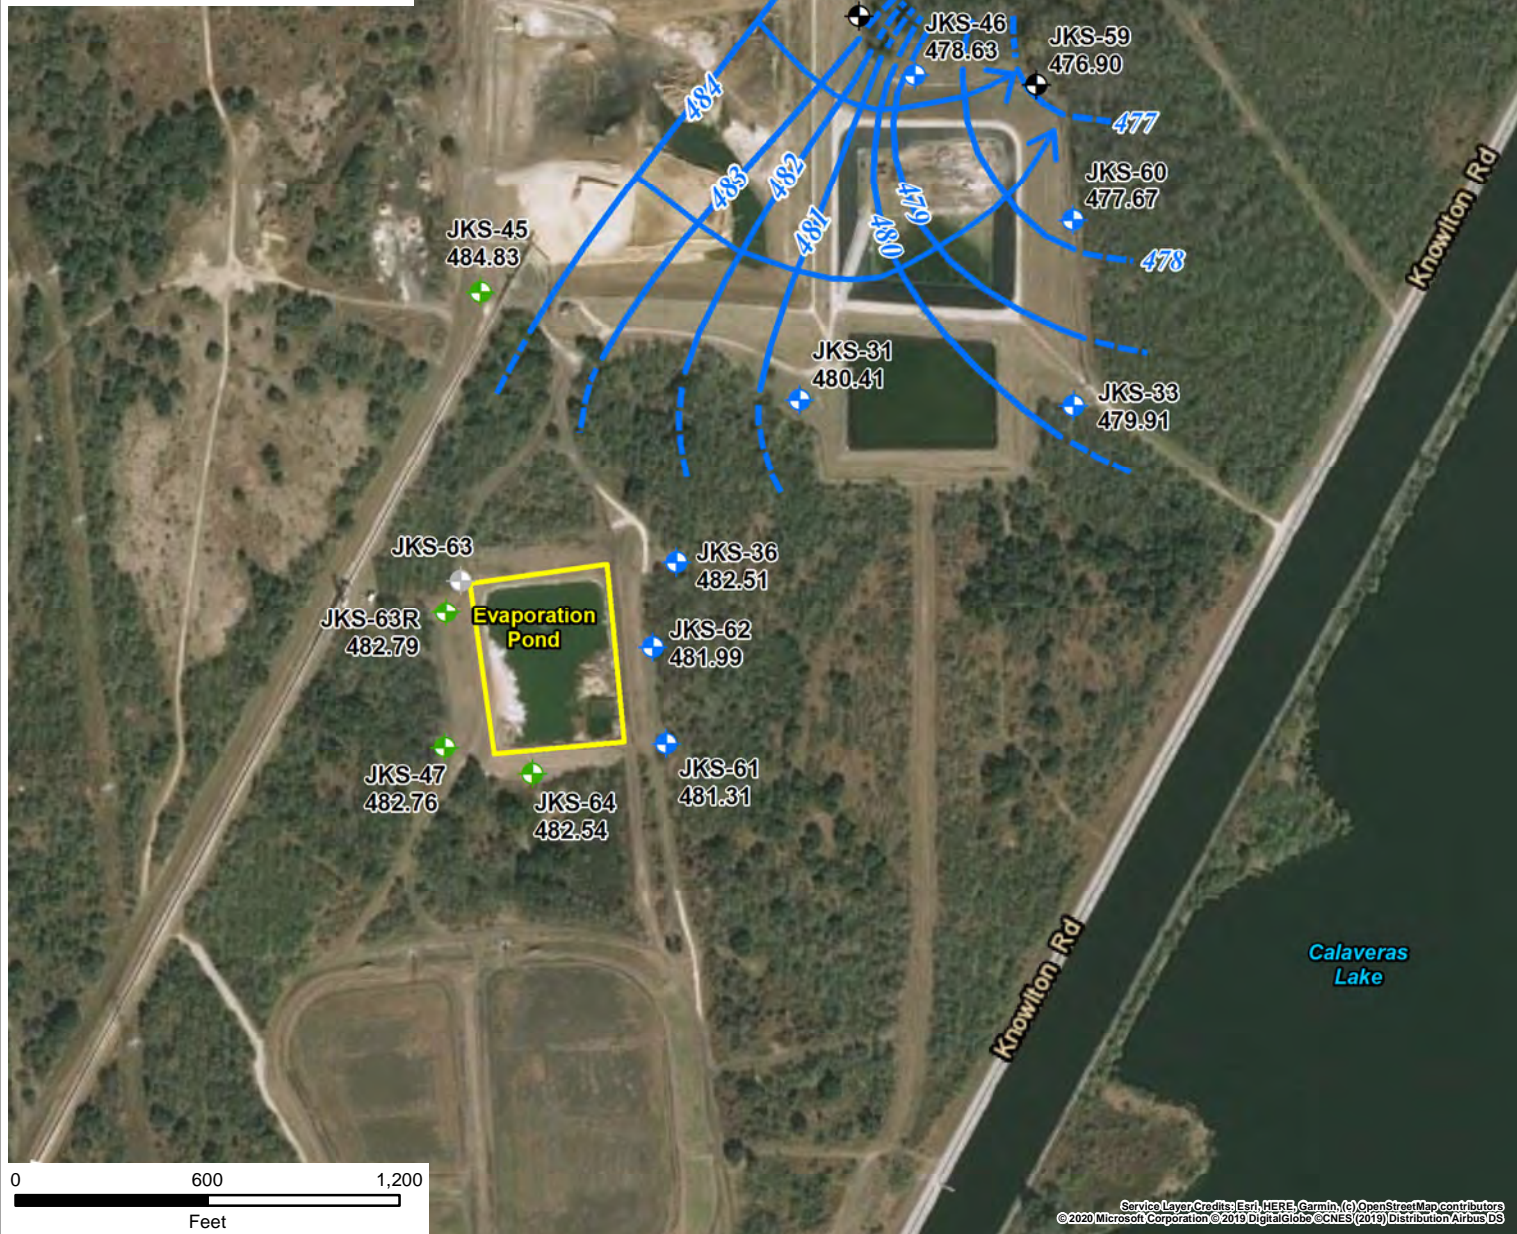
POTENTIOMETRIC SURFACE MAP -  
 OCTOBER 2019  
 Fly Ash Landfill CCR Unit  
 CPS Energy - Calaveras Power Station  
 San Antonio, Texas

Groundwater Flow Direction
- 484.83 Potentiometric Surface Elevation (Feet, Mean Sea Level)
